Roundabout Access for Visually Impaired Pedestrians: Evaluation of a Yielding Vehicle Alerting System for Double-Lane Roundabouts

Two experiments evaluated the feasibility of a pavement treatment to alert blind pedestrians when vehicles have yielded to them at double-lane roundabouts. The first experiment was conducted on a closed course with seven visually impaired individuals. The pavement treatment resulted in significantly more and quicker yield detections than the control condition. However, the number of false positive detections was problematic. The second experiment was conducted at an operating double-lane roundabout with five of the participants from the first study. In the field, the pavement treatment was not effective, probably because the majority of vehicles that yielded did not reach the treated area before stopping. The results were not encouraging for the development of alerting systems at double-lane roundabouts. The challenges to be overcome before an alerting system might be feasible are discussed.

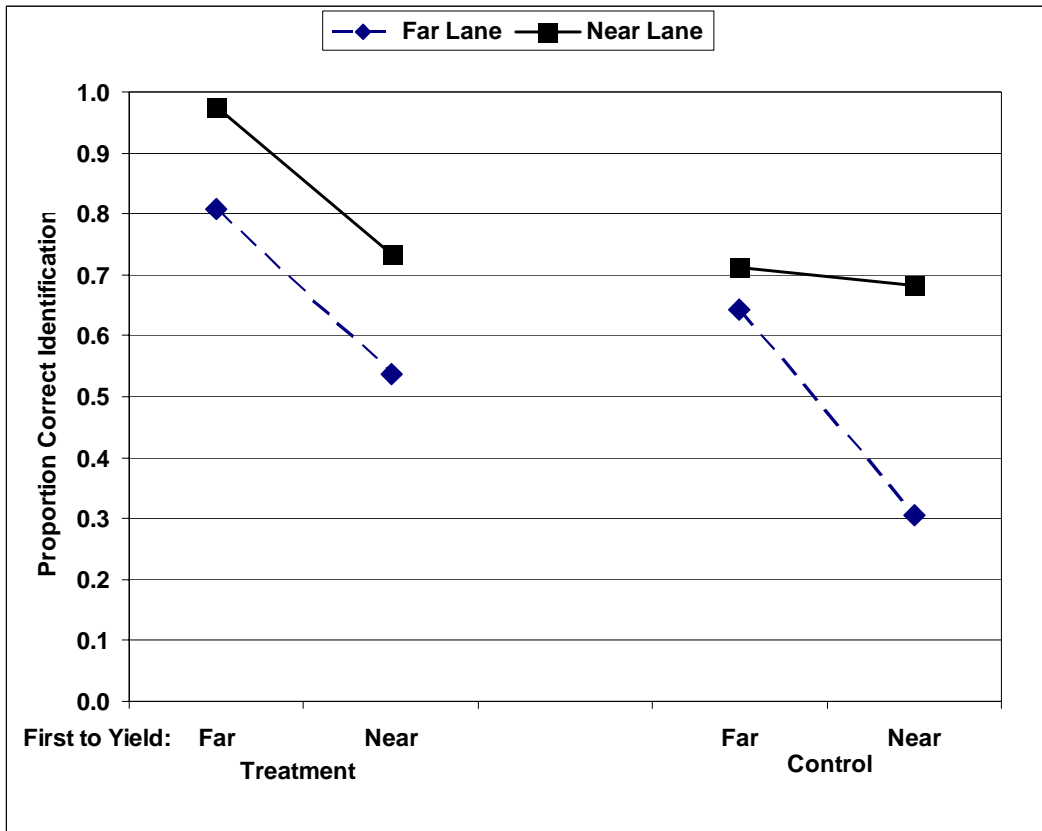
Figure 1. Proportion of correct identifications of stopped vehicles by test condition, first to yield lane, and the lane.

Figure 1 shows the proportion of correct identifications of stopped vehicles by condition, lane, and the lane in which the first yield occurred. Overall, performance was better in the treatment condition, $F(1, 6) = 15.4, p < 0.01$. Identification tended to be more accurate when the first vehicle to yield was in the far lane, $F(1, 6) = 12.3, p < 0.05$. The 3-way interaction of condition, lane to yield first, and lane was significant, $F(1, 6) = 10.4, p < 0.05$. In the control condition, performance in detecting yields in the near lane was little affected by the whether there was a stopped vehicle in the far lane. However, detection was poorest of vehicles yielding in the far lane when a vehicle was already idling in the near lane. In the treatment condition, there were no interactions. Near lane detection was consistently better than far lane detection, and both near and far lane detection was better when the vehicle in the far lane was the first to yield.

The first vehicle to yield creates noise as it idles at the crosswalk. When it idles in the lane nearest the participant, that noise can mask the later arrival of a second vehicle in the far lane. Participants were able to detect only 30 percent of the vehicles that yield in the far lane when there was a vehicle already idling in the near lane. However, when the first vehicle to yield is in the far lane, the participant can usually detect the arrival of a second vehicle that comes between the participant and the vehicle in the far lane. When a vehicle yielded in the near lane, between the participant and a vehicle already stopped in the far lane, detection performance averaged 98 percent correct detections.

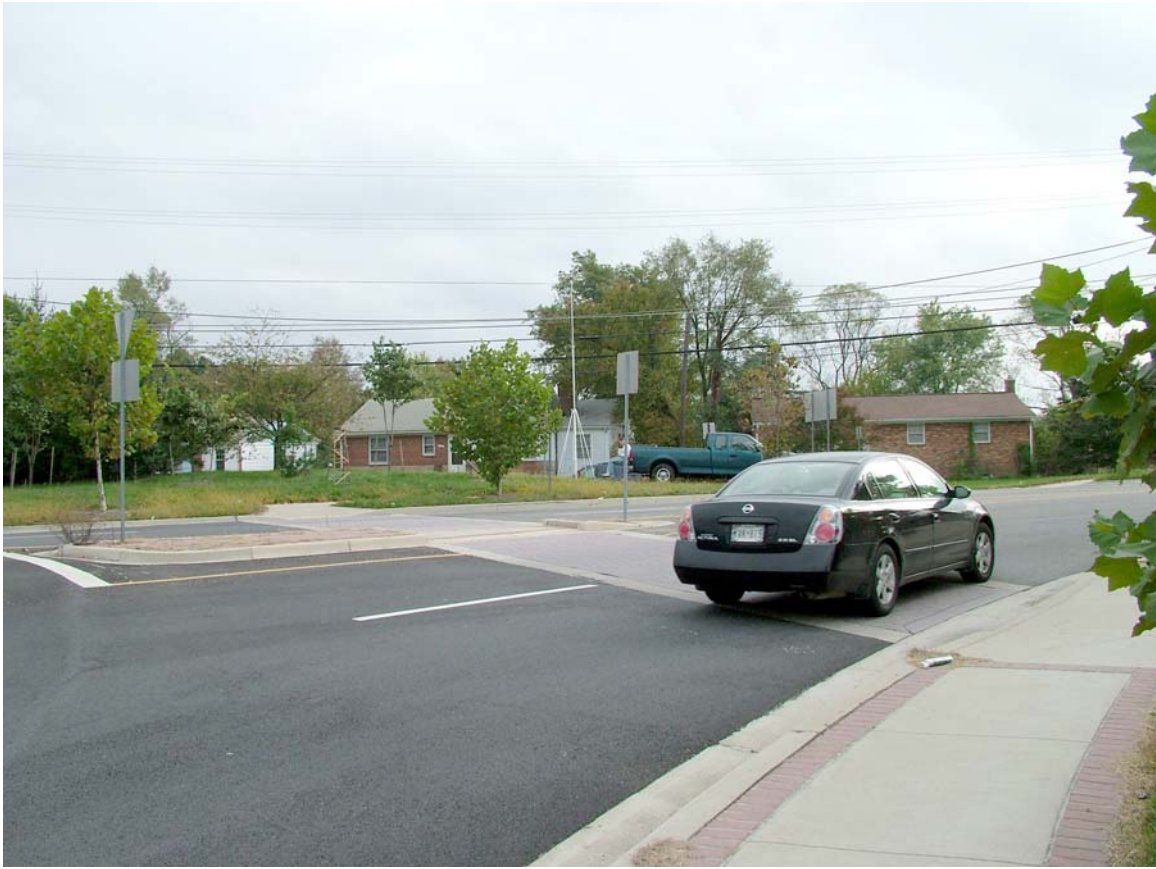
Figure 2. Roundabout exit in baseline configuration.

This study was conducted at a double-lane roundabout in Maryland. The roundabout had an inscribed circle diameter of 159 ft. It was a junction of a 4-lane road with a two-lane road. The exit used in the study had two 5 m (16 ft) lanes. The roadway itself was a dark colored asphalt. Two concrete transverse strips designated the crosswalk with brickwork between the strips. The exit is shown in Figure 2.

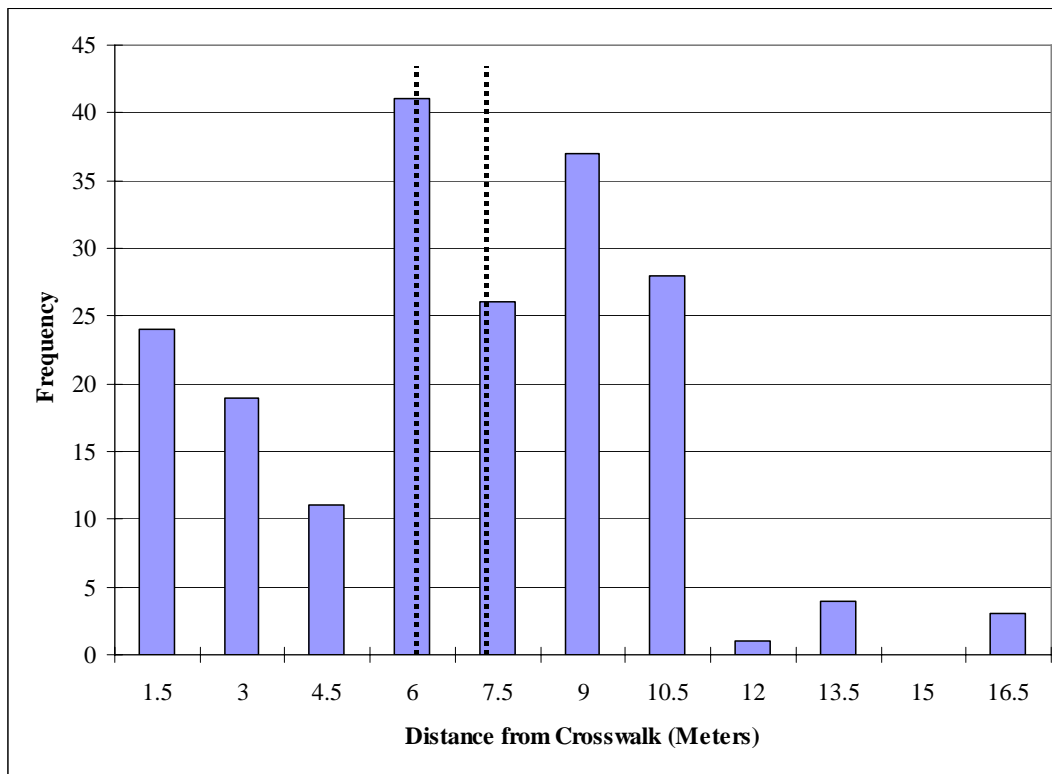
Figure 3. Distance from crosswalk of vehicles stopping in the near lane.

Although the in-street sign may have increased compliance with state law, the nature of the compliance was less than optimal for the effectiveness of the sound-strip treatment. Figure 3 shows the longitudinal distance from the crosswalk to the front of vehicles that stopped in the near lane. Dotted lines in the figure represent the distance from the crosswalk of the sound strips. It can be seen that the majority of vehicles in the near lane did not fully traverse the strips. Figure 4 shows a video capture of two vehicles that stopped well upstream of the crosswalk and, thus, did not cross the sound strips. Vehicles that stopped 6 meters from the crosswalk would have crossed the furthest upstream strip with their front wheels. Their rear wheels would not have crossed either of the upstream sound strips.

Only drivers that stopped within 2 meters of the crosswalk would be likely to have triggered sounds from both upstream strips with both front and rear wheels. Thus, only 24 of the 194 vehicles that stopped in the near lane are likely to have generated the intended sound pattern.

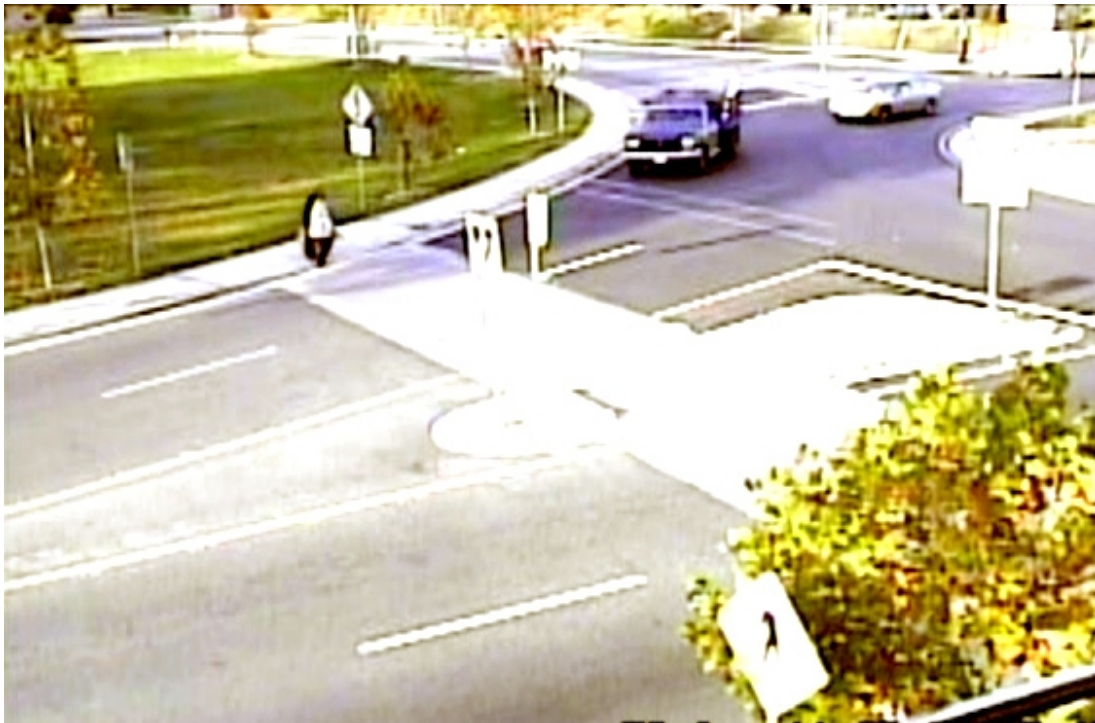
Figure 4. Two vehicles that stopped for the pedestrians.

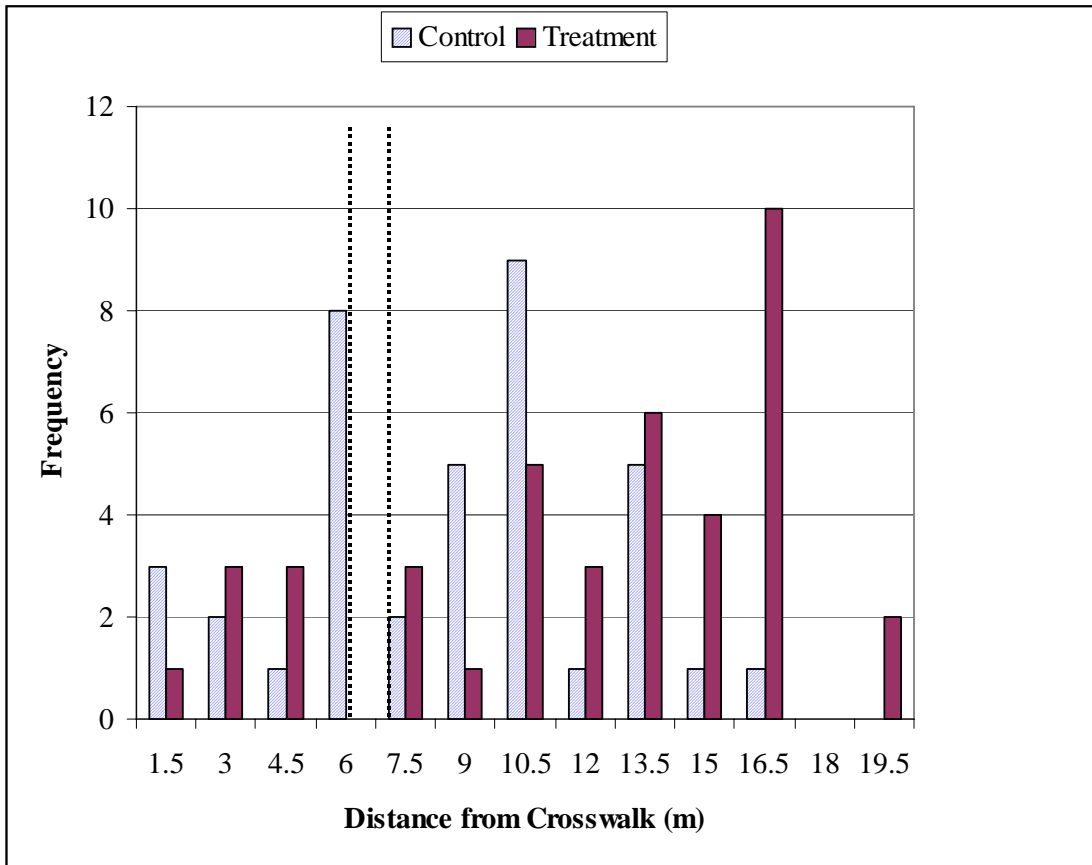
Figure 5. Distance from crosswalk that vehicles in the far lane stopped is shown as a function of treatment condition.

In the near lane, stopping distance from the crosswalk did not vary significantly with treatment, $t(77) = 0.061$, $p > 0.10$. However, vehicles that stopped in the far lane stopped further from the crosswalk in the treatment condition than in the control condition, $t(77) = 3.4$, $p < 0.01$. Figure 5 shows the distribution of far-lane stopping distances in the control and treatment conditions. We have no explanation for this unexpected phenomenon.

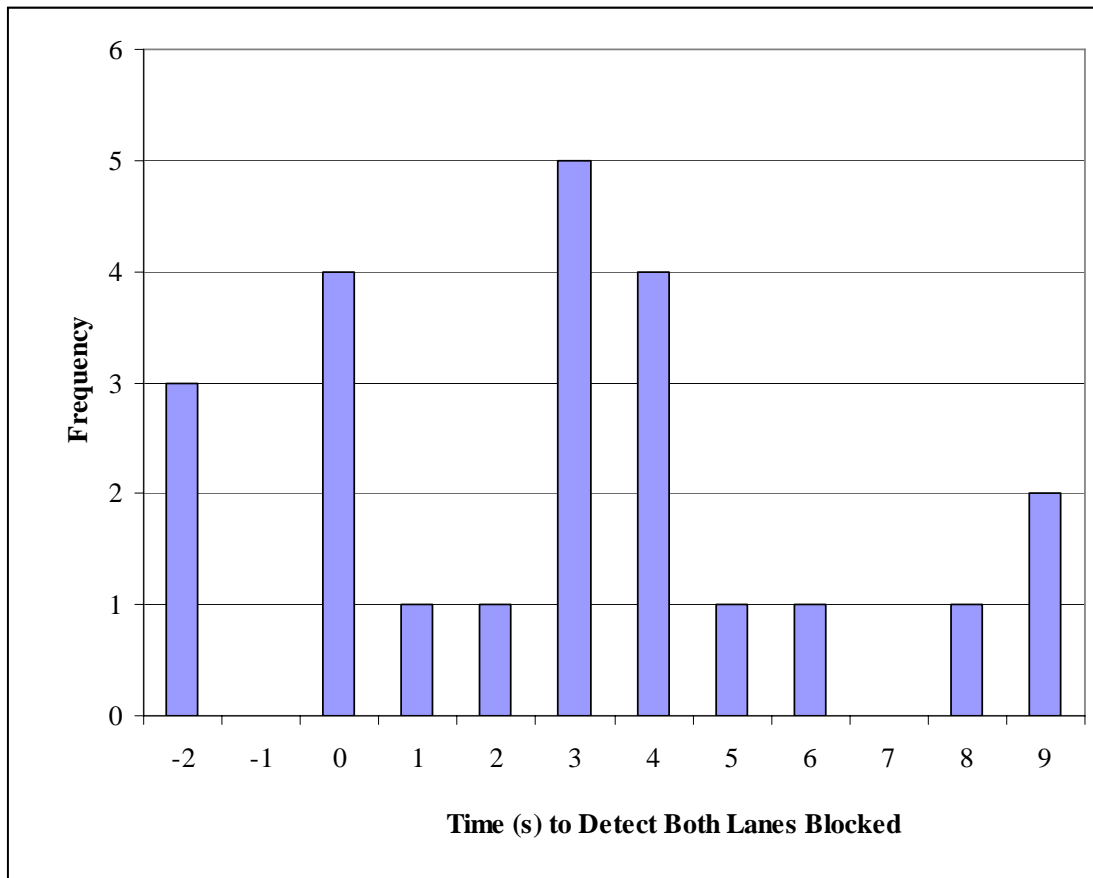
Figure 6. Frequencies of delay between the time both lanes were blocked by stopped vehicles and correct detection of that state by participants.

Figure 6 shows the distribution of delays between the time both lanes were blocked by fully stopped vehicles and the time when participants indicated that the lanes were blocked. The modal delay is 3 s. In three cases participants identified the blocked lanes 2 s before both vehicles came to a complete stop. This apparent anomaly may be attributed to participants shifting from the strategy they normally use to detect stopped vehicles – listening for idling engines – to listening for silence after detecting approaching vehicles.

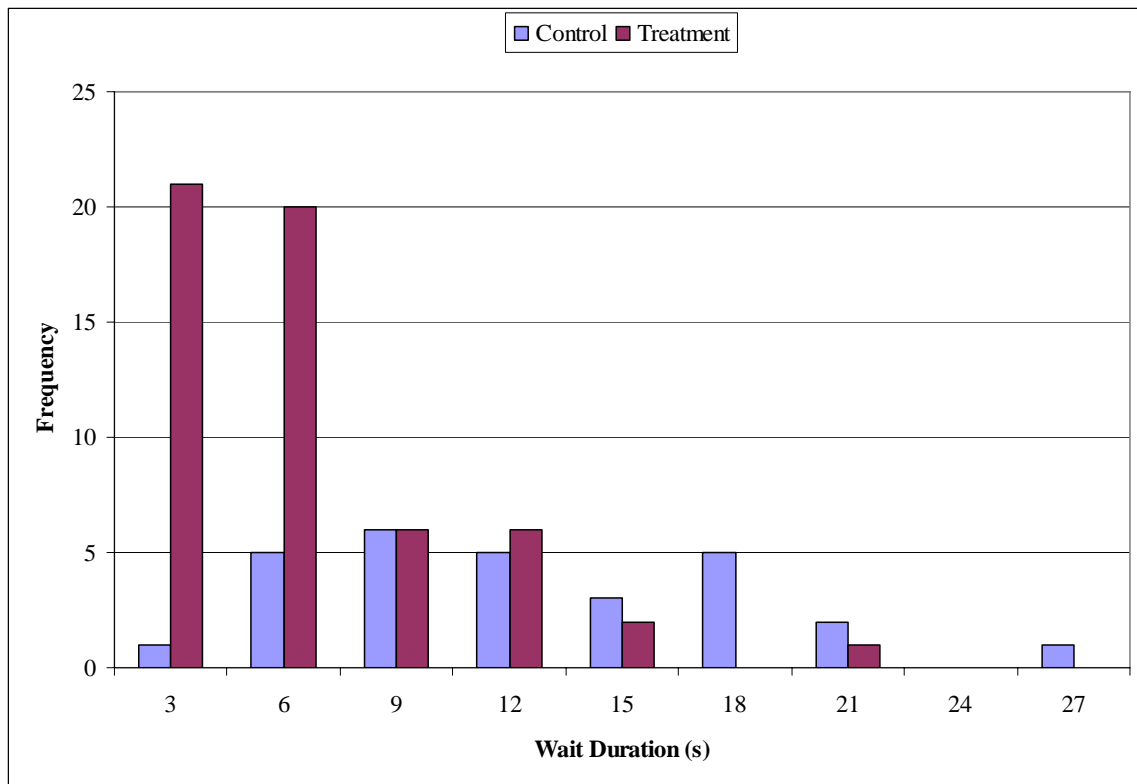
Figure 7. Amount of time drivers waited before moving on.

When the pedestrians do not immediately begin to cross, drivers may move on. To provide an estimate of how long drivers may wait, the amount of time drivers waited was tabulated. If the pedestrians crossed or stepped away from the curb, then the amount of time drivers waited was not included. This procedure yielded delay times for 28 drivers in the control condition and 56 drivers in the treatment condition. In the control condition, drivers waited an average 10.8 s. In the treatment condition, drivers waited an average of 4.7 s. In the control condition, wait times varied between 1 and 25 s. In the treatment condition, wait times varied between 1 and 20 s. The difference in willingness to wait was statistically reliable, $t(39) = 5.1$, $p < 0.01$. The difference in willingness to wait may have been because drivers who were induced to stop by the in-street sign were not as committed to wait as drivers were who stopped without the added inducement. If this hypothesis is correct, then the benefit of in-street signs to visually impaired pedestrians is diminished. The bulk of the drivers who are influenced by the sign appear to be willing to wait only 3 s to 6 s. Thus, these drivers may pull away just as the visually impaired pedestrian begins to cross.
