Performance Evaluation of Tall Oil Pitch Emulsion for Stabilizing Unpaved Forest Road Surfaces

D.M. Bennett, *Forest Engineering Research Institute of Canada*

K. Gleeson, *British Columbia Ministry of Forests, Canada*

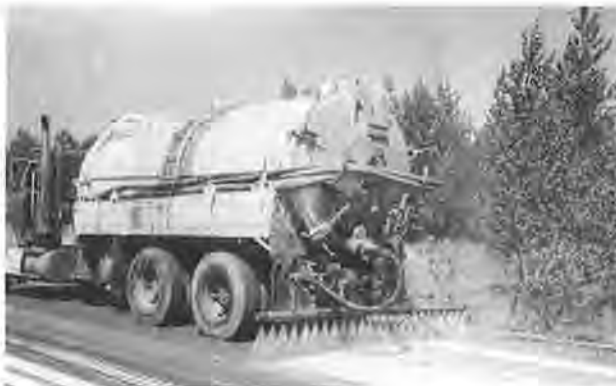
FIGURE 1 Emulsion application.

B.C. Chemicals Ltd. employed a contractor (Lobol Enterprises Ltd., Prince George, British Columbia) to apply the emulsion to the test road during two 12-hr periods on a weekend. A 25 percent water solution of TOP emulsion was specified for the trial. Two tanker trucks with capacities of 16 000 L and 35 000 L and one quad-axle tanker trailer carrying 19 000 L were used to transport a 50 percent solution to the work site from the Prince George plant. Water was added at the site to dilute the emulsion to the required concentration. The tankers, equipped with spray bars (Figure 1), applied the emulsion to the road surface and refilled from the trailer before returning to the plant 23 km away to reload.

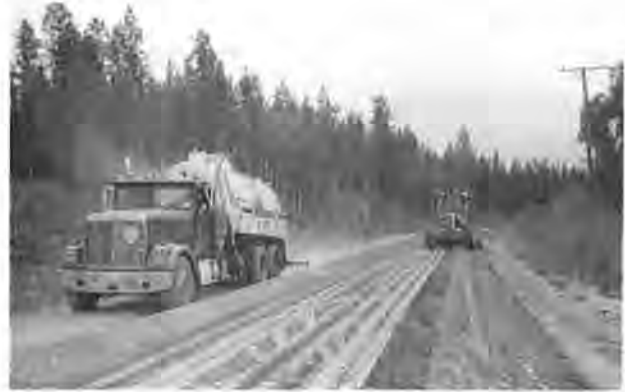
FIGURE 2 Motor grader spreads aggregate before each spray coat.

Two motor-graders prepared the road surface and blended the emulsion into the aggregate. One grader, equipped with carbide-tipped picks on the cutting edges, worked ahead of the application equipment, recovering material from the road shoulders and blading the surfacing aggregate into two windrows, one on each side of the road. The second grader, equipped with straight cutting edges, retrieved a portion of material from the windrow and spread a thin layer of aggregate in preparation for each spray coat of emulsion (Figure 2). To minimize disruption of traffic, the application was completed on successive subsections approximately 1 to 1.3 km long.

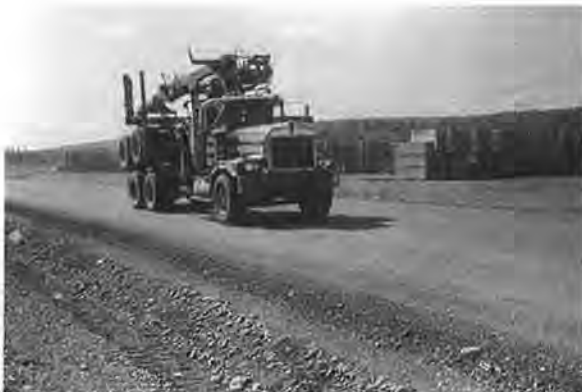
FIGURE 5 Treated road surface.

4). Maintenance managers found that industrial and public users appreciated the dust-free driving conditions. Figures 5 and 6 illustrate the differences in dustfall generated by vehicles passing over the treated and untreated sections on the same day.

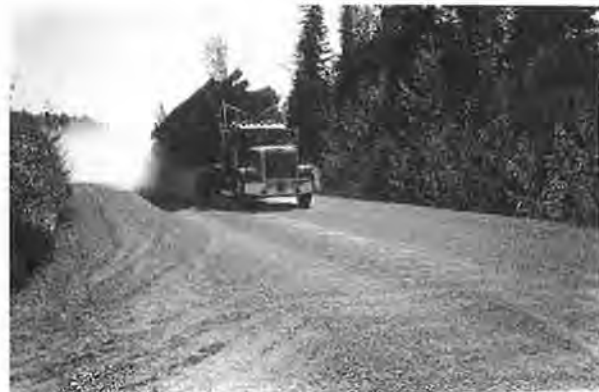
FIGURE 6 Adjacent untreated road section.

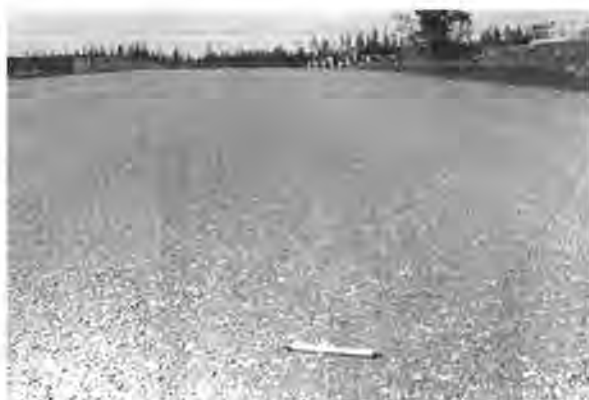
FIGURE 7 Surface performing well after 14 months of treatment.

In June 1993, after more than 1 year of service, strips of potholes had formed over much of the road surface of the treated section. Rather than attempting repairs, much of the treated section was ripped up and reshaped with a motor grader. However, the surface of one 500-m subsection remained remarkably smooth and well stabilized and was left intact (Figure 7).
