# Controlling Lead-Based Paint Emissions During Rehabilitation of the Williamsburg Bridge: A Partnering Approach

Ralph D. Csogi, *Greenman-Pedersen, Inc.*

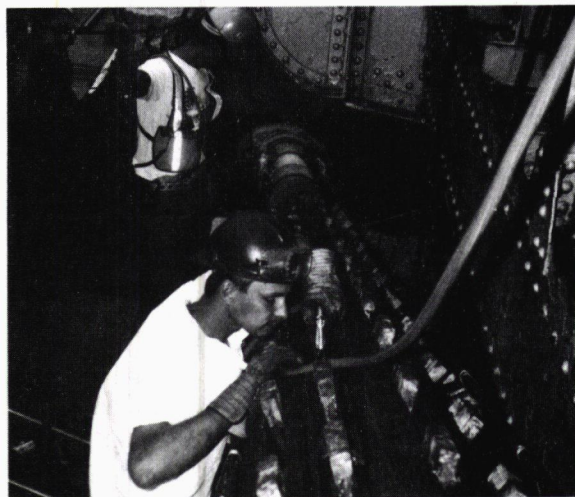
FIGURE 1 Typical main cable wedging arrangement.

rosion by-products. The main cable is then opened into "slots" by driving wooden or plastic wedges in a radial pattern into the cable at 18-in. (45-cm) intervals; Figure 1 shows details of this arrangement. Raw linseed oil is poured into these slots and allowed to penetrate into the interior wire areas of the cable. Waste oil is collected using a series of troughs, hoses, and drums.

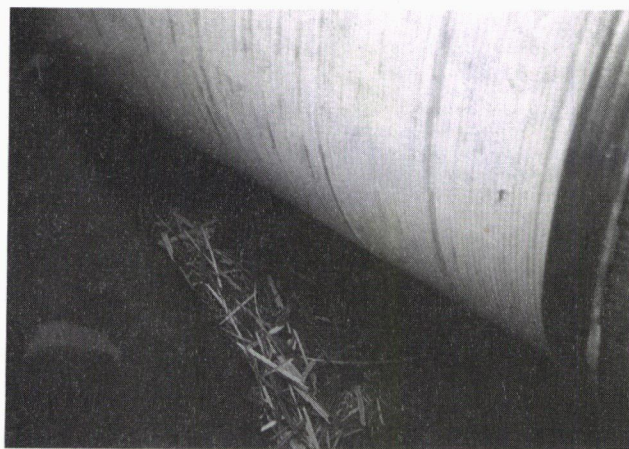
FIGURE 3 Containment system for wire wrapping removal and cleaning operations (top); paint chips contained in tarp pouch below main cable (bottom).

Hazardous waste was generated in copious amounts and ranged from large flakes of lead-based paint as the wire wrap was bent and removed to a fine dust containing lead particles from the power tool cleaning. The containment structure devised for this work was constructed primarily from tarps and secured to the footwalk and footwalk "high lines." These high lines doubled as hand-ropes and a system to move (slide) the heavy compacting and wire wrapping equipment. Figure 3 illustrates the general arrangement on the footwalk areas.

The tarp containment structure has three basic components and levels of protection. The first containment level consists of a tarp "pouch," which is suspended approximately 1 ft from the main cable. This pouch is used to catch the large chips coming from the wire wrap

and to temporarily hold the wire wrapping bundles as they are removed. This collection method is also illustrated in Figure 3. The second level of containment is a floor tarp placed directly on the wooden footwalk planking. This tarp also wraps up the sides of the footwalk side rails. This tarp is used to catch any chips that miss the pouch. The third level of containment addresses the high winds experienced at the cable areas. These windblocks are again tarps, affixed to the footwalk rails and high lines; they serve as a tent over the other containment measures to keep dust and chips from blowing from the work areas. These windblocks also extend across the footwalks to form "flap" doors to provide full containment. This containment system afforded a simple, inexpensive, yet effective method to contain the generated wastes and was readily moved along the footwalks as work progressed. The only precursor to moving this system was that it was vacuumed with a high-efficiency particulate air (HEPA) filtered vacuum to prevent the release of any loosely adhering dust particles.

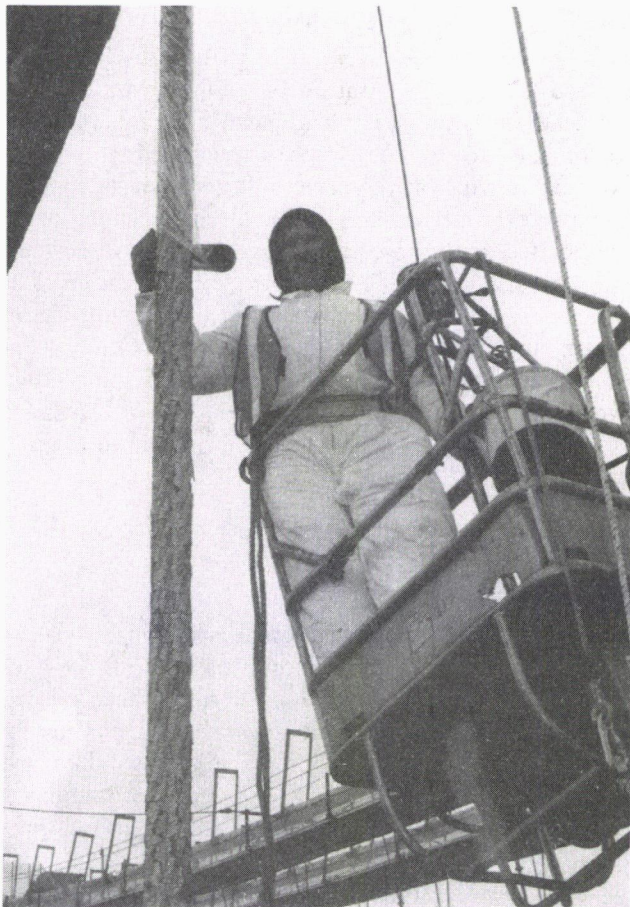
FIGURE 5 Paint chip containment for suspender removal operations: *left*, shrink wrap being applied to suspender from movable scaffolding; *right*, plastic-wrapped suspender being lowered to roadway level.

The solution was to completely encapsulate the entire length of the suspender ropes with a plastic shrink wrap material. The application of this material is illustrated in Figure 5, along with the lowering operation. As the suspender was lowered, the paint chips were contained in the plastic wrap, and the handling operations were conducted chip-free as long as care was exercised so as not to tear the wrapping. Lowered suspenders

were cut into manageable pieces at the point of removal. The cut sections were unwrapped at the designated disposal area, and the dislodged paint chips were collected in disposal drums.
