New Technologies for Improving Light-Rail Grade Crossing Safety

Linda J. Meadow, *Los Angeles County Metropolitan Transportation Authority*

James P. Curry, *Parsons Brinckerhoff/DMJM*

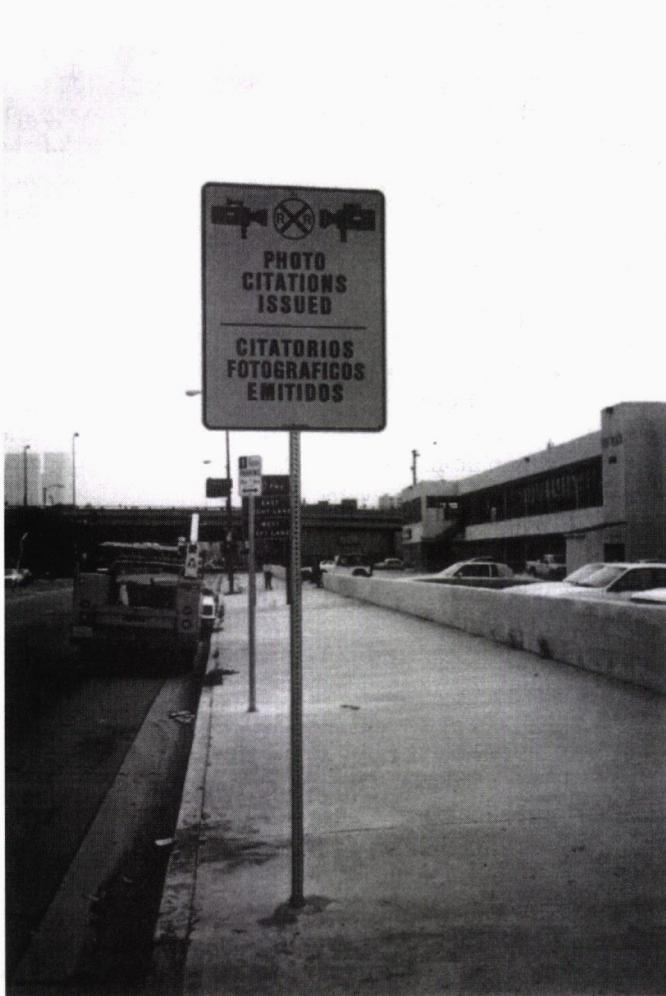
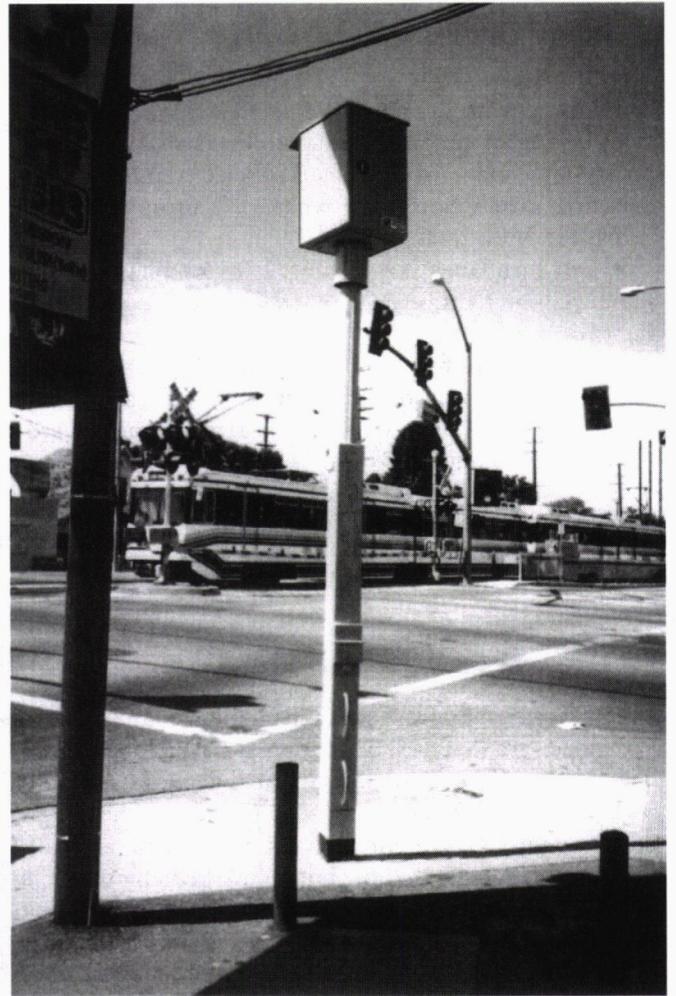
FIGURE 2 Photographic enforcement (a) sign, (b) pole, and (c) citation photograph.

Photographic enforcement systems use high-resolution cameras to photograph motorists driving under or around railroad crossing gates. Bilingual signs informing motorists that photographic citations are being issued at the crossing are installed on all street approaches to the crossing (Figure 2a). The camera equipment is mounted in a 2-ft (3.7-m) high bullet-resistant cabinet (Figure 2b). The camera is triggered when vehicles cross inductive loop detectors in the ground after the gates have started down or are already lowered. Two photographs of the vehicle, its license plate, and the driver's face are taken

as the basis for issuing a citation as required by the California Vehicle Code. Superimposed on each photograph is the date and time of the violation, the speed of the violating vehicle, and the number of elapsed seconds since the red flashing lights were activated at the crossing (Figure 2c).
