# Flexure, Shear and Torsion Tests on Prestressed Concrete I-Beam

B. C. GERSCH and WILLARD H. MOORE, Texas Highway Department

This paper presents the results of a series of full-scale tests performed to evaluate design procedures, determine ultimate strengths, and answer other design questions concerning prestressed concrete I-beams. To provide this information several beams both with and without compositely acting roadway slabs were tested in moment, shear, and torsion.

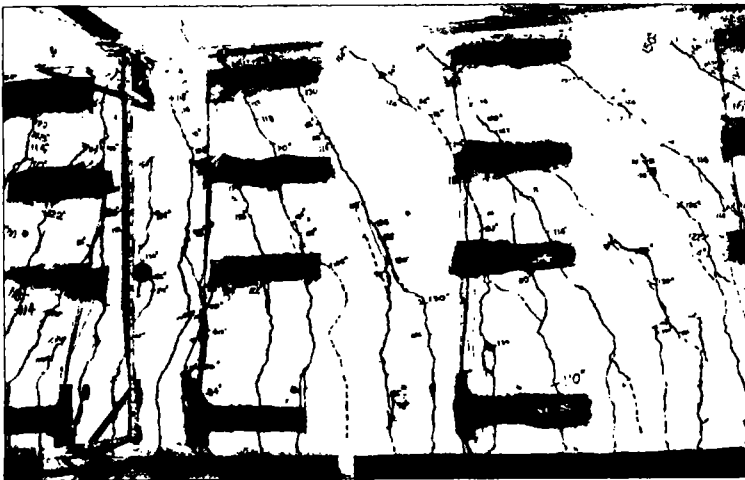
Figure 7. Load vs deflection, composite moment test, pretensioned beam.

penetrated approximately  $2\frac{1}{2}$  in. Flexural cracking of the beam under the loading point was extensive, as shown in Figure 7. Figure 8 shows a load vs deflection.

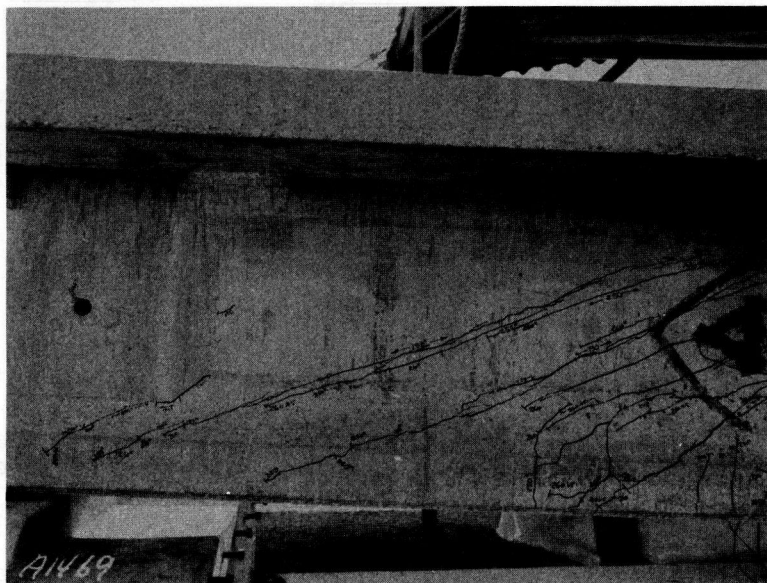
Figure 19. Cracking pattern, composite shear test, pretensioned beam.

Figure 20. Cracking pattern, composite shear test, pretensioned beam.

Initial diagonal tension cracks occurred at an equivalent design load of 1 dead load plus 4.56 live loads including impact. Shear compression failure occurred at 1 dead load plus 6.25 live loads, including impact. As in the previous test, longitudinal cracking in the bottom of the beam was noted. Figures 19 and 20 show the final cracking pattern of the beam, and Figure 21 shows longitudinal cracking of the slab.
