Relation of Traffic Signals to Intersection Accidents

CASE HISTORIES FROM MICHIGAN SIGNALIZATION EXPERIENCE

**J. CARL McMONAGLE, Planning and Traffic Engineer,
Michigan State Highway Department**

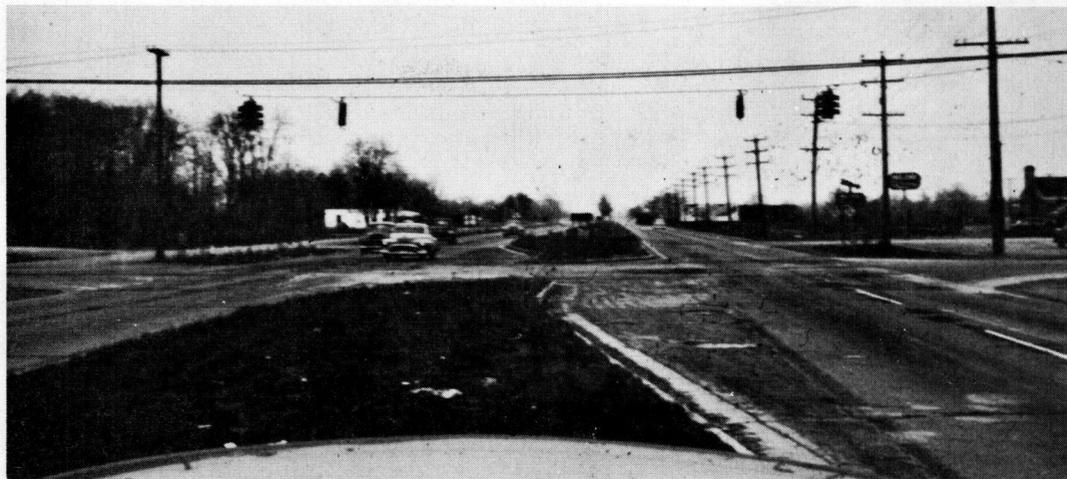
Figure 1.

The first case (Fig. 1) is the intersection of M 112 with M 56, commonly known as Belleville Road. M 112 is the Detroit Industrial Expressway, but in this particular area it has lost its expressway characteristics and has intersections at grade, even though it remains a divided highway with controlled access.

The figure shows M 112 to be a four-lane divided highway with the medial divider having a width of 32 ft. at this point. Belleville Road is a well-developed asphalt-surfaced road. There are dual signal heads for both directions of M 112. Belleville Road has one signal head for both the near slab and far slab of M 112 in both directions. Signal head visibility is, therefore, better than average and not a contributing factor for the accident pattern to be discussed.

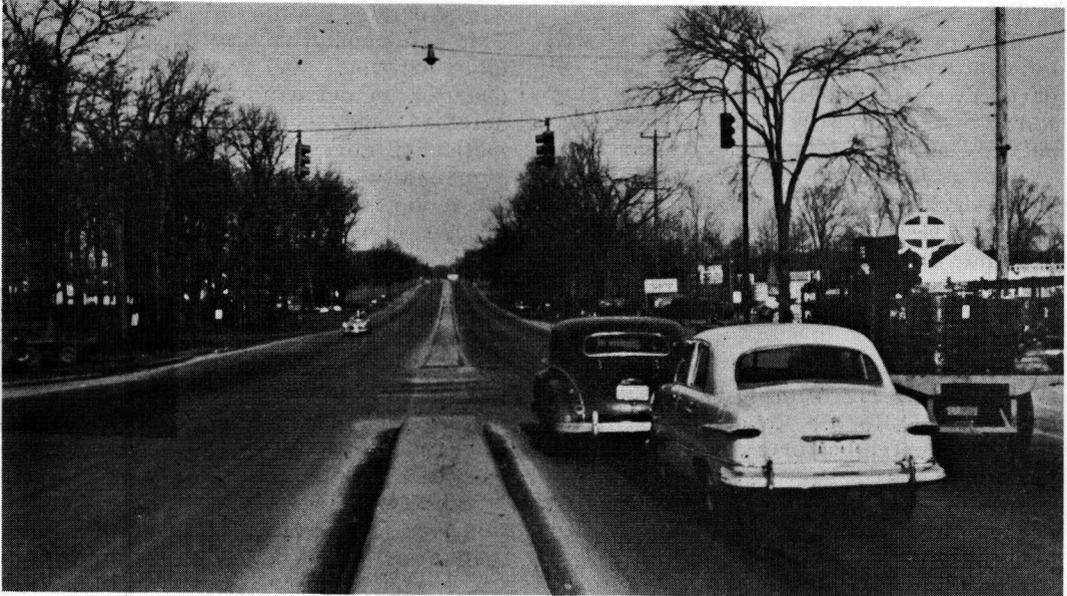
Figure 5.

Maple Road runs west from Birmingham and intersects US24 in a rural area although there is intersection development (Fig. 5). Maple Road carries considerable traffic. The view shows US24 as a four-lane highway, during the time covered in the accident study, US24 was a two-lane highway carrying near capacity vehicle volumes for such a roadway.

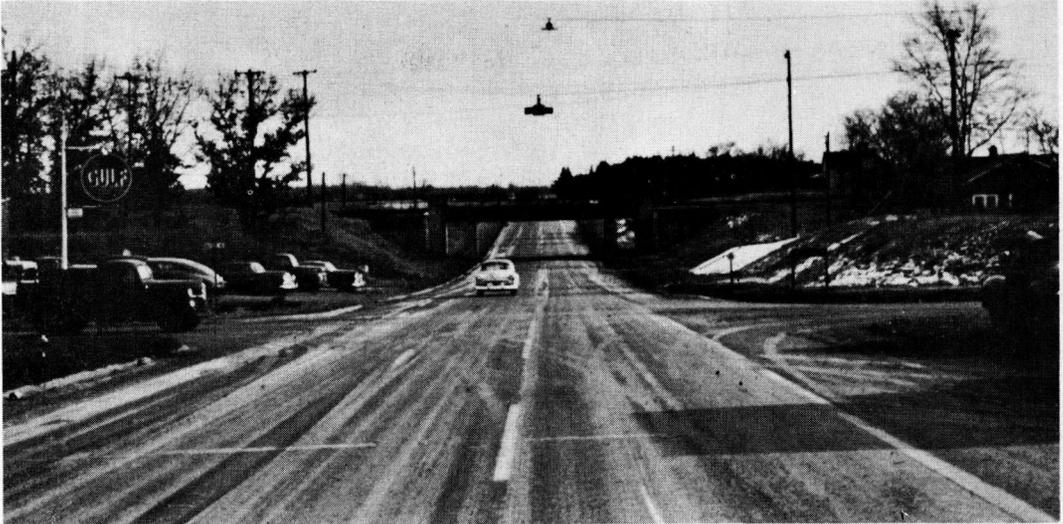
Figure 7.

angle collisions were occurring due to the suddenness with which motorists found themselves upon M59. It is a two-lane concrete pavement with moderate vehicle

Figure 7 shows the intersection of M59 with Milford Road. A small village named Highland lies to the south of this intersection on Milford Road. A number of

volumes traveling at a high average speed.

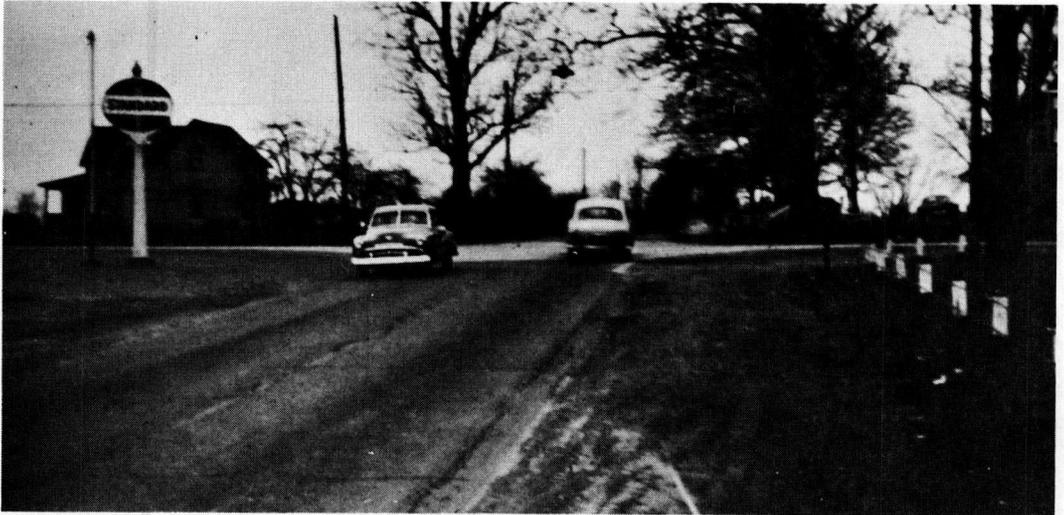
Figure 9.

The intersection of US223 with US223

(Business Route) southeast of Adrian (Fig. 9) makes an interesting intersection to study, since it operates from a traffic standpoint like a T intersection, even

though it has four approaching legs physically. US223 splits into a business route going north into Adrian, while the bypass route continues west from the intersection.
