THE DURABILITY OF CONCRETE

C H SCHOLER

Professor of Applied Mechanics, Kansas State College

This paper is primarily a progress report on the work of the Engineering Experiment Station of the Kansas State College which for over six years has been investigating the durability of concrete and concrete aggregates. Use has been made of information and material gathered by other investigators associated with the author on committees of national societies and in cooperative research programs. The author desires especially to acknowledge the assistance of Mr E Viens of the Department of Public Works, Ottawa, Canada, Mr F R McMillan, Director of Research for the Portland Cement Association, Chicago, Illinois, Mr L V Haegert of the A T & S F Railway Company, Chicago, Illinois, Mr A D Conrow, Special Engineer for the Ash Grove Lime & Portland Cement Company, Chanute, Kansas, and Mr Harold Allen of the Kansas State Highway Commission. Much of the material of this paper was included in papers presented to the American Society for Testing Materials.

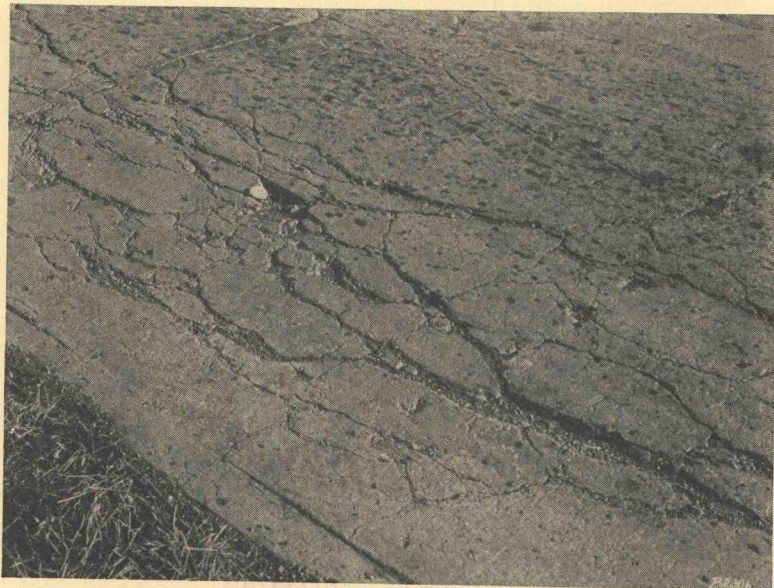
Figure 5. A Concrete Pavement Ten Years Old on Route 4 in Kansas

It is two course construction using flint in the wearing course and an unsound limestone containing chert nodules and shale-like material in the base course. The disintegration became apparent in about 3 years. Note pop-outs and general disruption of the mass. Traffic on this road is not heavy.

In Figures 5 and 6 is illustrated the disintegration of a concrete pavement due to unsound stone. This road, now about ten years old, began to show distress in two to four years after it was placed. The coarse aggregate is an argillaceous limestone containing some chert formation. Pop-outs of chert may be seen in the illustration, but the real failure is due to the general breaking down of the unsound stone all through the mass. The road does not carry heavy traffic, but the general appearance of the surface might lead one to believe that the pavement was failing due to excessive loads. Evidence of distress appeared first in portions of the pavement placed on a subgrade subject to the seepage of water. Some of these portions have been replaced. Portions of the road where

Such stone if used in concrete, produces results like those shown in Figures 5, 6 and 17.

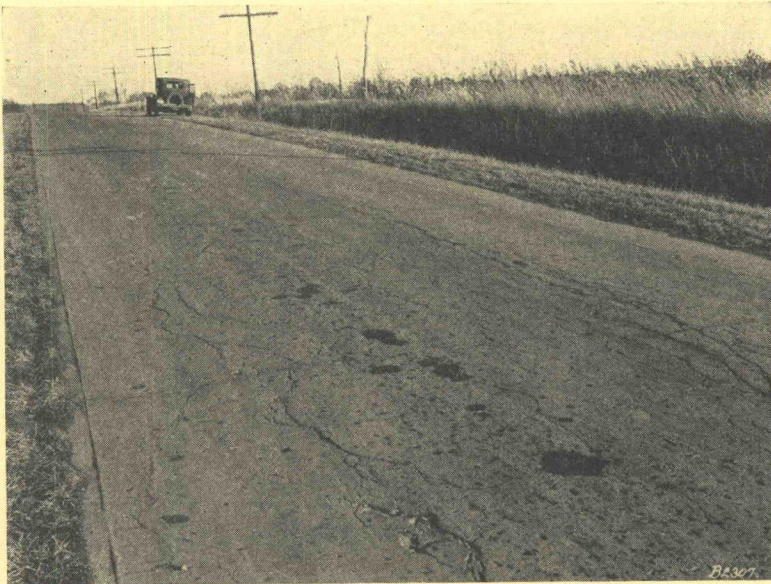
Figure 6. A General View of the Pavement Shown in Figure 5

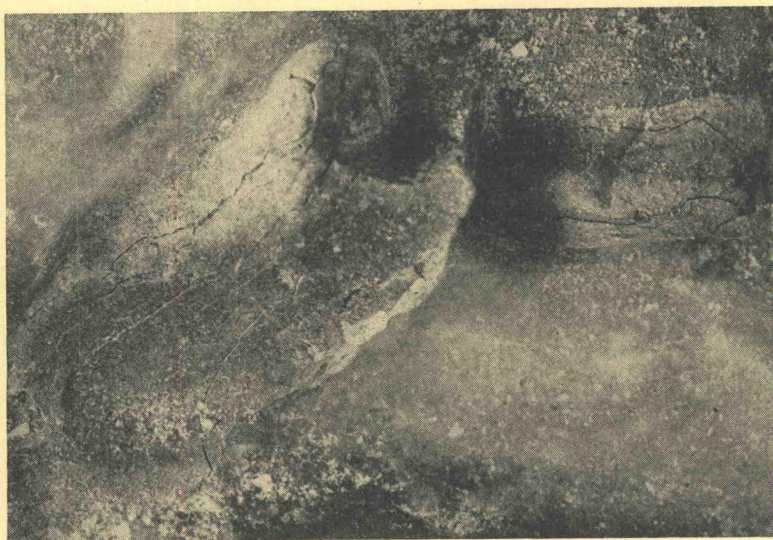
Figure 16. A Failure of Chert after 12 Cycles of a Freezing and Thawing Test

When chert embedded in concrete fails in this way the disruptive forces are sufficient to break out large pieces of concrete. Some chert which appears sound when tested alone, breaks down when embedded in concrete.

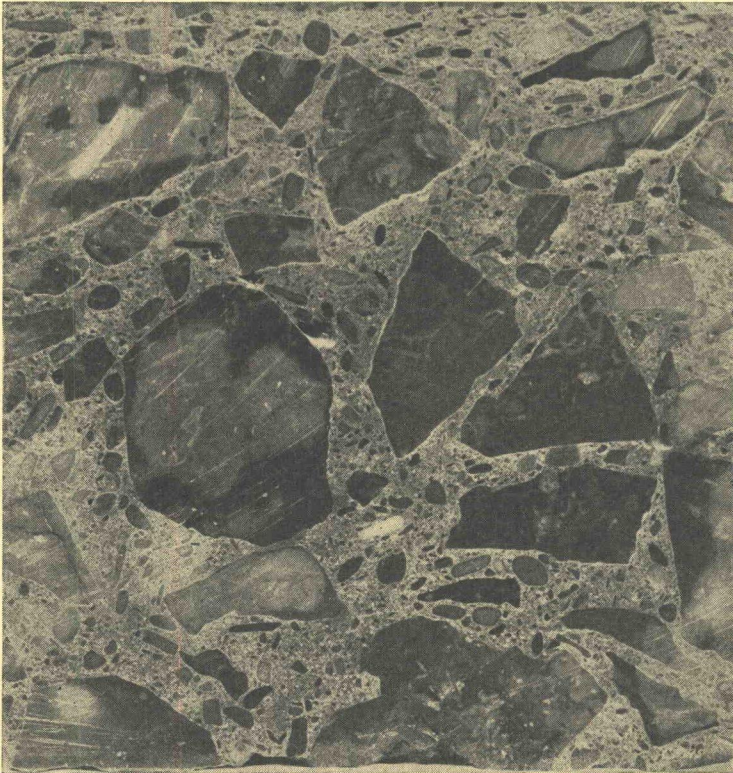
Figure 20. Specimen Cut from a Piece of Pavement from New York State

In places this pavement was scaling deeply. The photo was taken after 25 cycles of freezing and thawing of the specimen. Note the horizontal lines near the top. These indicate disintegration of the mortar. After the photo was taken the upper part was removed and crumbled by hand. The scaling might be classified as manipulation scaling and is evidence of excessive finishing. After 100 cycles the upper 21 per cent of this block was completely disintegrated due to failure of the mortar.
