# RESURFACING WITH PORTLAND CEMENT CONCRETE

By E M Fleming, Manager, Highways and Municipal Bureau Portland Cement Association

#### SYNOPSIS

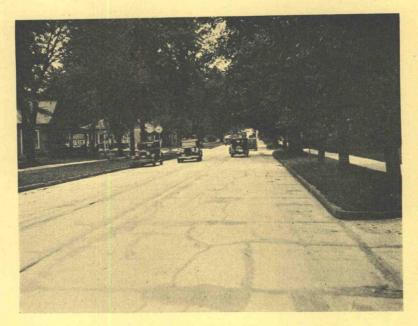
Figure 1. East Main Street, Marshalltown, Iowa. Resurfaced in 1911. Photographed 1932. Four-inch plain concrete on a five-inch natural cement concrete base. The railway track was built later and the pavement had to be cut out in the track area, which is blamed for much of the cracking in this twenty-one-year-old pavement.

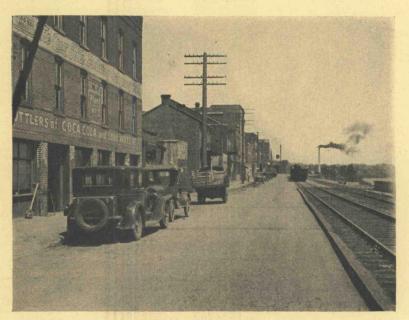
Figure 3. Water Street, Cape Girardeau, Mo. Resurfaced 1916. Photographed 1932—16 years old. Four inches of plain 1:1½:3 concrete on seven-year-old concrete base. In good condition except one broken area. Dray and truck traffic.

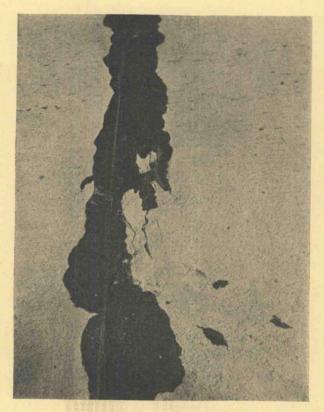
Figure 7. A transverse dummy joint in resurfacing which does not have expansion joints. Concrete at the joint is crushed by expansion stresses. Photographed in 1932. Pavement near Fort Story, Princess Anne County, Virginia.

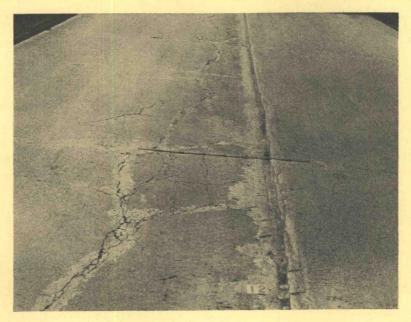
Figure 8. Five-inch resurfacing increasing to seven inches over edge of old base. Center joint having no mechanical bond nor tie bars. Mesh in outer 4 feet of old slab only. Longitudinal cracking 2 to 3 feet from center joint because of lack of bond across joint. Badly broken base.

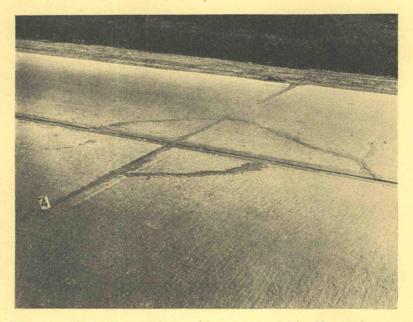
Figure 9. Five-inch resurfacing (along center line). No reinforcement. Three corner breaks at intersection of joints having neither dowels nor tie bars. Center joint a butt construction joint without tie bars. No dowels across transverse joint.

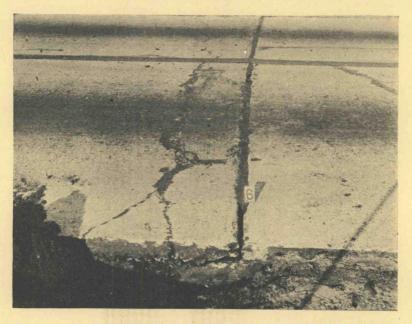
Figure 10. Three-and-one-half-inch resurface on four-inch base with widening section eight inches deep. Joint space not cut through to old base. Resulting underspall faulted joint and caused joint breakage under loads.

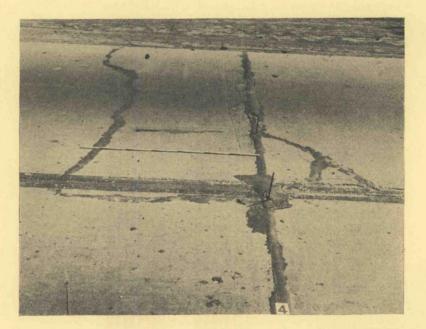
Figure 11. Longitudinal crack (marked by pencil) over a dowel not placed parallel to surface of slab. Corner crack also starts over dowel. Joint itself is properly placed. Old base not broken.

It is extremely important that construction defects be eliminated from transverse joints in resurfacing, else expansion stresses will damage the thin slabs. Joint faces must be accurately perpendicular to the subgrade, the full depth of expansion joints be unobstructed by concrete or other solid material and dowels accurately parallel to surface and center line.

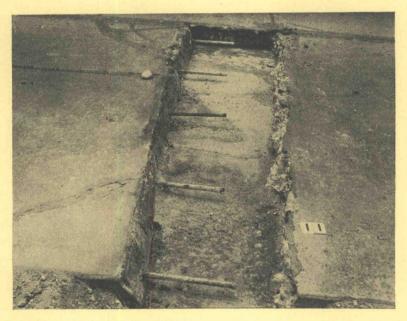
Figure 13. Above joint (Fig. 12) with broken concrete removed. Note sloping face, which caused the faulting. In this case, as in others noted, dowels did not prevent faulting.

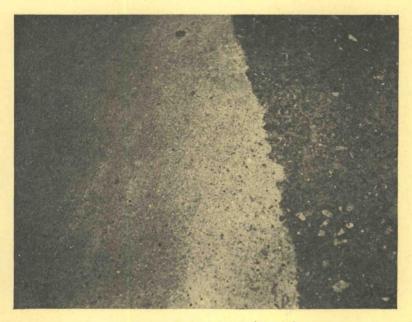
Figure 15. Close-up of edge of above patch (Fig. 14) where it is zero inch thick. No scaling after seven years of "Main Street" traffic.
