REPORT OF JOINT COMMITTEE ON ROADSIDE DEVELOPMENT

EFFECTS OF TREES ON WIND VELOCITIES

BY FRANZ A AUST

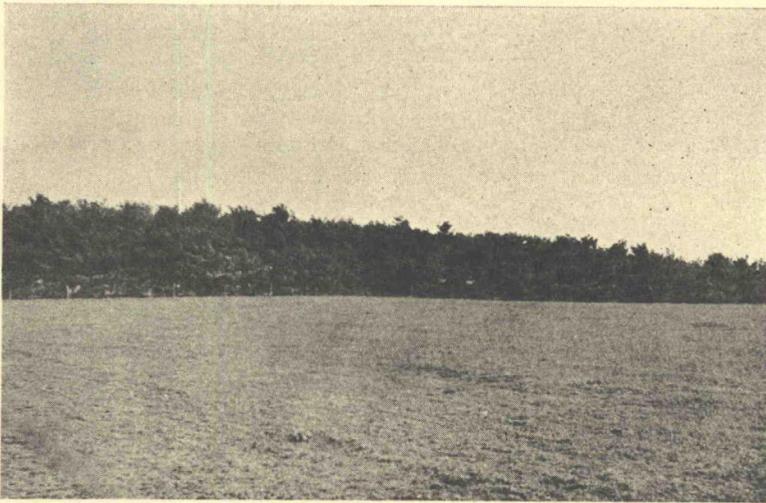
Figure 1. White Pine Barrier, consisting of 3 rows of trees 18 ft. apart, the trees spaced 12 ft. in the row. With wind velocity 34 miles an hour on the windward side, the instruments registered only $5\frac{1}{2}$ miles an hour on the leeward side.

Planted White Pine Barrier, Figure 1.

This consisted of three rows of white pine, 600 ft. long, planted on an approximate north and south line. The rows were 18 ft. apart, and the trees were spaced 12 ft. in the row. The trees were approximately 35 ft. high. The age of the windbreak was 30 years. The trees were well branched from tip to base. In the center row natural pruning had removed the branches to a height of 10 ft.

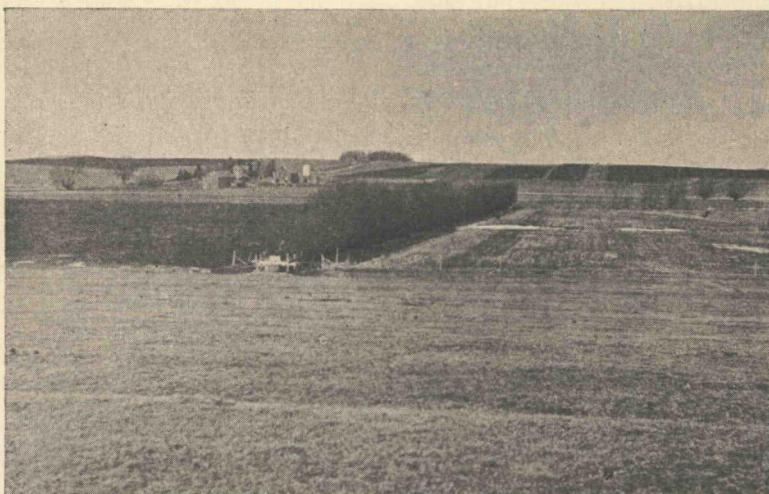
Figure 2. Willow Barrier 1800 ft. long, planted on a north-and-south line; trees 6 to 15 ft. apart

Willow Barrier, Figures 2, 3 and 4. This was a single row of Russian willow,

1800 ft. long, planted on a north and south line. The trees were spaced 6 to 15 ft. apart. Branching was uniform from base to tip. The height of the windbreak was 20 ft., the age 10 years.

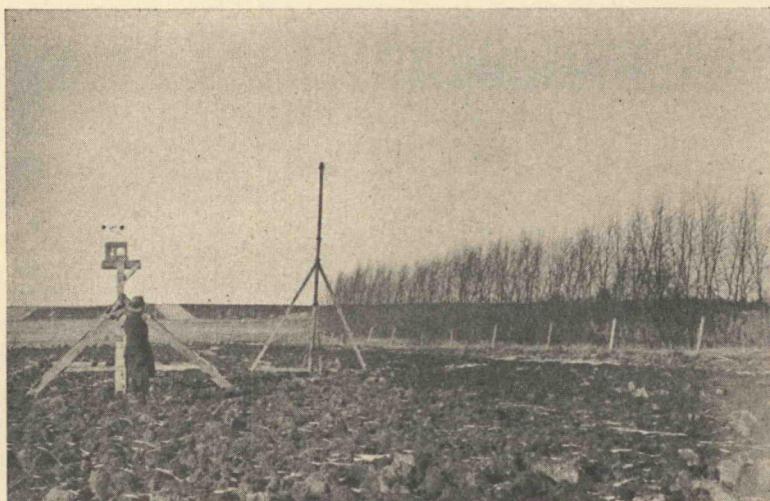
Figure 3. Willow Barrier. At the left, recording anemometer in place. Center, support for anemometers placed at different elevations

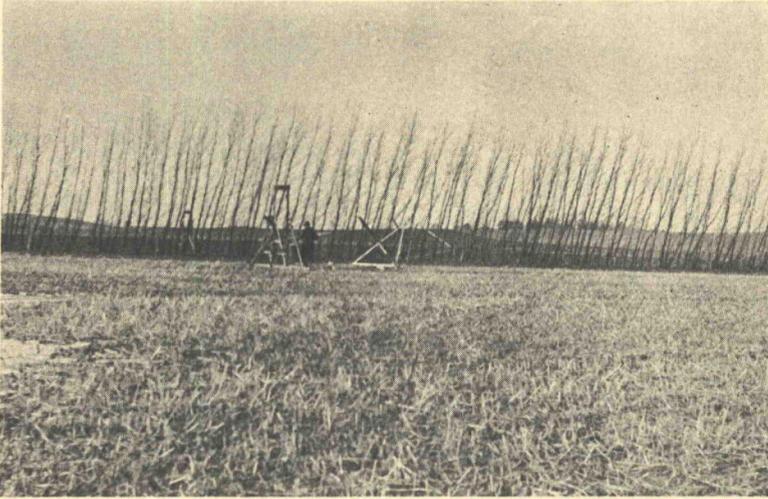
Figure 4. Willow Barrier, showing relative density. The instruments recorded a maximum decrease of 52 per cent and a minimum of 10 per cent

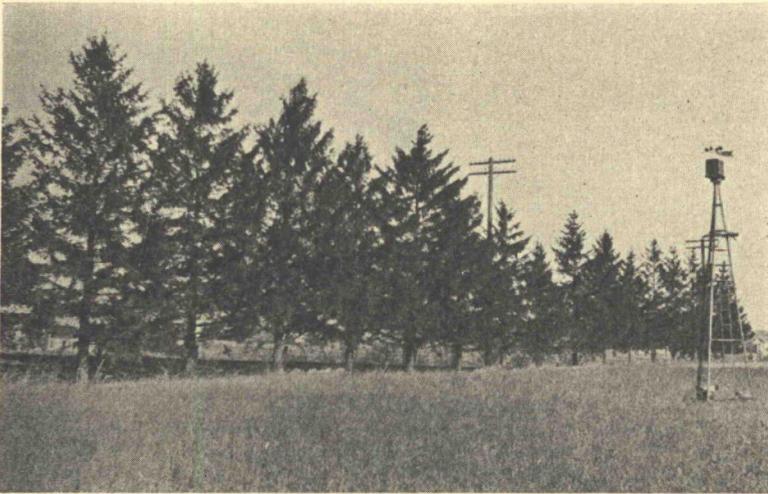
Figure 5. Norway Spruce Barrier. At the right, steel tower supporting recording anemometer. The instruments recorded a maximum decrease of 88 per cent and a minimum of 30 per cent, at a distance 60 ft. from the windbreak.

Norway Spruce Barrier, Figure 5. This consisted of a single row of Norway spruce spaced one rod apart, located immediately adjacent and on the south side of an east and west roadway. The height of the trees was approximately 45 ft. They were in good condition, well branched from a height of 5 ft. above the

the north and northwest. The recording anemometers used in making the observations were mounted on steel windmill towers (see Fig. 5). The height at which

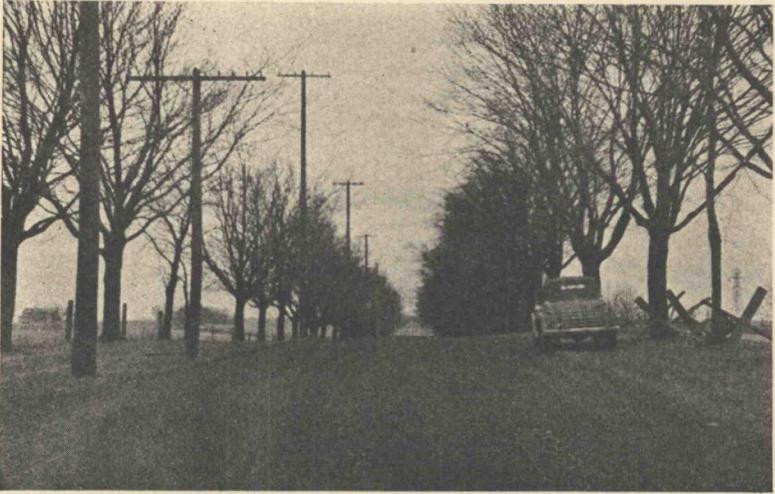
Figure 6. Hard Maple Barrier, consisting of a row of trees on each side of a north-and-south highway; trees located 22 ft. from the center line. These trees caused an increase in the velocity of the wind immediately over the roadbed.

Hard Maple Barrier, Figures 6 and 7. This barrier consisted of a row of hard maples planted on each side of a north and south roadway. The trees were located $22\frac{1}{2}$ ft. from the center line of the road, and originally spaced one rod apart. The planting was approximately a quarter of a mile long. Occasional failures spacing the trees two rods apart caused some irregularities in velocity observations.

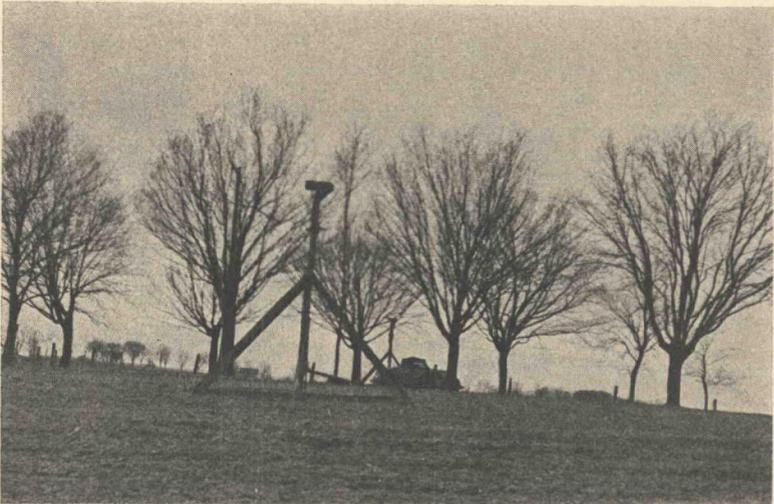
Figure 7. Hard Maple Barrier, showing relative density of the trees. In the center is shown a support for the recording anemometer

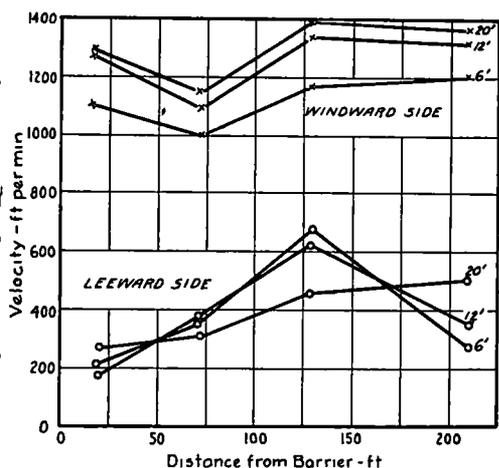
Figure 8. Wind velocity studies at various elevations and distances. The Barrier—A North and South White Pine windbreak 35 ft high Jan. 11, 1934. Average wind velocity 11 miles per hour.

White Pine Barrier. The results of the readings for the white pine barrier shown on Figure 8 indicate that at a distance of 27 ft to the leeward side there is an average decrease of 82.9 per cent over the velocity recorded 160 ft on the windward side. At various velocities, this decrease

reached a maximum of 97.2 per cent and a minimum of 61.7 per cent. The least effectiveness was found to obtain at velocities from 9 to 12 miles an hour. Both above and below, the rate of decrease of the velocities to the leeward was greater. The maximum wind velocity recorded was 34 miles an hour. At this velocity there was a decrease of 84 per cent on the leeward side. The area of marked influence was approximately 5 to 7 times the height of the barrier. Farm buildings located to the east immediately adjacent to the

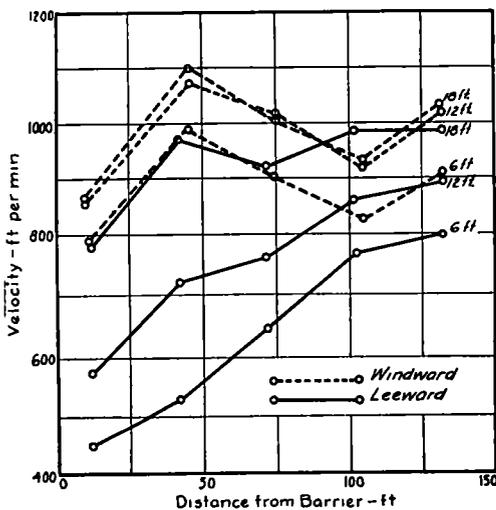
Figure 9. Wind velocity studies at various elevations and distances at the Willow Barrier—A North and South row of Willows 20 ft. high. Jan 11, 1934. Average wind velocity 11 miles per hour.

Detailed studies were made of the wind velocity at various elevations and distances. The results are shown in Figure 9. The elevations which were used were 6, 12, and 18 ft. Observations were taken at these different elevations and for distances of 10, 45, 70, 100, and 130 ft both to the windward and leeward side of the windbreak. Observations were taken as nearly at the same time as possible and a day was chosen when there was little variation in wind velocity. The results show that with average wind velocity of 11 miles per hour there is a consistently marked decrease on the leeward side for the elevation of 6 ft. The effectiveness varies indirectly with the distance from the windbreak. When one compares the velocities at the height of 12 and 18 ft to the leeward with corresponding distances and elevations to the windward, it is observed that at a distance of 50 ft there is a decided peak in the curve. On the windward side the veloc-

ity is greater at this point than the average velocity beyond the range of influence of the barrier. On the leeward side there is little or no effect. At a distance of 100 ft from the barrier there is a depression in the curve especially on the windward side. This is true for all the elevations, namely, 6, 12, and 18 ft. From this point there is a gradual rise in the curve until we reach a distance of 150 to 175 ft where conditions on the windward side are again normal giving

rise to the average wind velocity and on the leeward side a consistent rise until one leaves the area of influence of the barrier.

Additional observations were taken with a higher wind velocity and the curves here obtained approximate in form those shown on Figure 9.

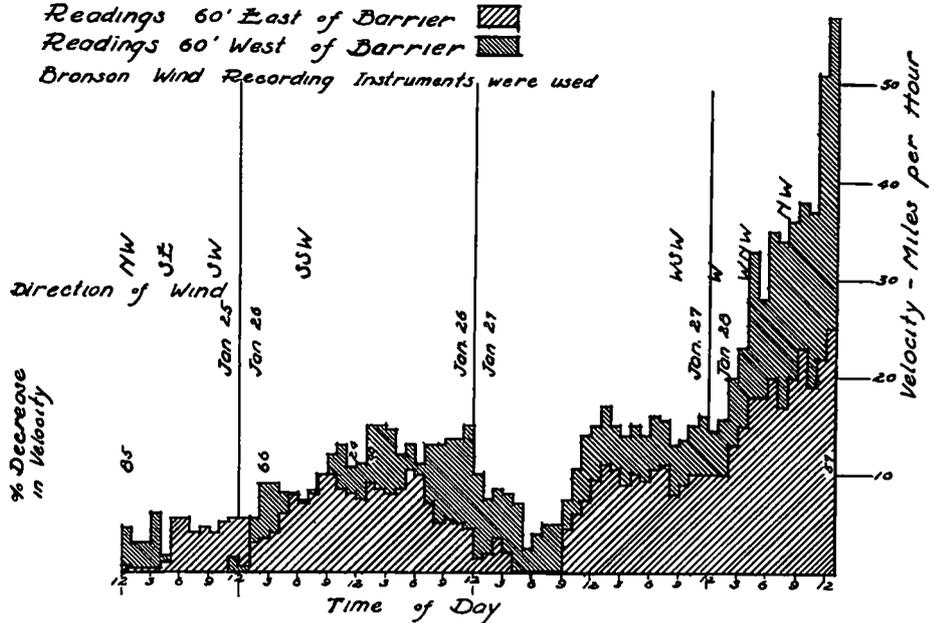
Figure 12. Hard Maple Barrier—Double Row—North and South Highway, Mendota, Wisconsin Jan. 25-28, 1934

Hard Maple Barrier An interesting feature of the hard maple barrier lies in the fact that while a substantial reduction in velocities occurred on the leeward side of the barrier with either an easterly or a westerly wind, an actual increase was recorded at the center line of the road. This action of the wind has been observed in many similar situations. It is apparently explained by the fact that the openings at a level below the branches above tend to constrict the passage besides offering resistance to the passage of the air through the barrier. This apparently builds up the velocity immediately over the roadbed. See Figure 11. The average increase above the roadbed for velocities of 10 miles per hour was 9.3 per cent. The average decrease for selected readings 60 ft to the leeward of the hard maple barrier was 44.8 per cent. See Figure 12. The maximum wind velocity of 57 miles per hour occurred on January 28. This gale was decreased by 57 per cent on the leeward side of the windbreak.

5 In the case of the two rows of the sugar maple it seems that there was a decided increase in the wind velocity midway between the two rows directly over the roadbed. This is of significance in any problem of snow drift control where roads are lined with trees.

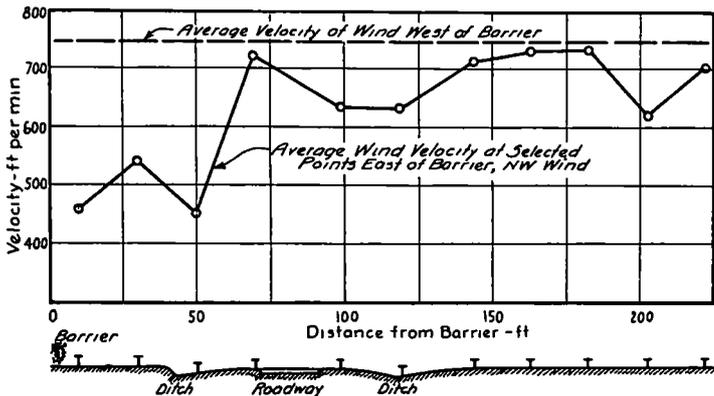
Figure 13 Observations at planted Evergreen Barrier. The cross section shows the points at which velocities were determined 3 ft above the ground

Planted Evergreen Snowfence A detailed study was made of the wind velocities in connection with this barrier. Velocities were recorded at eleven selected intervals for a distance of 250 ft to the leeward side of the windbreak and 3 ft above the ground level as shown on Figure 13. The assumed normal reading was taken 100 ft to the windward side
