LONGITUDINAL CRACKING OF CONCRETE PAVEMENTS ON STATE HIGHWAY 13 IN CLARK AND TAYLOR COUNTIES, WISCONSIN

BY H F JANDA

SYNOPSIS

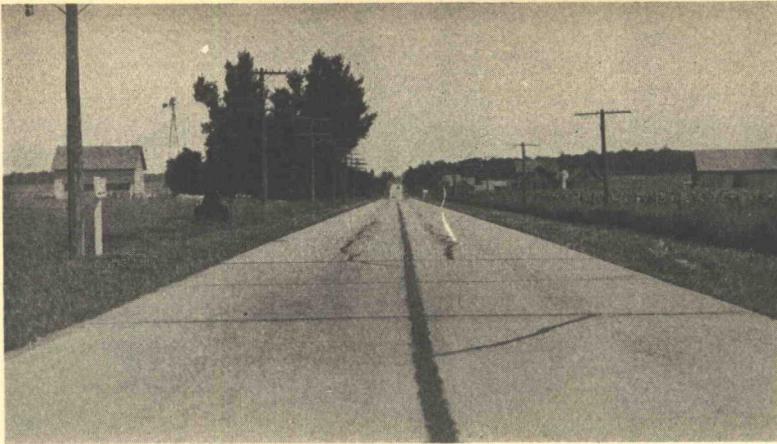
(147-S and 332-B) did not show as much longitudinal cracking as did Projects 147-Re' and 31, it is not known whether this lessened cracking was due to the presence of the old road under the concrete slab or to the fact that the tie-bar spacing was 4 ft This latter phase will be discussed in subsequent paragraphs

Figure 5 shows the juncture of Project 332-B with Project 31 and illustrates the difference in longitudinal cracking of these two projects

Figure 5. Junction of Project 332-B and Project 31. Project 332-B in foreground. Constructed 1928. Four-foot tie-bar spacing. Project 31 in rear. Constructed 1930. Two-foot tie-bar spacing.

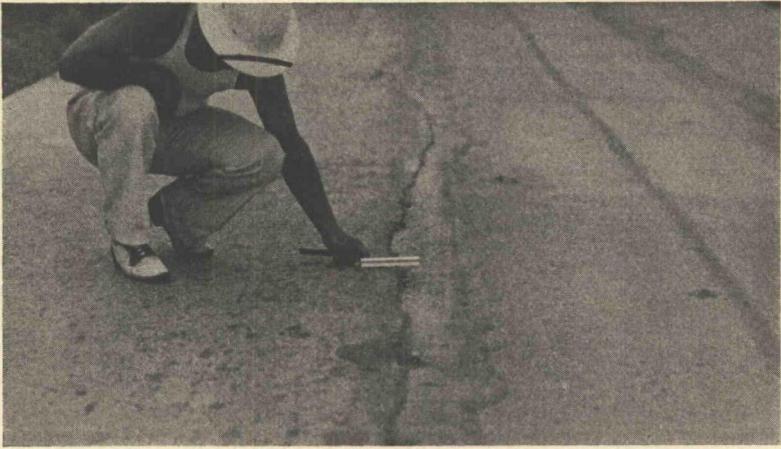
Figure 8. Typical Cracking Non-Reinforced Concrete Pavement. S.T.H. 13, Clark and Taylor Counties, Wisconsin. (Maximum width of longitudinal cracks 3 to 4 inches)

(5) The longitudinal cracks in all non-reinforced sections were open, and, in some cases, were 3 or 4 in wide at the top of the slab due to spalling

3 All concrete road slabs in these areas should be reinforced with mesh reinforcement
