BRICK TEST ROADS UNDER TRAFFIC MAY POINT THE WAY TO IMPROVED CONSTRUCTION METHODS

By FRED E SWINEFORD, *Chief Engineer*

Bureau of Tests, Ohio State Highway Department

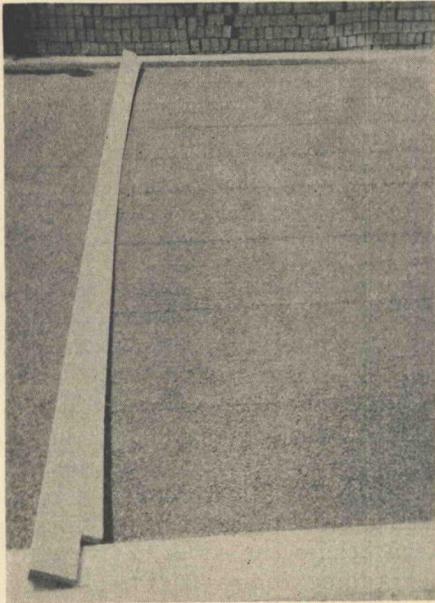
Figure 1. Templet Used to Score Bedding Course, Enabling the Droppers to Maintain Straight Rows of Bricks.

The concrete base and integral concrete headers on each side were placed without joints except those which occurred at the end of each day's work. A $\frac{3}{4}$ -in natural asphaltic limestone bedding course was spread over the concrete base. In order to aid the brick droppers in maintaining straight courses, the bedding course was lightly scored with parallel lines 2 ft apart, by dragging over it a templet with spikes 2 ft apart.

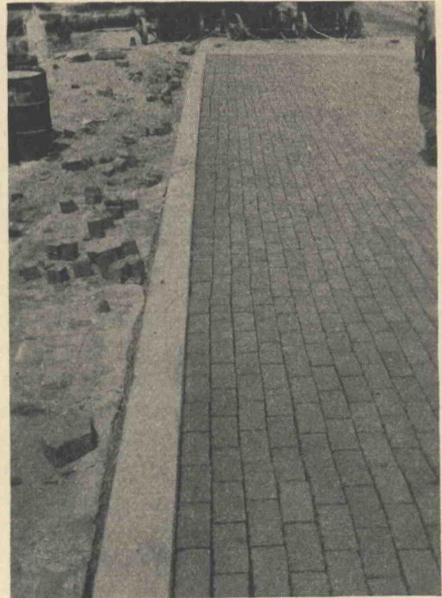
Figure 2. Such Batting to Closure as Was Necessary Was Done Along One Curb. Two thirds of a brick broken lengthwise was permitted for a bat.

brick dropper to work continuously down the road with his several courses without being compelled to walk across the road to start new courses frequently. On this project four brick droppers placed the brick. All the batting necessary due to irregularity in the size of the brick and the slight variation in width between the curbs was done along one curb.

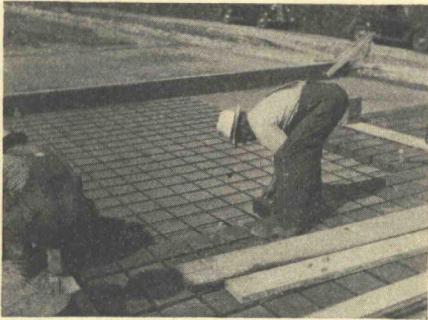
Figure 3. As Laying of the Blocks Progressed the Mats Were Raised to Their Proper Elevation Above the Cushion.

Bar mats consisting of $\frac{3}{8}$ " round bars spaced 9 inches center to center each way and supported three-fourths of an

inch above the bedding course were placed upon the bedding course to act as reinforcement. Adjacent mats were joined by $\frac{3}{8}$ in. by 30 in. deformed bars wired to the adjoining mats.

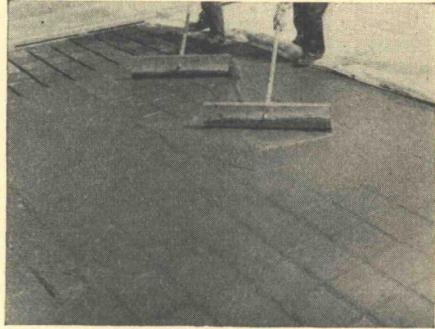
Figure 5. Distribution of Grout Was Handled by Means of Hand Squeegees. Cotton mats for curing are visible back of the workmen.

with a hand roller weighing 12.5 lb. per in. of width. Portland cement grout was then squeegeed over the surface to complete filling of the joints. Cotton mats kept wet were used to cure the grout.

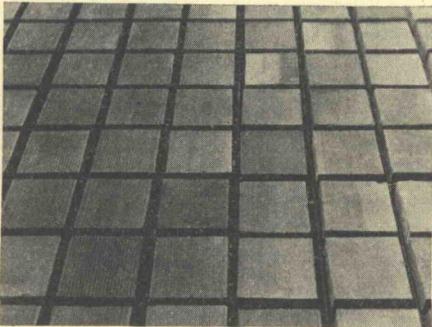
Figure 4. Looking Across the Block Pavement Prior to Grouting

The 8 by 8-in. vitrified blocks were placed in the squares formed by the bar and spaced to form a neat checkerboard pattern. The blocks were then rolled

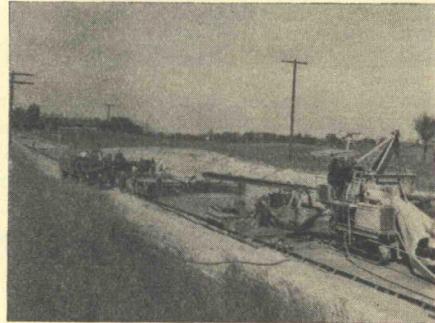
Figure 6. Train of Equipment Used in Constructing Monolithic Vibrated Brick Pavement. This view shows the approximate normal spacing.

Following immediately behind the concrete paver which was used for the base was a vibratory concrete finisher. The contractor elected to exercise his option and use vibratory finishing on the base

course in order to have firmer concrete on which to lay brick and thereby shorten the interval between placing the concrete and dropping brick. This machine is also equipped to strike off the concrete 3-in. below the finish grade on the first pass in order to place the required steel mesh reinforcing. Behind the finisher came the machine by means of which the longitudinal ribbon center joint material was installed. The ribbon joint material consisted of a $\frac{1}{8}$ -in. thickness of premolded bituminous material 5.5 in. wide and was furnished in 50 ft. rolls. It was placed 2.5 in. into the base and the 3 in. remaining above the surface was held

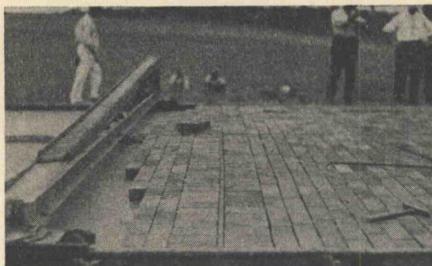
Figure 7. The First Course of Brick on Each Side of Transverse Expansion Joints Are Laid Longitudinally. The joint material visible here is premolded cork which extends downward $3\frac{1}{2}$ in. where it rests on bituminous premolded joint material extending to the bottom of the base slab.

One-inch transverse expansion joints extending the full depth of the surface course and base course were installed at 60 ft. intervals. The joint filler for the bottom 6 in. was bituminous premolded material between metal plates shaped to form extrusion chambers on each side. Resting directly on the bituminous joint material was 3.5 in. of premolded cork which filled the joint to within one-half inch of the pavement's surface. A poured bituminous seal completed the filling. The joint assembly exclusive of the cork was contained in a welded wire

cage which served to hold the joint material and dowel bars in place during the concreting operation. The dowels were 24-in by $\frac{3}{4}$ -in smooth round bars capped and greased, spaced 12 in center to center and served to transfer load across the joint.

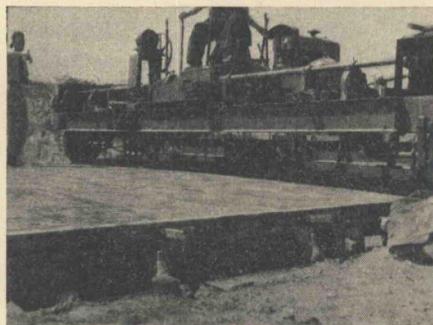
Figure 8. Brick Vibrator for Removing Surface Irregularities and Imbedding Brick in Plastic Concrete Base.

The Flexible Road Joint Machine Company's new brick vibrator was then used in place of the conventional rollers. This new machine which is similar to a concrete paving screed was carried on steel side forms and performed two operations. First, that of firmly bedding the brick in the plastic concrete and, secondly, that of forming a good riding surface. Eighteen metal straight edge tampers which rested on the brick surface were 12 in wide and 6 ft long and were actuated by four high frequency electric vibrators mounted on a beam

spanning the straight edges. As the machine passed over the brick the mortar from the base was brought up into the joints about one-half inch. There was very little breakage or chipping of the brick due to the action of the vibrator.

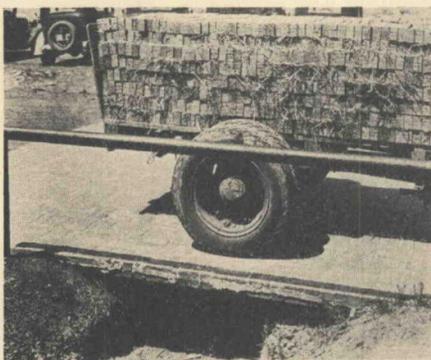
Figure 1.

then grouted in. Two weeks after the slab was completed, an excavation 5 ft. square was made under one side of the slab. It has been estimated that during the past seven years 30,000,000 bricks have been trucked over that portion of the slab which spans the excavation (Fig. 1). In addition, the Illinois State Highway Department ran a ten week concentrated test on the bridged slab. The slab today remains in perfect condition. The Ohio test section described by Mr. Swineford was a cooperation of the Ohio State Highway Department, the National Paving Brick Association, the Wire Reinforcement Institute and the Concrete Reinforcing Steel Institute.

Our previous experience with reinforced brick pavement construction was in Springfield, Illinois, on a reinforced brick pavement slab constructed, in 1931, in the yard drive of a paving brick plant. In constructing this slab there was no preparation of the subgrade except the placing of a thin sand cushion. Bricks were placed on edge and in "basket-weave" fashion with three bricks constituting a square unit. The reinforcement consisted of $\frac{3}{8}$ -in round deformed bars placed at approximately nine inch centers, both transversely and longitudinally, and at

1 in. above the slab bottom. A mortar (one part cement to two parts sand) was
