EXPERIMENTS WITH CONTINUOUS REINFORCEMENT IN CONCRETE PAVEMENTS

H. D. CASHELL, *Assistant Highway Engineer*

S. W. BENHAM, *Research Engineer*

SYNOPSIS

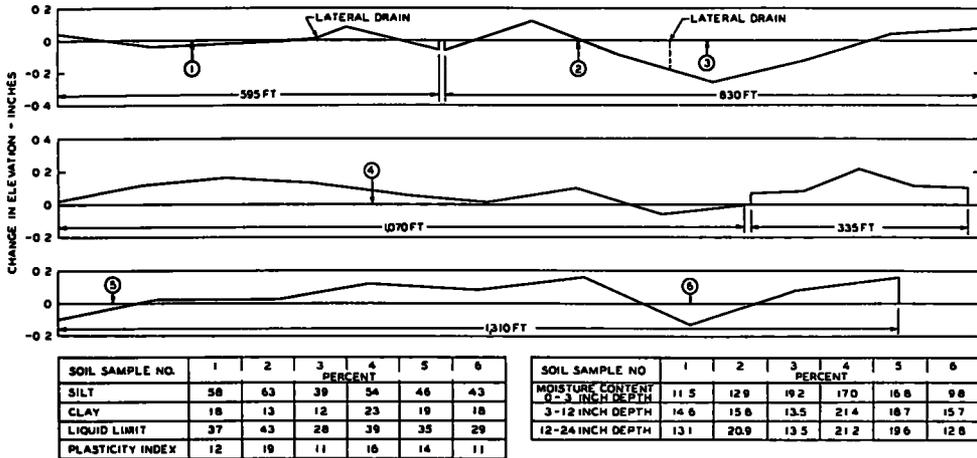
Figure 1. Changes in Elevation of Certain Sections of Pavement at End of First Year

In Figure 1 are shown the changes in pavement elevation that had occurred on typical sections at the end of the first year of pavement life, using the elevations determined in the fall of 1938 as a base. The moisture condition and other subgrade soil data at the time the pavement was placed are shown also on this graph. While no moisture determinations were made at the time the second set of elevation data were obtained it is only reason-

tion In the 830-ft section the most noticeable change was a settlement of 0.2 in. near the center. During construction it was observed that the subgrade in this area was somewhat spongy at the time the concrete was placed. The figure shows that over much of the length of both the 335-ft and the 1,070-ft sections the elevation increased 0.1 to 0.2 in.,

The data in Figure 1 give a fair indication of the general order of the changes in elevation that were observed at the end of the first year. Over the entire length of the experimental sections no change in

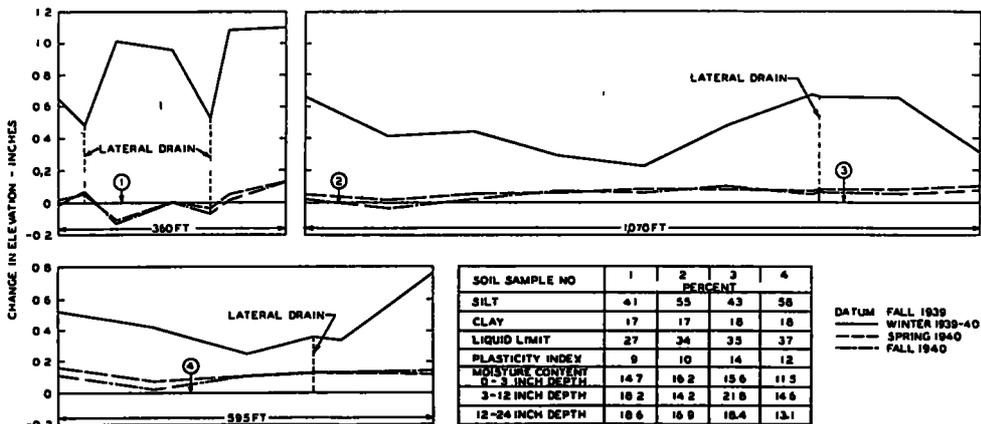
Figure 2. Seasonal changes in elevation of selected sections during the second year. One-inch bar, sections of considerable length

Using as a datum the elevations measured on the pavement surface in October 1939, when presumably the sections had stabilized at their normal position for this season of the year, the position of certain selected sections are shown in Figures 2, 3 and 4 as they were found to be (1) in

three groupings on the basis of the amount of longitudinal reinforcement present (and indirectly the general length of the sections). In Figure 2 are sections containing 1-in. diameter bars and of considerable length; in Figure 3 are those containing 1/2-in. diameter bars and of intermediate section length, while in

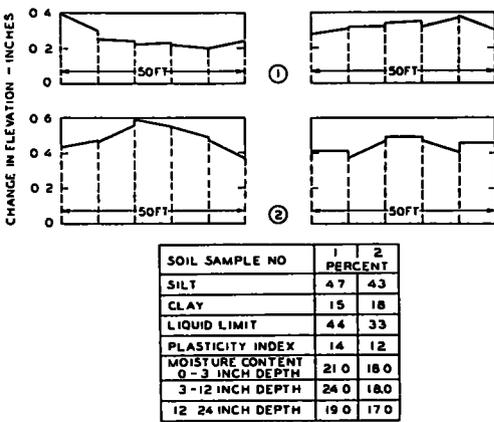
Figure 5. Increase in elevation caused by freezing of subgrade to a depth of 20 inches of sections containing 10-foot slabs.

Figure 5 contains similar data showing changes in elevation caused by freezing at six joints in the central area of each of the four 500-ft. sections that have warping joints at 10-ft. intervals. The same general order and nonuniformity of heav-

order of the frost heaving is not large, being generally within the range 0.2 to 1.0 in. It is not uniform, varying probably with the physical nature and condition of the subgrade soil. In this connection it is of interest to note that where lateral drains were placed under the 360-ft section there appears to have been a decrease in the magnitude of the frost heaving.

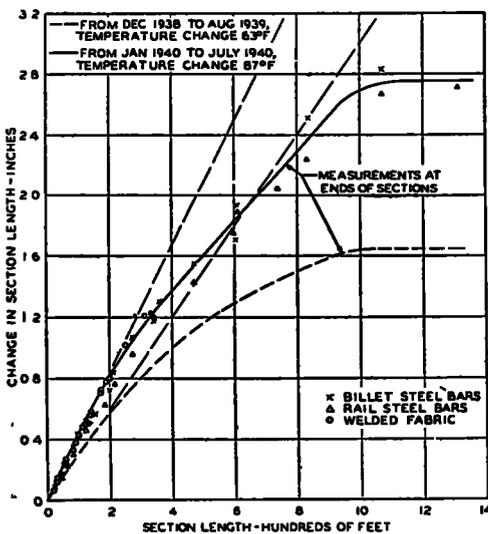
Figure 6. Relation between Section Length and Annual Change in Length

In Figure 6, the broken line and the full line curves are the average maximum changes in length observed for sections of different length during the first and the

second years, respectively, of the pavement's life. The change in average pavement temperature accompanying these changes in length were 63°F. for the first year and 87°F. for the second year. For clarity in presentation, the points representing observed values for the first year are omitted from the graph. The two light weight straight lines, that appear to be tangent to the lower portion of the two curves, were drawn through the points for the shorter sections and thus

represent the relation for short sections that are comparatively free to expand and contract.

The type of reinforcement used in the various sections is denoted by the character of symbol and it is apparent that type of reinforcement exercises no significant influence on the magnitude of the length changes thus far observed.

The two curves represent length changes that accompanied temperature changes of quite different magnitude. When the two sets of data are reduced to a common temperature base, it is found that the length changes observed during

the second year, for sections exceeding 600 ft. in length, are appreciably greater than those during the first year. For example, take the extreme case of the 1,310-ft. section. During the first year the observed change in its length, as indicated by the broken line curve, was 1.64 in. Multiplying this by the temperature ratio 87/63 gives 2.27 in., the change in length that might be expected with an 87° change in temperature. During the second year, however, a change in length of 2.72 inches was observed. Thus, it appears that the change in length was affected by temperature

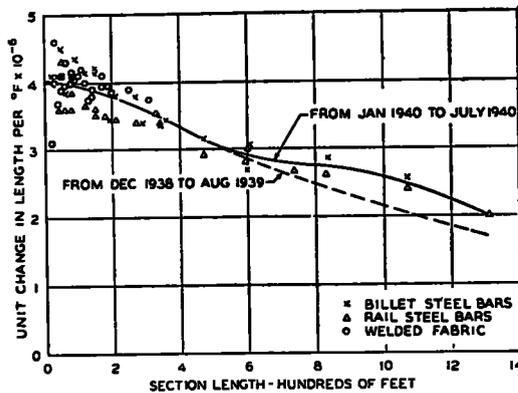
Figure 7. Relation between Section Length and Annual Expansion

When the changes in length observed during the two annual cycles are reduced to unit values per degree temperature change and related to the corresponding section lengths, the curves shown in Figure 7 result. This figure shows how the

magnitude of the annual length change varies with the length of the section. The unit length change, while expressed in terms of temperature, is not actually a coefficient of thermal change alone but rather a coefficient of length change that involves temperature, moisture and perhaps other factors. The relation is useful in indicating the order of movement to be expected at the ends of pavement slabs of various lengths. It appears from this figure that for sections of about 150 ft or less in length the coefficient has a value of about 0.000004. As the length of section is increased to about 600 ft, the value of the coefficient is reduced to about 75 percent of that for short sections, while for sections 1,200 to 1,300 ft long it is reduced to about 50 percent.

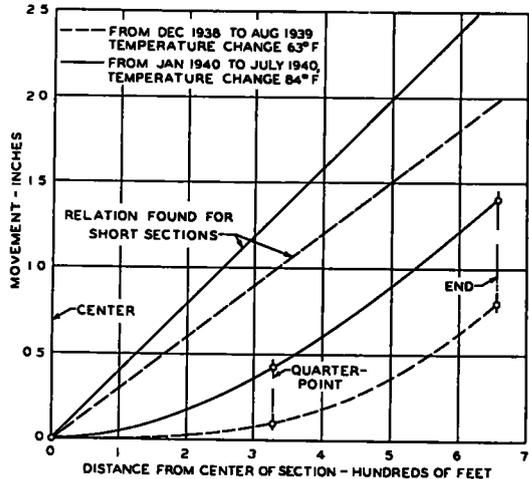
Figure 8. Annual Movement at the Center, Quarter-point and End of a 1310-foot Section

The annual longitudinal movements observed at the center, quarterpoints and ends of the 1,310-ft section are shown for each of the two years in Figure 8. The value shown for the quarterpoint and that shown for the end is in each case the average of the measurements at both quarterpoints and at both ends of this section. In this graph are shown also straight line relations between movement and section length as observed on the short and relatively unrestrained slabs during each annual period.

dence that less restraint to longitudinal movement was present during the second cycle of length change.

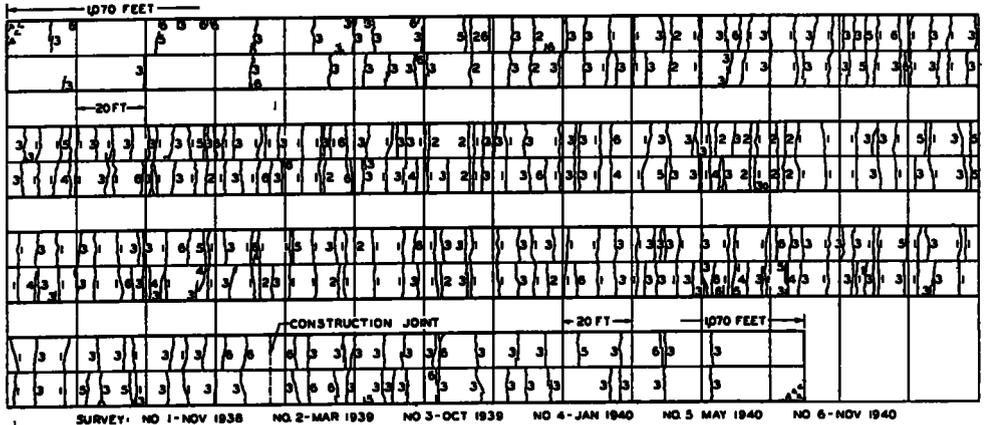
Figure 9. Typical crack survey sheet for long sections reinforced with one-inch diameter steel. Sections placed September-October, 1938

Figures 9, 10 and 11 are typical crack survey sheets, including all data obtained in the six surveys made up to this time. These were made during the various seasons of each of the two years of the service life of the pavement. Figure 9 shows the crack formation in a section 1,070 ft in length reinforced with 1-in. diameter billet steel bars, Figure 10, sections 90, 150 and 330 ft in length reinforced with ½-in. diameter steel bars;

Referring to Figure 9, it will be noted that a very large number of cracks have formed in the central area of this long, heavily reinforced section. In this area cracks are frequently less than 2 ft apart but near the ends the spacing gradually becomes much greater. This manner of cracking was anticipated. The cracks are barely visible even on very close inspection and none has opened enough to indicate an inelastic elongation.

of the steel. At this time there is no spalling or disintegration and the section is structurally intact. Figure 12 is a recent photograph of a crack typical of

Comparison of Figures 9, 10 and 11

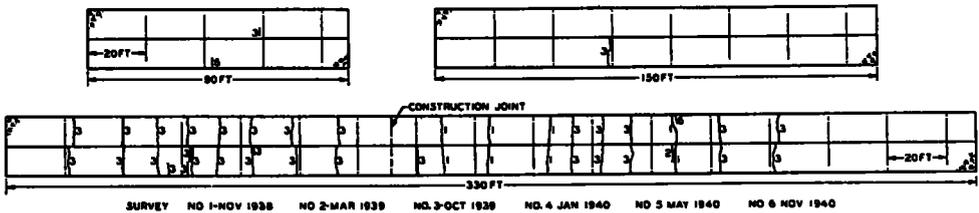
Figure 10. Typical crack survey sheet for intermediate length sections reinforced with 1/2-inch diameter steel. Sections placed September-October, 1938

ure 10, only the 330-ft. section has an appreciable number of cracks discernible at this time. In the 150-ft. sections contains no full length cracks.

The cracks in this group appear to be slightly more open than those in the more heavily reinforced sections but the difference is slight and no quantitative data are available at this time. There is no spalling, disintegration or evidence of inelastic deformation of the steel in these intermediate length sections. Figure 13 is a photograph showing the present appearance of a typical crack in this part of the pavement.

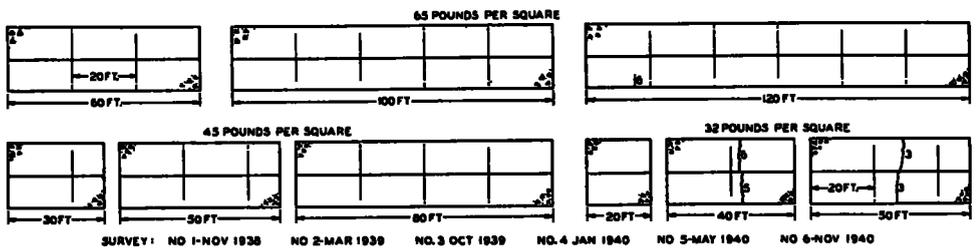
Figure 11. Typical crack survey sheet for short sections reinforced with welded fabric. Sections placed September-October 1938

and Figure 11, sections 20, 30, 40, 50, 60, 80, 100 and 120 ft long containing three different weights of welded wire fabric reinforcement as noted.

As will be noted from Figure 11, little or no cracking has occurred to date in

the shorter sections reinforced with welded wire fabric. Of the nine sections represented in this figure only two have cracked. These are 40- and a 50-ft. sections reinforced with the 32-lb. fabric, the lightest weight used. One full-width crack has developed in each of these sections. Figure 14 shows the present appearance of one of these cracks. The cracks are open slightly but there is no spalling, disintegration or evidence of steel failure at this time.

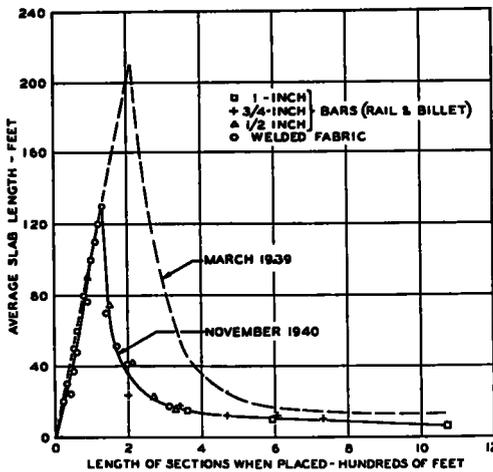
Figure 15. Relation between Length of Sections and Average Slab Length

forcement. A study has been made of this relationship and in Figure 15 is shown the relation between length of section and the average slab length of the section as found in March 1939 and again in November 1940. The sections represented in this graph include three sizes of bar reinforcement and several weights of welded wire fabric. As in other figures, the points for the first survey have been omitted for the sake of clarity.

sections having a length of 210 ft. or less. In sections of a length greater than 210 ft. cracking occurred and the frequency, as indicated by the average slab length, increased rapidly with section length. For example, at the time of this survey the average uncracked slab length of the 250-ft. sections was approximately 120 ft., that for the 600-ft. sections was about 16 ft., and that for the 1,070-ft. sections was about 13 ft.

There appears to be a relation between the length of the section as constructed and the average slab length (or distance between transverse cracks). So far there appears to be no relation between the average slab length and either the type or the amount of longitudinal steel.

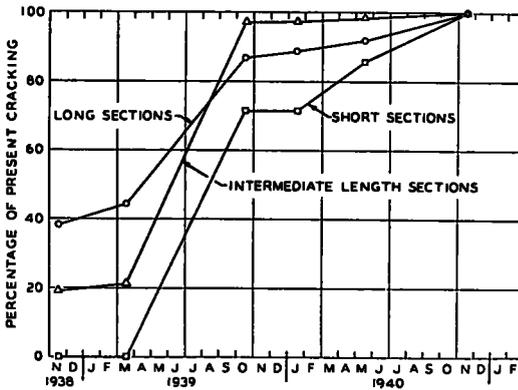
Figure 16. Rate of Crack Development

Figure 16 was constructed to show the manner in which the cracking developed in the sections of various lengths, particularly with respect to time of year. In this graph the long sections are reinforced longitudinally with 1-in. diameter bars, the intermediate sections with $\frac{1}{2}$ -in. diameter bars, while the short sections contain the three lighter weights of welded fabric (32, 45 and 65 lb. per square). The condition at the time of each of the six surveys is shown. The first survey was made after the completion of the curing period and within about one month after the section was laid. At this time about 40 percent of the cracking that now exists was present in the long sections and about 20 percent in the intermediate length sections. By March 1939 there had been but little change although the pavement had passed through a winter. The next survey in October 1939 showed a very great change in all groups, however. Since October 1939 there has been only a gradual increase in the number of cracks in all of the different length sections. The rate of cracking during this period has been greater for the shorter sections, although so few cracks have occurred that this is probably not significant. This graph indicates that the severe freezing of December 1939 and January 1940 had no noticeable influence on the rate of cracking.

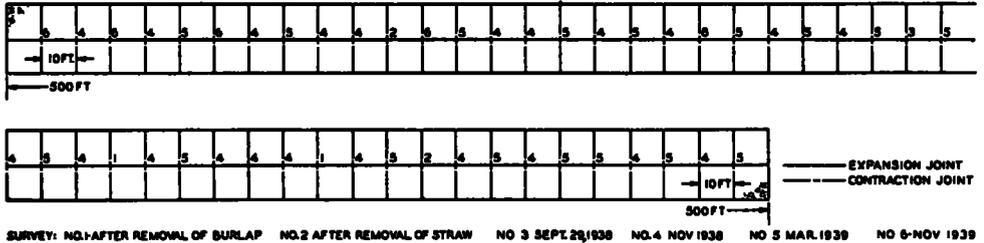
Figure 17. Progressive cracking of submerged plane of weakness contraction joints. Section placed September 8, 1938

pavement, and this record is shown in Figure 17. It is noted that only two cracks were found at the time of the removal of the burlap and only two more during the remainder of the curing period. The others occurred gradually until by the end of the first year complete fractures had developed at all of the joints.

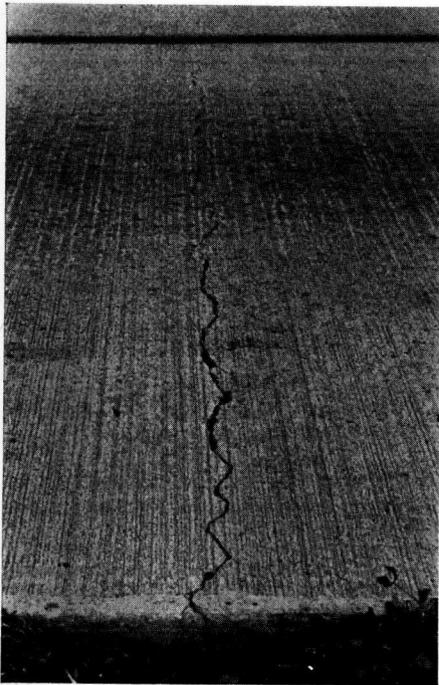
Figure 18. Typical Crack over Submerged Parting Strip in Lane Carrying Heavy Traffic

Figures 18 and 19 show the appearance of cracks over the submerged grooves in the right hand and the left hand lanes, respectively. These cracks have opened slightly and the edges have become slightly rounded. This condition is more noticeable in the right hand lane.

In the four special 500-ft sections containing 10-ft slabs separated by plane-of-weakness type joints, the sections as a whole are in excellent condition. The joints in which the surface groove was used are apparently perfect, while those formed by a submerged parting strip have opened and raveled slightly.

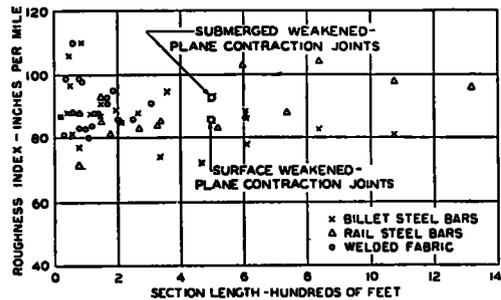
Figure 20. Relative roughness of various sections. Values obtained with Public Roads roughness indicator. (80-120 smooth surfaces, 200 and over, rough surfaces.)

The relative roughness index as determined during August 1940 for the various sections of the experimental reinforced pavement is shown in Figure 20, plotted with respect to section length. The pavement at this time was nearly two years old. It will be noted that in this graph different symbols are used to distinguish between sections reinforced with the different types of steel.

10-ft. intervals is shown on the graph as a section length of 500 ft., the distance between expansion joints. Two points are shown, one for the two sections with submerged joints and one for the two with surface joints. These sections appear to be no rougher than sections of equal length having no intermediate joints. In fact, their surface roughness appears to be about the average for the experimental pavement as a whole.

3. With modern methods of construction and proper care, the number or spacing of joints in a concrete pavement apparently need not affect its surface roughness.
