THERMOSETTING SYNTHETIC-RESIN PAINTS FOR CONCRETE PAVEMENT MARKINGS

BY FLOYD O. SLATE

Research Chemist, Purdue University¹

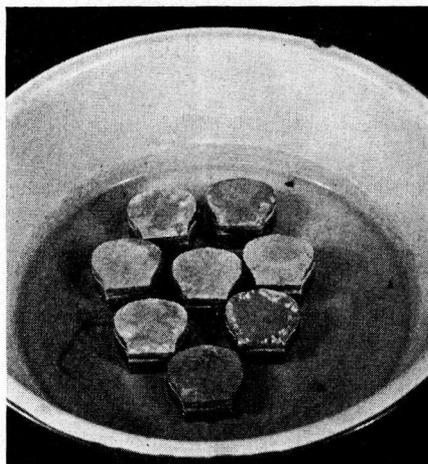
Figure 1. Apparatus for Water Exposure Tests for Concrete Paints

Laboratory tests were performed to determine why proper adhesion is not always attained and maintained. For the evaporation tests, the specimens with their tops painted were placed to about one-half their depths in

water in pans as shown in Figure 1. (Note the salt crystals.)

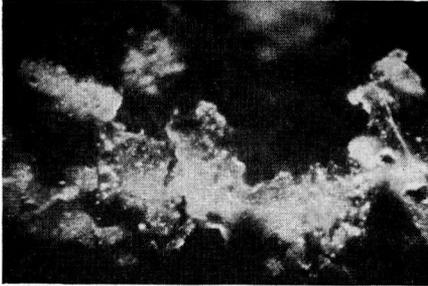
Figure 3. Paint Failure Caused by Capillary Evaporation of Tap Water Showing the Film Raised Completely Off the Cement Mortar Base. 100X

First, a specimen coated on top with a standard air-drying traffic paint was placed for three weeks in tap water. The paint film scaled off after the bond was broken. Large accumulations of salt were in evidence on the remainder of the film (Fig. 2), which was raised high off the cement surface (Fig. 3). This surface was badly disintegrated and

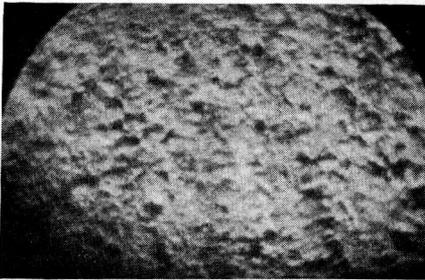
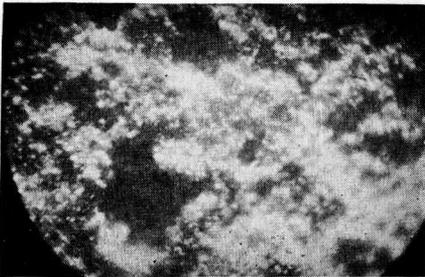
Figure 4. A Cement Mortar Surface Badly Disintegrated by Growing Salt Crystals Formed by Capillary Evaporation of Tap Water. 100X

crumbly as is shown in Figure 4. (Refer to IV in the adhesion outline under "Discussion of Adhesion and Use of Synthetic Resin Paints.")

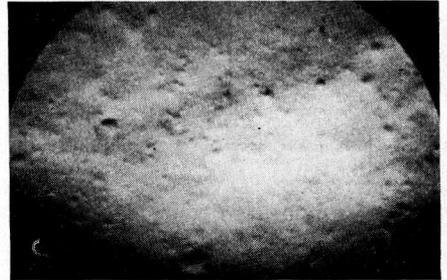
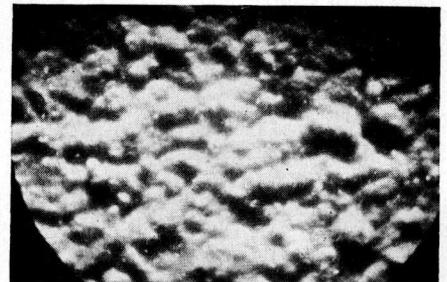
Figure 5. Comparison of Areas of Contact of Baked and Air-dried Paint Films to a Cement Mortar Base. 100X

Figure 5 shows photomicrographs of baked and air-dried paints (Nos. 1 and 12). It appeared that the former film was clinging to the mortar base throughout, while only one-half to one-third of the area of the latter

appeared to be touching the base at all. The rest seemed to be raised as small bubbles. Note that small holes are located at the tops of these bubbles, which were apparently formed by displacement of air by rise of capillary water before the paint was set, and then burst, leaving the small holes at the top. This indicates that much better adhesion can be attained with baked than with air-dried coatings on concrete under the conditions of this test. (See IIIC in the adhesion outline under "Discussion of Adhesion and Use of Synthetic Resin Paints.")

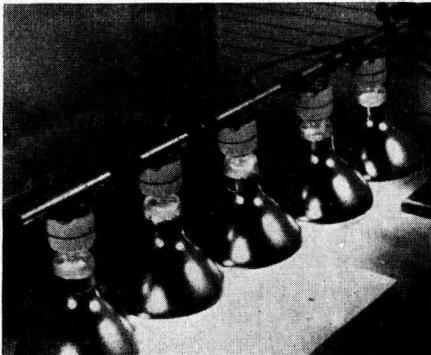
Figure 6. Arrangement of Lamps on Adjustable Structures for Laboratory Experimentation.

The infra-red lamps used were 5-in. max. dia. G. E. type R-40, 250 watt bulbs with built-in evaporated-aluminum reflectors. They were wired in parallel circuit and placed on an adjustable support as shown in Figure 6. A home-made ball mill, used for mixing and

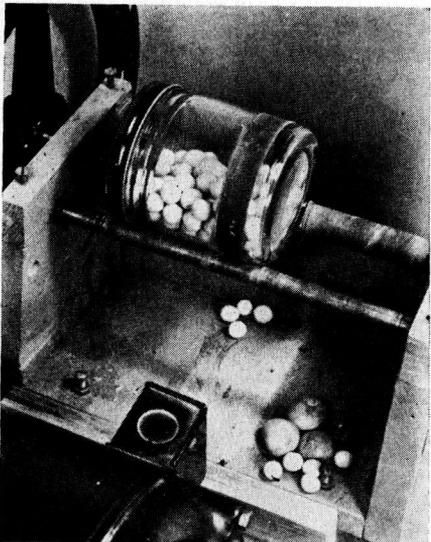
Figure 7. Ball Mill Used for Grinding Paints

grinding the paints, is shown in Figure 7. The machine used to measure the abrasion resistance of the paints was a standard U. S. Dorry Hardness Machine, slightly modified (7).

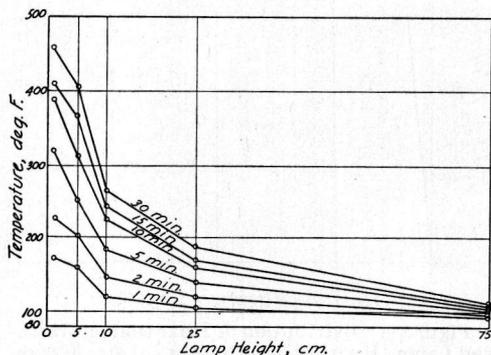
Figure 8. Variation of Temperature with Lamp Height for Various Heating Times.

Since a straight path, no wider than the lamps, was to be irradiated, the lamps were mounted touching each other in a straight line. The height of the lamps was varied to determine the optimum height. The results are shown in Figure 8.

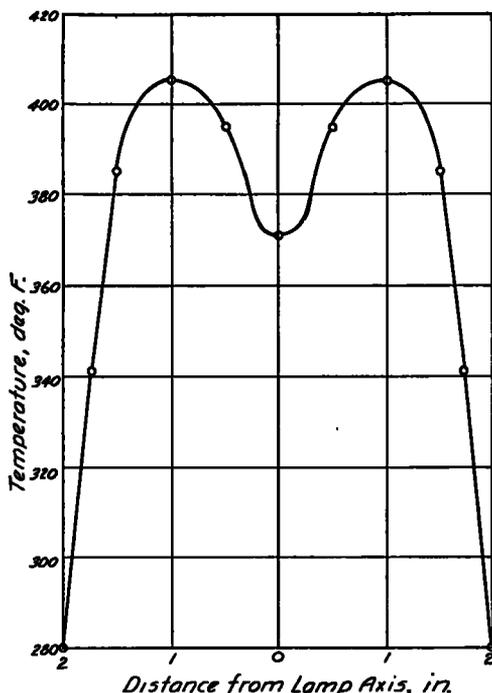
Figure 9. Distribution of Heat from an Infra-red Lamp (Heating time 10 min. Lamp Height 1 cm.).

The efficiency of heating in different places under the same lamp is shown in Figure 9. The dip in the center is readily explained by the fact that the space immediately under the center of the lamp is out of focus. Since the reflector is built in, the lamp has a fixed focus. The focal length is about 12 in. However, as shown in Figure 8, more efficient heating is obtained at close range even though the lamp is out of focus.

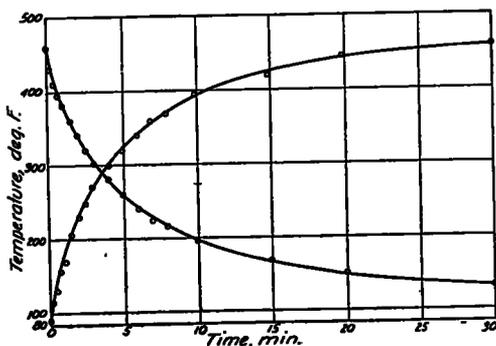
Figure 10. Heating and Cooling Time of a Concrete Surface. Heating was done by infra-red lamps at a height of 1 cm.

Complete heating and cooling curves of a concrete surface are shown in Figure 10. This experiment was performed using the optimum conditions of lamp arrangement.

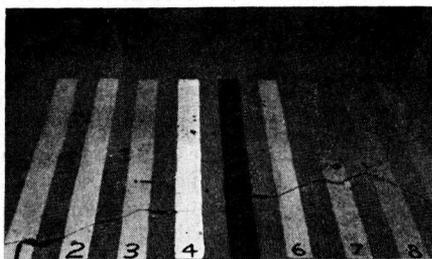
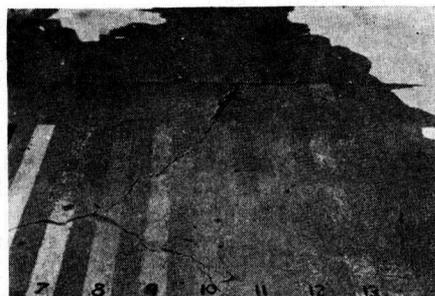
Figure 11. Field Comparison of Paints, Series No. 1, Age Six Months.

Figure 11 is a photograph of these lines six months later, after they had been weathered for a winter. Most rapid failure, by far, occurred in February and March.

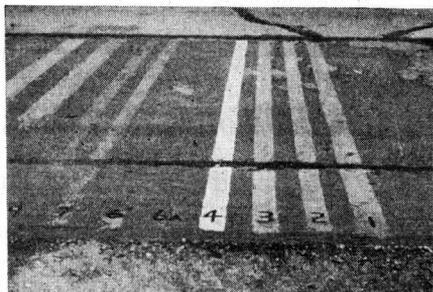
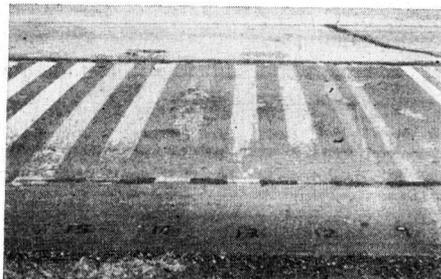
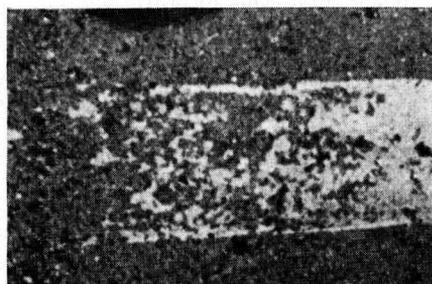
Figure 12. Field Comparison of Paints, Series No. 2, Age Two Months.

Figure 12 is a photograph of the lines of Series No. 2 taken two months after they were painted.
