CONDITION OF CONCRETE PAVEMENTS IN KANSAS AS AFFECTED BY COARSE AGGREGATE

BY L. V. WHITE AND R. L. PEYTON

Kansas State Highway Commission

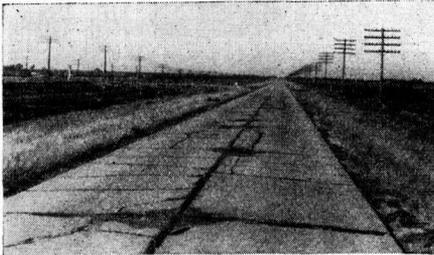
Figure 1. Moline Limestone in Foreground, Changing to Lincoln Sandstone at Crossroads, Saline County near New Cambria

Lincoln sandstone and Moline limestone are two materials which definitely indicate that they have a large influence in the occurrence of the group II failure or D-lines. Apparently the sandstone prevents such deterioration and the limestone creates and accelerates it. As an example of these conditions, U. S. 40 near New Cambria in Saline County is outstanding. Here the slab was constructed in alternate sections using the two materials, due to production difficulties rather than design. Figure 1 shows a stretch of this road with Moline limestone pavement in the foreground, changing to Lincoln sandstone at the cross-road. Figure 2 is a close-up of the joint at the transition point between the two aggregates, Moline limestone on the right, Lincoln sandstone on the left. This pavement was built as one project and is all of the same age. The failure in the Moline stone at this location is a typical case for failure type No. 5. The influence of

the character of the aggregates may be considered as governing in this situation as all other factors must be approximately equal in such a short distance.

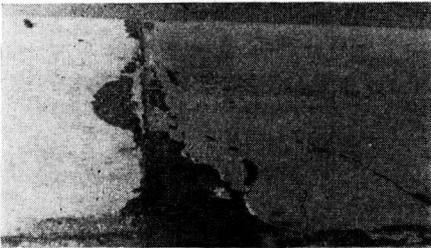
Figure 2. Close up of Figure 1. No. 5 Type Failure Moline Limestone Right, Lincoln Sandstone, Left

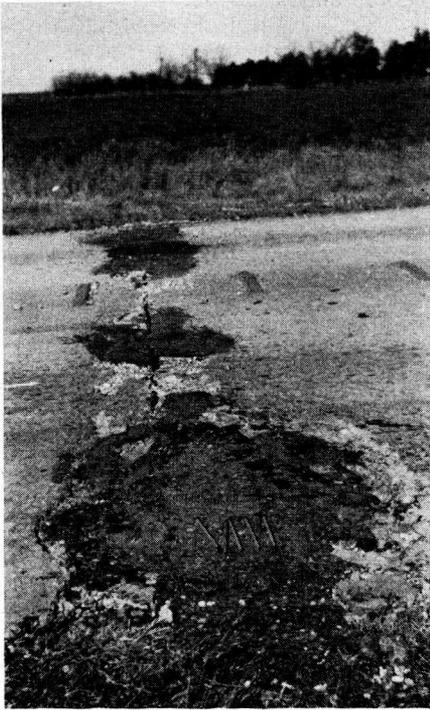
Figure 7. No. 5 Failure. Some concrete has been removed and patched with bituminous material. 1936 Marion County, Bazaar Gravel

Bazaar gravel pavements were rated "poor" in all Bazaar pavements examined. Figures 7 and 8 show why. Figure 7 is a full view and Figure 8 a close-up of a No. 5 failure typical of those found in the Bazaar gravel pavements. This one is on U. S. 50 in Marion County.

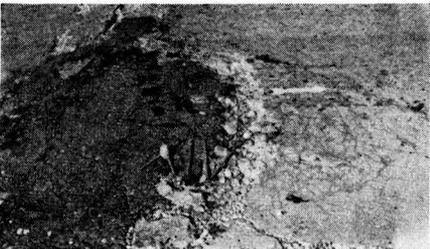
Figure 8. Close-up of No. 13 Bazaar Gravel

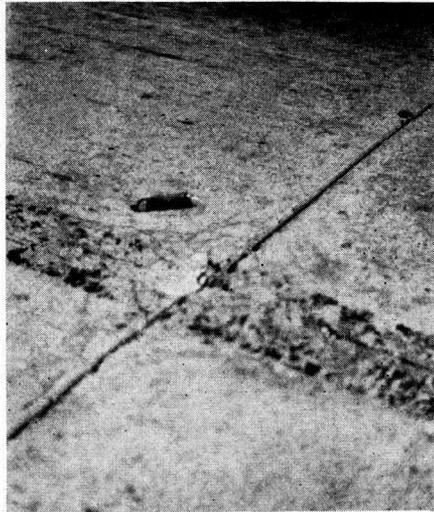
Figure 10. Wyandotte Co. D Cracks Well Developed in 4-yr. old Pavement. American Rock Crusher Limestone

but which must be considered in the dark because of scanty information is the limestone from the American Rock Crusher Company. Figure 10 shows the development of a No. 4 failure in a 4-yr. old slab containing this material in Wyandotte County on U. S. 40. The west end of this slab is paved with Holliday gravel and is entirely clear of this type of

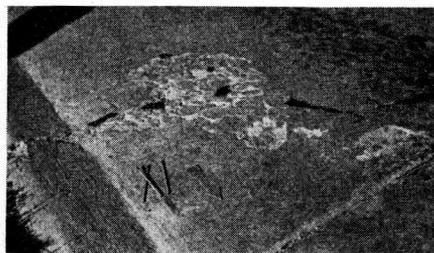
Figure 12. Type No. 5 Failure. Concrete has scaled from surface for area of 9 sq. ft. Johnson Company, Cement City Limestone.

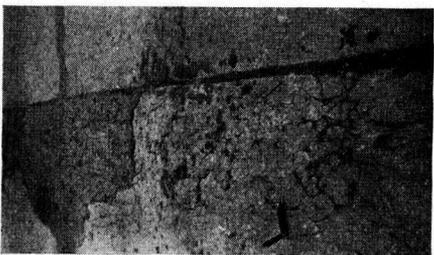
Figure 13. No. 5 Failure, Complete Disintegration, Douglas County, Lawrence Limestone

Figure 13 is a No. 5 failure found on U. S. 59 in Douglas County. This disintegration is in

concrete from the Lawrence limestone group, a material with a record of very good service. This picture is of a slab 18 yr. old.
