ACCELERATED TRAFFIC TESTS FOR FLEXIBLE AIRFIELD PAVEMENTS

By W. K. Boyd, *Chief, Flexible Pavement Branch,
U. S. Waterways Experiment Station, Vicksburg, Mississippi*

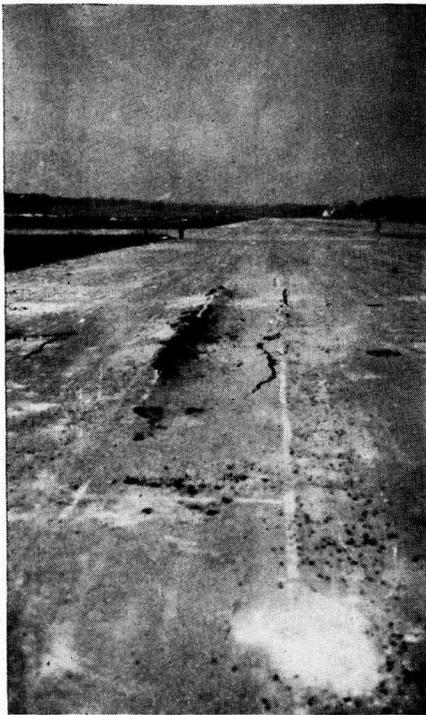
Figure 4. Failure Along Construction Joint in Soil Cement Base—Construction Joint is Along the left edge of the Traffic Lane as shown in the picture.

Soil-cement bases were constructed at two locations: Beltsville, Maryland, and Fargo, North Dakota. At Beltsville, the soil-cement base was a mixture of local sand and clay with approximately 10 percent cement by volume. The base was 6 in. thick and was constructed on a plastic subgrade in 25-ft lanes. In one test area, the traffic lane was located along a longitudinal construction joint. At the end of 227 coverages of a 15,000-lb wheel load, the base was pushed up along the construction joint for about three-fourths the length of the traffic lane and a large crack developed on the opposite side of the lane as illustrated in Figure 4. In a second test, the traffic lane was in the interior of a construction lane. No photograph is available for comparison; however, the cross-sections from this area illustrate the results. On Figure 5 it should be noted that deformations were in general about 1 in. or less until after the completion of more than 1800 coverages. It is pointed out in the summary report that the subgrade may have been stronger in the second test area, which might account for the ability of the soil-cement base to withstand the much larger number of coverages.

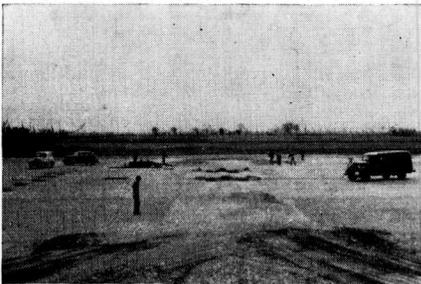
Figure 7. After 170 Coverages—30,000-lb Traffic Lane.

been placed. Failures occurred in all three of the traffic tests at from 10 to 130 coverages. The development of failure in each test was similar in that springing started at the edges of the runway and at the construction joints in the early stages of the test, followed by cracking and displacement of the soil-cement. Figure 7 shows the failure that took place at the construction joints for the 30,000-lb wheel load.

It is believed that the weakness of the construction joints in an important consideration and until they are eliminated or strengthened the soil-cement base must be evaluated on the basis of the strength of the joints rather than on the interior of the slab. Such an evaluation severely penalizes this type of construction since at both Beltsville and Fargo the interior of the base withstood a considerable amount of additional traffic without any particular distress after the joints had completely failed.
