THE APPLICATION OF AERIAL STRIP PHOTOGRAPHY TO HIGHWAY AND AIRPORT ENGINEERING

By JEAN E. HITTLE

Research Engineer, Joint Highway Research Project, Purdue University

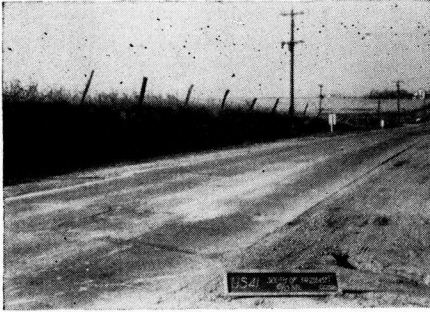
Figure 8. Ground View of Maintenance Patching and Pumping Slabs in Cut Section Shown in Figure 7

ditions. The pavement in the cut section has been patched over a considerable area while that in the fill section is entirely free from this type of maintenance. The poor pavement performance in the cut sections shows up in the form of slab pumping. Figure 8 shows a ground view of the pavement performance in the cut section shown in Figure 7. This contrast in performance must logically be attributed to the corresponding contrasts in soil textures and moisture conditions encountered in the cut and fill sections.

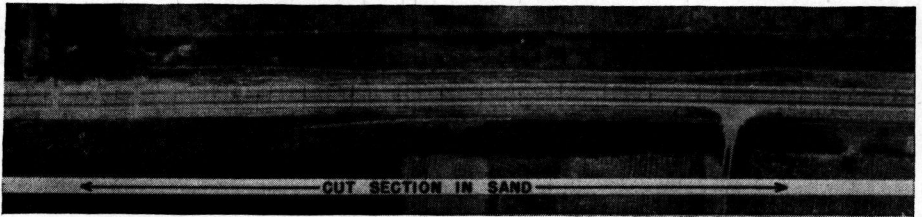
Figure 12. Good Pavement Performance on Sand Subgrade in Cut Section

photos covering adjacent cut sections on US 31 in southern Indiana (Fig. 12 and 14). Figure 12 covers a cut section on a sand subgrade. At this location the highway cuts through a sand dune. Note that this section of pavement is showing good performance. The good pavement condition for this section is also shown in Figure 13 which is a corresponding

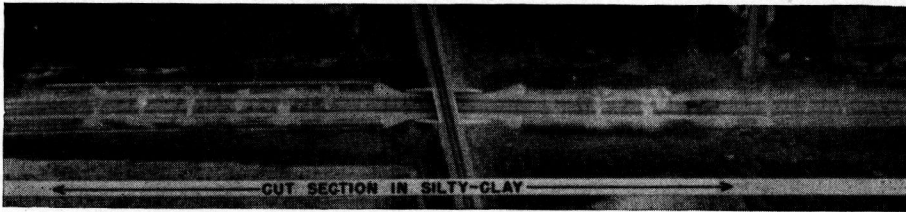
Figure 14. Poor Pavement Performance on Silty-Clay Subgrade in Cut Section—This section of pavement is adjacent to the location shown in Figure 12. The poor performance has been caused by pumping joints.

ground view. In an adjacent section, where the highway goes through a railroad underpass, another and deeper cut section is encountered. In this cut section the subgrade soil is a plastic silty-clay. Figure 14 records the pavement performance in this cut section.

Note that numerous patches have been made. A ground view of the pavement condition and patches in this silty-clay cut is shown in Figure 15. Note that the poor pavement performance is restricted to the cut section where the silty-clay subgrade soil is encountered. The contrast in the pavement performance in these two adjacent cut sections is attributed to the contrasts in soil textures of the sand and silty-clay subgrades. However, the poor performance of the pavement in the silty-clay cut section has been caused by pumping joints which is a problem of concrete pavement design where silty-clay and clay-like subgrades are encountered.
