SEVEN YEARS' PERFORMANCE OF A BITUMINOUS SURFACE TREATMENT TEST ROAD

By W. H. GOETZ, *Research Engineer, Joint Highway Research Project, Purdue University*

SYNOPSIS

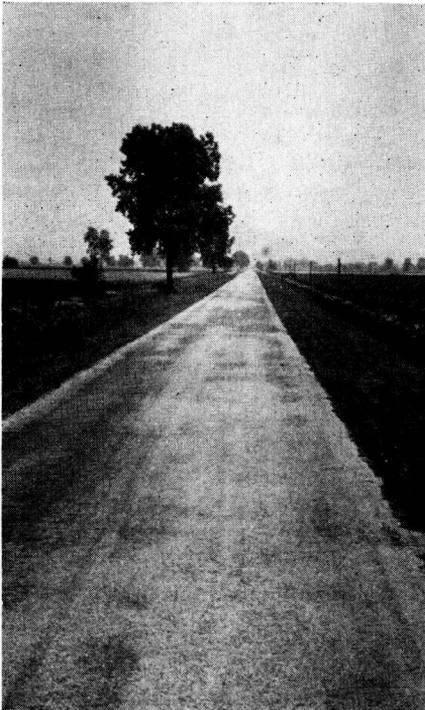
Figure 1 shows a general view of the west end of the test road as it appeared during the past summer. At this time, the 51 sections were carefully rated by methods very similar to those used in the earlier ratings. However, because considerable failure of the test

Figure 1. General View of Test Road 3 (West End)

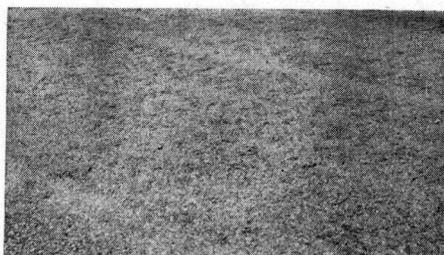
blade of the mixing drag. Spots are left on the surface which are bare of covering aggregate. See Figure 5. This failure is readily distinguished from raveling failure by the shape of the area and its occurrence. Figure 6 shows a portion of one of the better-performing sections.

Figure 5. Failure Caused by Pulling in the Mixing Operation
