# MAPCRACKING IN CONCRETE PAVEMENTS AS INFLUENCED BY SOIL TEXTURES

By HAROLD S. SWEET AND K. B. WOODS, *Purdue University*

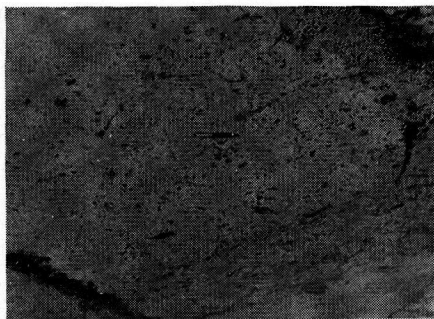
Figure 4. Mapcracking Typical of Performance in Cuts on S.R. 37

tive rating of different sections by counting the number of joints and cracks in a section which were affected. The severity of mapcracking varied in the different soil areas and was noted. Figures 4, 5 and 6 show the range in mapcracking conditions on these three road projects. This procedure was followed on each of the three projects described.

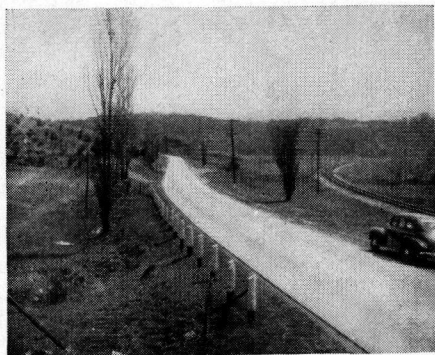
Figure B. This picture of the pavement built with coarse aggregate "A" illustrates excellent performance.

"A" is further illustrated by Figure B. It should be mentioned, however, that most of the pavement in this picture is located on a fill where natural drainage conditions are normally good.

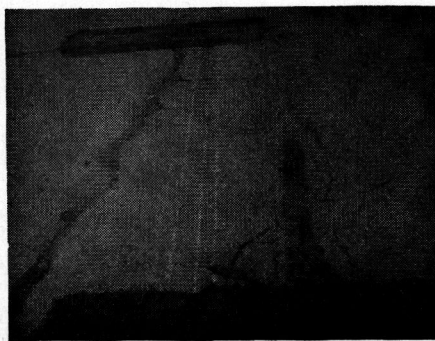
Figure D. A close-up view of a portion of the pavement in Figure C. Note particularly the extensive mapcracking.

In contrast, Figure C illustrates the condition of the pavement containing aggregate "B". Extensive ravelling or spalling at cracks, mapcracking and general disintegration are in evidence. These failures have necessitated a considerable amount of patching. A close-up of this pavement showing the extensive amount of mapcracking is further illustrated in Figure D.
