A SEGMENTED ELECTRICAL ELEMENT FOR DETECTING VEHICULAR TRAFFIC

J. H. MATHEWSON, R. BRENNER, AND R. J. REISS, *Institute of Transportation and Traffic Engineering, University of California, Los Angeles*

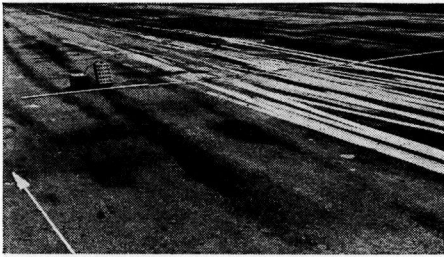
abrasions were noted on the adhesive tape covering and after repeated skids the covering was split along the aft edge. This was the entire extent of the damage. There were no electrical malfunctions and the harness and pick-up element showed no apparent damage. This was verified by high-speed tests which were repeated (two actuations of each segment) at the conclusion of the skidding tests and during which all circuits operated satisfactorily. The slide marks at the conclusion of the skidding tests are shown in Figure 3.

Figure 3. Slide Marks at the Conclusion of the Skidding Tests

(Arrow indicates direction of travel)

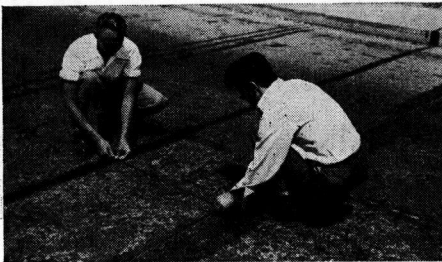
Figure 8. Installation Procedure: Locating the Detecting Unit for Speed Measurements

One of the factors in the design of a detecting unit with which the traffic engineer is concerned is the time required to complete an installation under traffic conditions. The time must be a minimum, not only to minimize traffic delay but, of even greater importance, to minimize the exposure to danger of personnel making the installation. Repeated measurements indicated that a 35-ft. unit could be installed by one man in 7 min. and that traffic could move over the unit immediately after the installation was completed. It is believed that this time compares favorably with the time required for installing any detecting unit which is attached to the road. Installation procedures are shown in Figures 7, 8, 9.

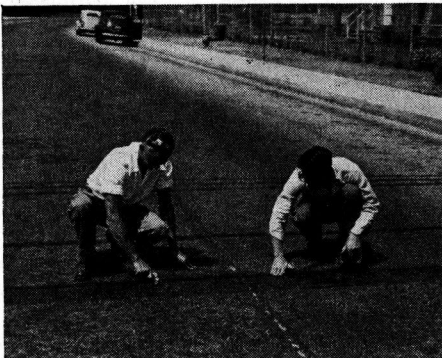
Figure 9. Installation Procedure: Applying the Protective Adhesive Tape Covering Over the Detecting Unit
