THREE-YEAR PERFORMANCE REPORT ON EXPERIMENTAL CONTINUOUSLY REINFORCED CONCRETE PAVEMENT IN ILLINOIS

H. W. RUSSELL, *Engineer of Materials* AND J. D. LINDSAY, *Assistant Engineer of Materials, Illinois Division of Highways*

SYNOPSIS

This paper covers the performance of the experimental continuously reinforced concrete pavement in Illinois during the period since its construction in 1947-48. Details of construction were previously reported at the 27th Annual Meeting of the Highway Research Board.

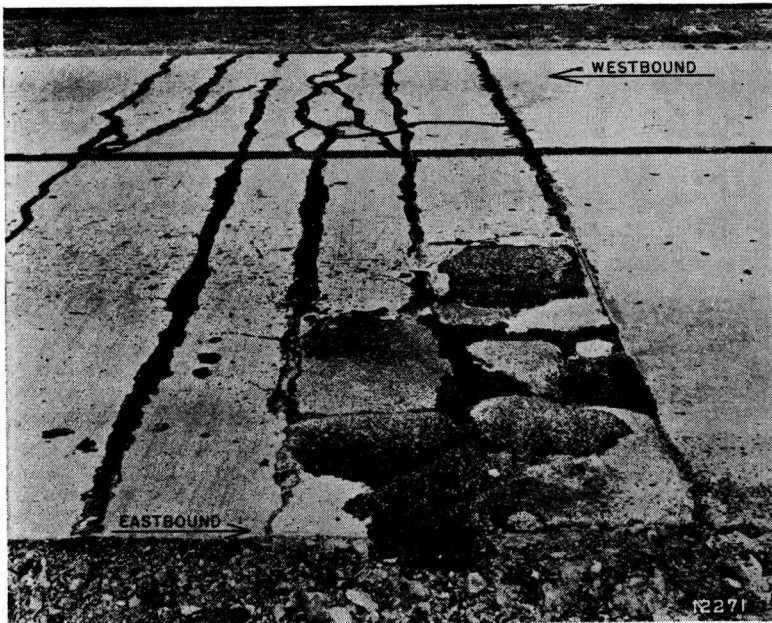
Figure 12. Localized Failure Near Sta. 292 + 75 as Seen from South Side of Slab (8-in. Pavement, 0.3 Percent Steel).

The larger of the two occurred adjacent to a construction joint at Station 292 + 75 and involved a length of about 8 ft., which included four closely spaced transverse cracks. It was first observed on October 15, 1948, only 5 months after construction. Pumping had developed at the construction joint and at two adjacent transverse cracks and severe spalling had developed at the transverse cracks. In November 1948, this area was undersealed with asphalt in an attempt to reduce the pumping. The failure became progressively worse, and in March 1950 the east-bound lane had developed to the condition shown in Figure 12.

While the major causes of this failure are thought to be insufficient steel and poor sub-

construction the four transverse cracks shown in the photographs developed within 8 ft. of the construction joint, due probably to the resistance to shrinkage offered by the reinforcing steel which was securely anchored in the older slab. Undoubtedly the closely spaced cracks and poor subgrade made the pavement extremely flexible, which resulted in unusually large deflections under heavy vehicles. Considering this condition and the characteristics of the subgrade, it is not surprising that pumping occurred.

About May 1, 1950, the condition of the pavement had become so bad at both locations that it became necessary to remove the broken concrete and replace it with concrete patches. At the larger failure the patch was 8 ft. long for the full width of the eastbound traffic lane. The other patch was about 3 ft. long at the centerline and 6 ft. long at the south edge of the pavement. In neither case was it necessary to patch the westbound lane.

It was possible to remove the old concrete without a great deal of damage to the reinforcing bars. Only one bar was broken at each location during removal of the old concrete. At the larger failure four bars had broken under traffic. An inspection of the concrete removed from the larger failure showed it to be of inferior quality, which points to the possibility that the concrete placed in that area, the first batch poured that day, may have been excessively wet when placed or poorly proportioned.

At both locations the subgrade was found to be wet and unstable for a depth of 7 in. and this material was removed and replaced with sand. A French drain was constructed across the shoulder at each location to provide drainage for the area. An excellent job was performed in placing both patches, indicating that this type of pavement can be properly repaired if failures occur.

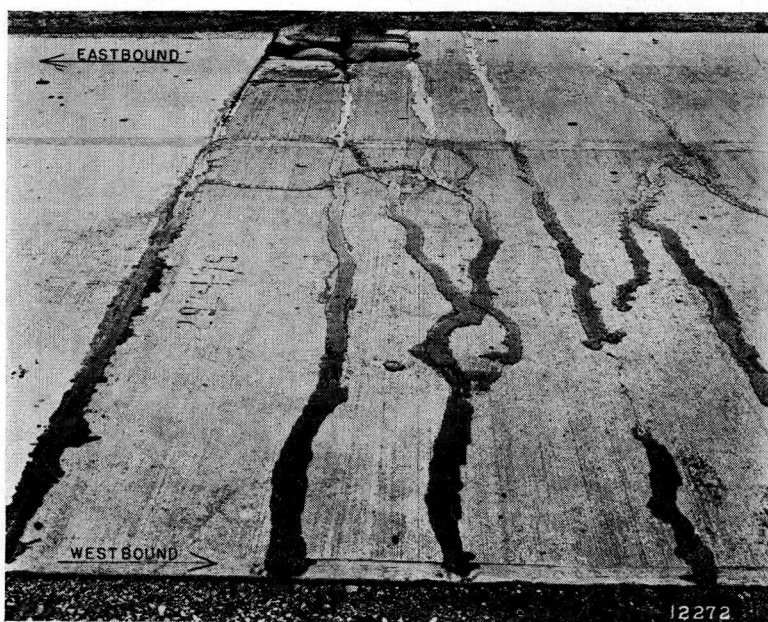
Figure 13 shows the condition in the west-bound lane at the same location and at the same time. It will be noted that the pavement in this lane is in comparatively good condition and there is none of the serious distress that developed in the other lane. The reason for this difference is not known since it does not appear that traffic or soil conditions in the two lanes are relatively different. It does, however, emphasize the local nature of the failure.

Figure 13. Localized Failure Near Sta. 292 + 75 as Seen from North Side of Slab (8-in. Pavement, 0.3 Percent Steel).

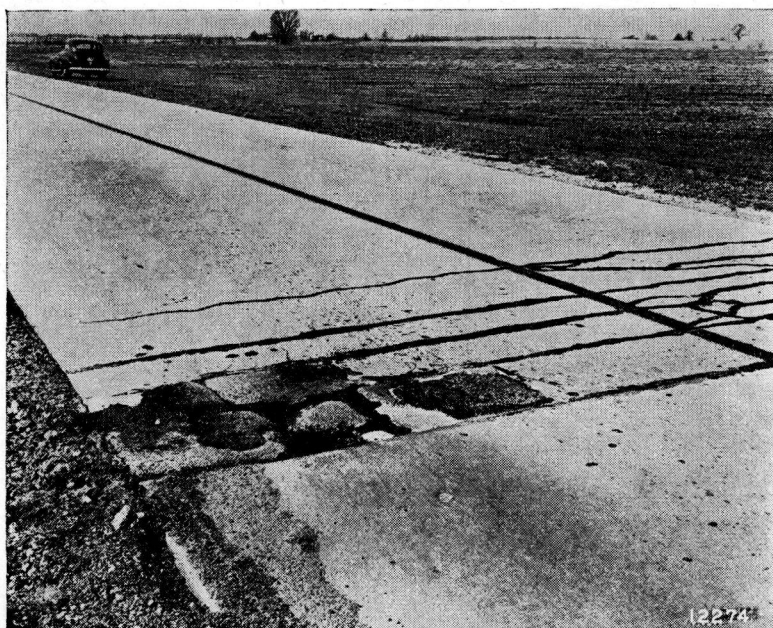
graph shows the excellent condition of the pavement east of the construction joint. The first transverse crack is 47 ft. east of the joint. Figure 15 shows that the pavement west of the joint is also excellent. The pavement shown on both sides of the damaged area is representative of the general condition of the remainder of this test section and, for the most part, the other sections are equally as good or better. It is needless to say, therefore, that the general condition of the entire pavement is good.

Figure 15. View Looking West from Sta. 292 + 75 Showing Excellent Pavement Beyond Localized Failure.
