KANSAS' EXPERIENCE WITH CONCRETE SAW FOR CUTTING CONTRACTION JOINTS IN CONCRETE PAVEMENT

W. J. ARNDT, *Assistant Engineer of Materials, State Highway Commission of Kansas*

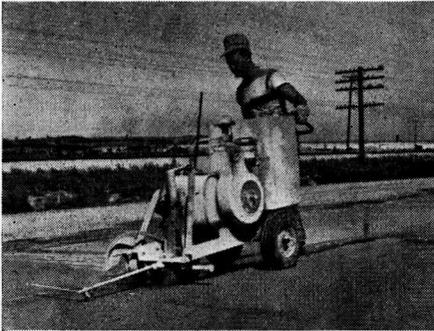
Figure 1. The Saw which Was First Used on the Topeka Test Road to Cut Contraction Joints—This saw was purchased to cut bad areas of concrete pavement preliminary to patching. Here the saw is cutting pavement which is 25 years old.

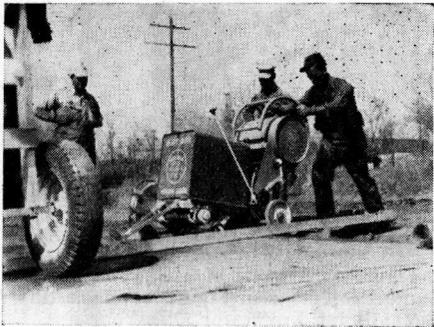
Figure 2. A Typical Saw Differing in Manufacture from the Saw Shown in Figure 1—Portable guides are being used in this photo.

Concrete Saw Described—Essentially the concrete saws which we have been using are portable outfits weighing between 350 and 500 lb. each, powered by a heavy duty gasoline motor which drives a spindle upon which is mounted a thin circular segmented diamond abrasive wheel (Fig. 2 and 3). The available abrasive wheel diameters that we know of vary from 8 to 18 in. The segmented wheels are approximately ½ in. thick made of high grade steel and have numerous commercial diamonds imbedded in their circumference. The abrasive wheel when in operation, is water-cooled from a tank mounted on the machine. The entire assembly is mounted on

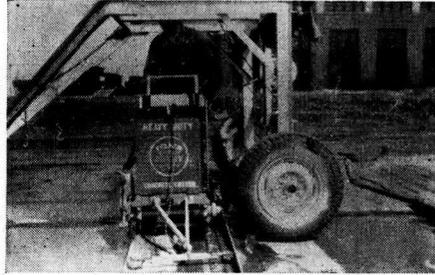
Figure 3. A Front View of the Saw in Figure 2—This picture shows the saw cutting a 2-in. groove at the edge of the angle guide on the left side. The framework is for the purpose of portability down the pavement to the next joint.

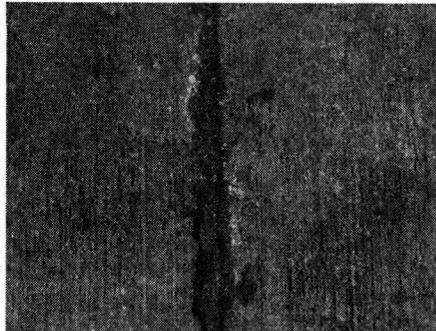
Figure 4. A Typical View of a Hand Formed Joint Which has Spalled to This Extent After Only Two Weeks Traffic—This groove has been filled with thermo-plastic sealing compound.

It was apparent that during the process of removing the metal cracker bar and finishing this joint, unsound concrete was being created around these joints (Fig. 4). We were also dissatisfied with the roughness which was developing during this operation which left a slight ridge adjacent to the groove. Joint finishers who were not too skillful and who were inclined to be careless exaggerated this condition. After several unsuccessful attempts to improve the situation the division engineer

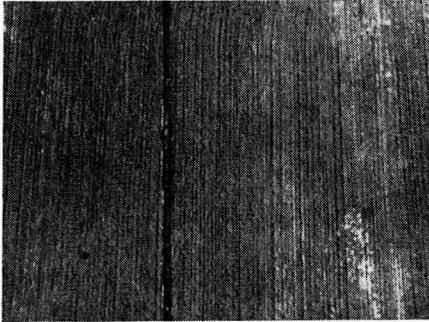
Figure 5. A typical View of a Joint Which Was Formed by Sawing and Filled with Thermo-Plastic Sealing Compound. Note the clean-cut appearance of the joint. After being under traffic for one year this joint still has the same good sound appearance.

So definite was the improvement and efficiency of this operation that it was continued for the remainder of this project (Fig. 5) and was used on another project built the same year by the same contractor. It then became a definite requirement that the contraction joints in all 1950 concrete pavements be formed with the concrete saw. With this years experience, the saw has undoubtedly found a permanent place in our specifications. The use of the saw eliminates all of the shortcomings of the hand formed groove such as

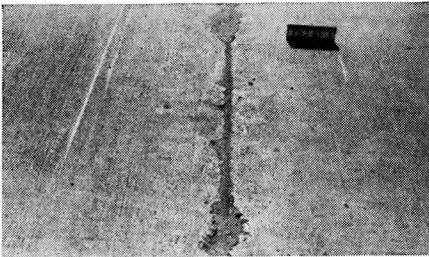
Figure 6. A View of a Hand Formed Joint Which Has Been Under Traffic for One Year

spalling, and rough and noisy riding surfaces (Fig. 6).

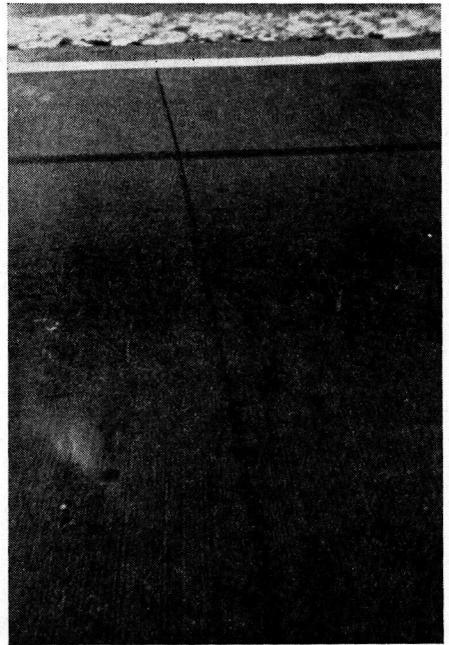
Figure 7. A View of a Sawed Joint on the Same Project as in Figure 6 Which Has Also Been Under Traffic for One Year

We have had an opportunity to observe the sawed joints which have been under traffic for more than a year (Fig. 7). There were 52 miles of concrete pavement built during 1950 in Kansas, by five separate contractors, and

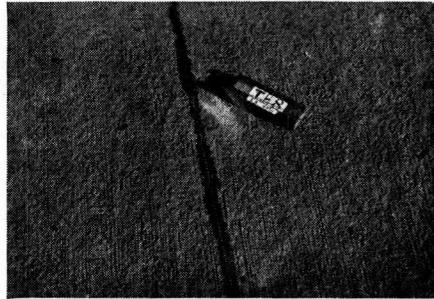
Figure 8. A Typical View of a Sawed Joint on the One-Year Old Topeka Test Road Showing the Good Condition of the Thermo-Plastic Sealing Compound

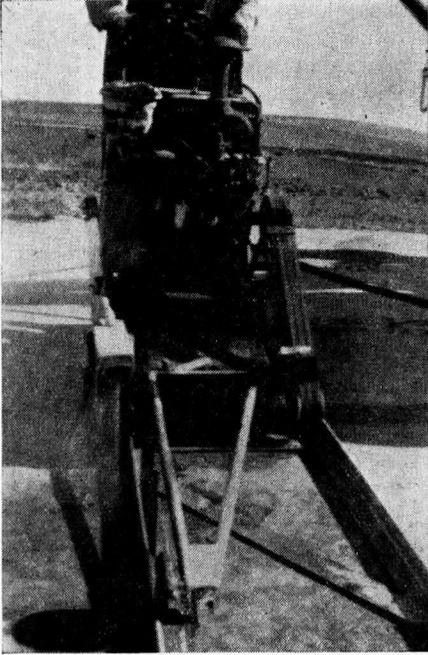
Figure 9. A Photo Showing the Saw Being Used and Guided by a Portable Light-Weight Guide for Straight Sawing

1. Keeping the saw in a straight line without sideplay was a very effective means of obtaining greater footage per blade. The portable guides shown in Figure 9 prevent sideplay. Sideplay loosens the granular constituents of concrete and they act as an abrasive tending to shorten the life of the blade by stripping it of its imbedded diamonds. Forcing the saw by applying too much pressure to its forward motion tends to lessen the life of the blade. Maximum life is obtained with gentle pressure that permits the blade to cut its groove as one would use a circular saw for cutting wood. A good cutting speed for the 2-in. cut was found to be about 8 to 10 ft. per min.

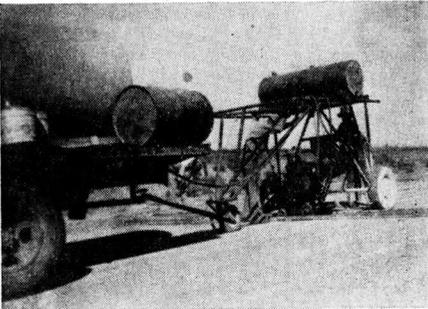
Figure 10. Showing the Auxiliary Water Tank Mounted on the Framework—The tank is being filled from a supply tank wagon. Usually a small water pump is used in conjunction with this extra water supply.

for water supply (Fig. 10). They added a small water pump to this supply and with this large quantity of water playing on the blade constantly, the life of the blade was measurably increased. Heat will wear the diamonds faster and also tends to loosen them.

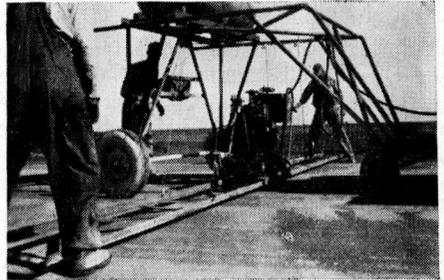
Figure 11. Showing how the Framework is Used to Hoist the Portable Guides and Concrete Saw for Transportation to the Next Joint
