LIVE-LOAD STRESS MEASUREMENTS ON FORT LOUDON BRIDGE FINAL REPORT¹

NEIL VAN EENAM, *Highway Bridge Engineer, Bureau of Public Roads*

SYNOPSIS

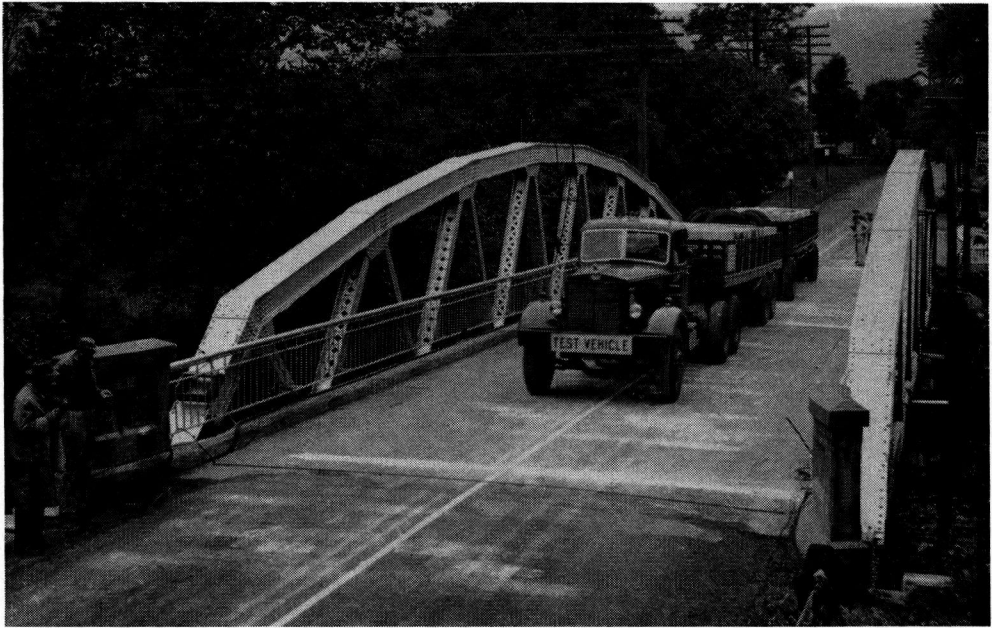
Figure 1(a). View of bridge; the test vehicle is Truck 7.

The tested structure, which was built in 1924, has a span length of 110 ft. 8 in. between centers of bearing and a roadway width of 23 ft. 0 in. between curbs. It was designed for H20 loading, with a basic unit stress of 16,000 psi. The trusses are of the Warren type, with a panel length of 13 ft. 10 in. and a maximum depth of 14 ft. 0 in. between centers of chords at midspan. The 7-in. reinforced concrete floor slab is supported directly on 7 lines of 12-in. 40.8-lb. I-beam stringers, spaced 3 ft. 10 in. on centers. The bottom of the floor slab is flush with the top surface of the stringers, so that there is no encasement of the stringer flanges. Over the floor slab is a concrete wearing surface of 4½ in. maximum thickness. All floor beams are 24-in. 121-lb. Bethlehem girder beams. The bottom lateral system consists of double cross-braces in each panel. It lies in the plane of the bottom of the bottom chords and of the floor beams. The laterals are connected together at their intersections on the center line of roadway, but they are not connected to the stringers. All laterals are 3-in. by 3-in. by ⅝-in. single angles. A view of the bridge, looking west, is shown in Figure 1 (a), and a typical section through the roadway appears in Figure 2.
