CRACKING OF CONCRETE IN THE TUSCALOOSA LOCK

BRYANT MATHER, *Engineer, Concrete Research Division, Waterways Experiment Station, Corps of Engineers, U. S. Army, Jackson, Mississippi*

SYNOPSIS

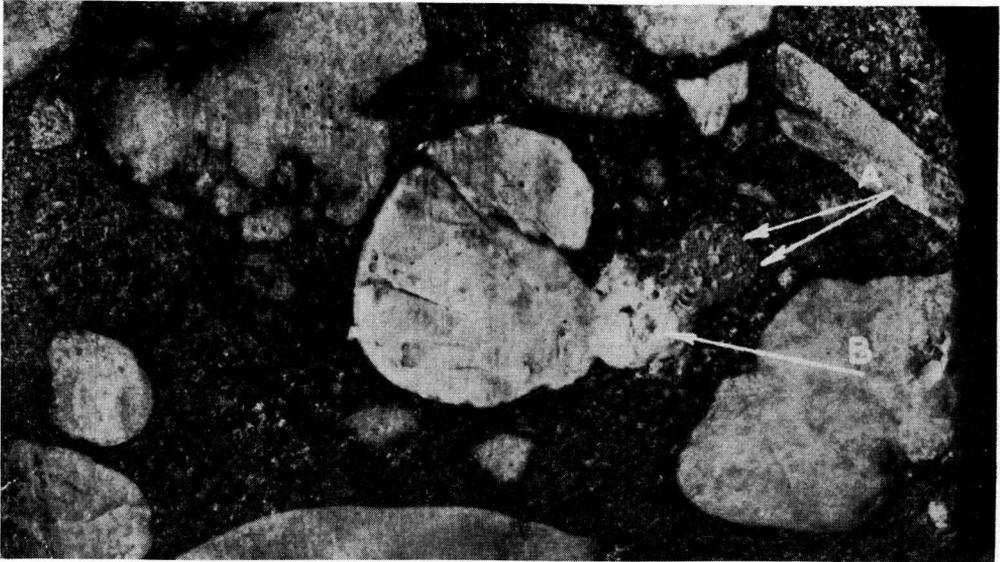
Figure 1. Flecks of gel with included sawdust (A) and mound of gel (B) which grew on core surface after drilling (slightly enlarged). Core 5-1, depth 7.5-9.0.

but not on coarse aggregate particles of other types. Frequently the gel entirely inclosed sawdust¹ particles; mounds of gel rose up as much as $\frac{1}{8}$ in. above the core surface (Fig. 1). These facts make it plain that some of the gel deposition took place after the cores were drilled. All of the drilled surfaces cut air pockets and underside voids containing white or clear exudates with outer surfaces continuous with those of the adjacent paste and mortar and, accordingly, older than the drilling of the core. A number of the drilled surfaces show cracks visible to the naked eye. A few show such cracks filled or partly filled

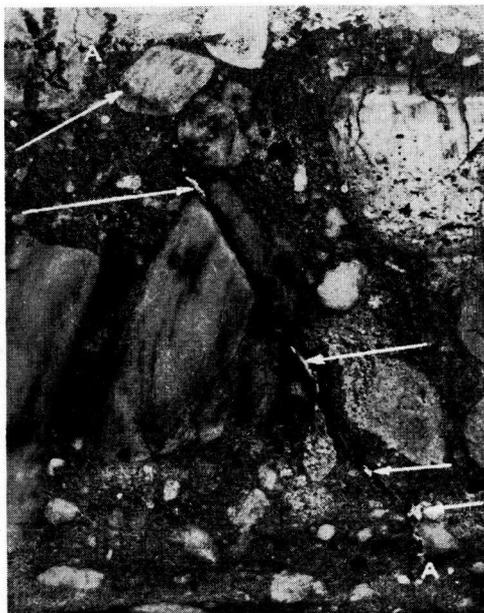
Figure 2. Open crack. (A-A). Partially filled with gel (arrows). The crack reaches its greatest width in the chert pebble near the center of the photograph (slightly reduced). Core 60-1, 7 in. from formed surface.

with exudate (Fig. 2). The smoother surfaces produced by sawing with a diamond-edged blade reveal more cracks than appear on the outside of the core. When the concrete was broken open and the surfaces of the largest cracks examined, the surfaces were found to be covered with desiccated gel, which filled the crack and saturated the adjoining mortar. Some of the drilled surfaces intersected empty pebble sockets where poorly bonded aggregate was lost during drilling. Some of the surfaces

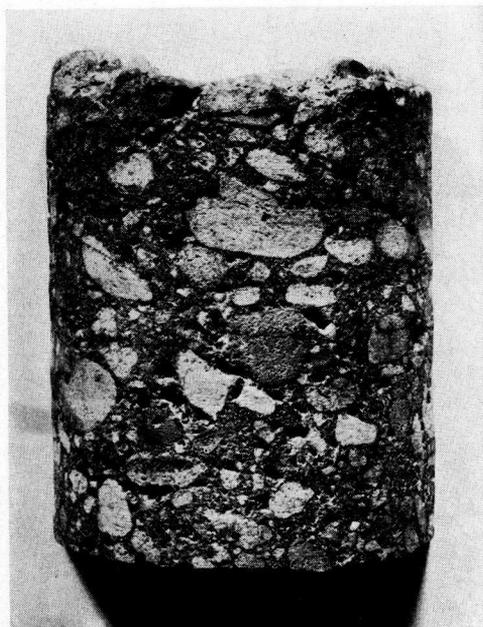
Figure 3. Concrete with numerous large voids, depth about 33 ft, core 5-1. The surface is typical of the core from 14.5 ft to 39.6 ft. Direction of placement towards bottom of photograph. The voids are more frequent adjacent to coarse aggregate particles.

intersected coarse aggregate particles containing cracks visible to the naked eye. Most of the cracked particles were chert; a few were quartzite or sandstone. Many of the cores were fairly dense and free of large voids on the drilled and sawed surfaces. In those cores the concrete near the outside of the structure appeared generally more dense than the concrete in the interior. Other cores were noticeably less dense, and in certain cases were found to contain numerous large irregular voids and, in one case, showed conspicuous honeycomb (Figs. 3 and 4). In all of the con-

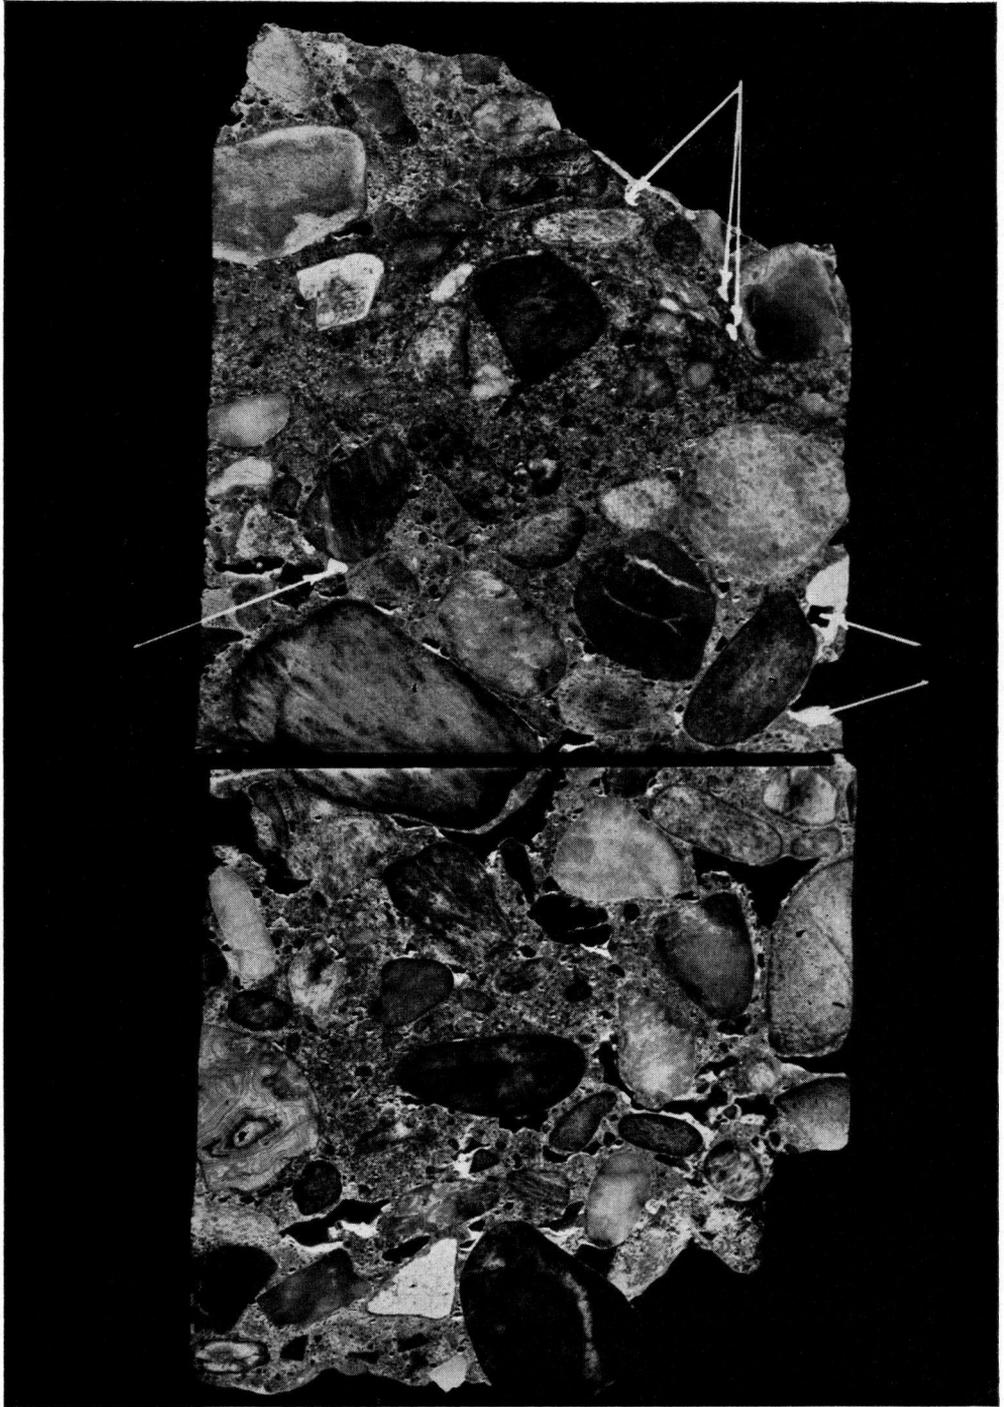
Figure 4. Honeycombed concrete from core 5-1, depth 13-14 ft. Direction of placement towards bottom of photograph. Arrows indicate gel pockets; the large voids in the lower section are gel-lined.

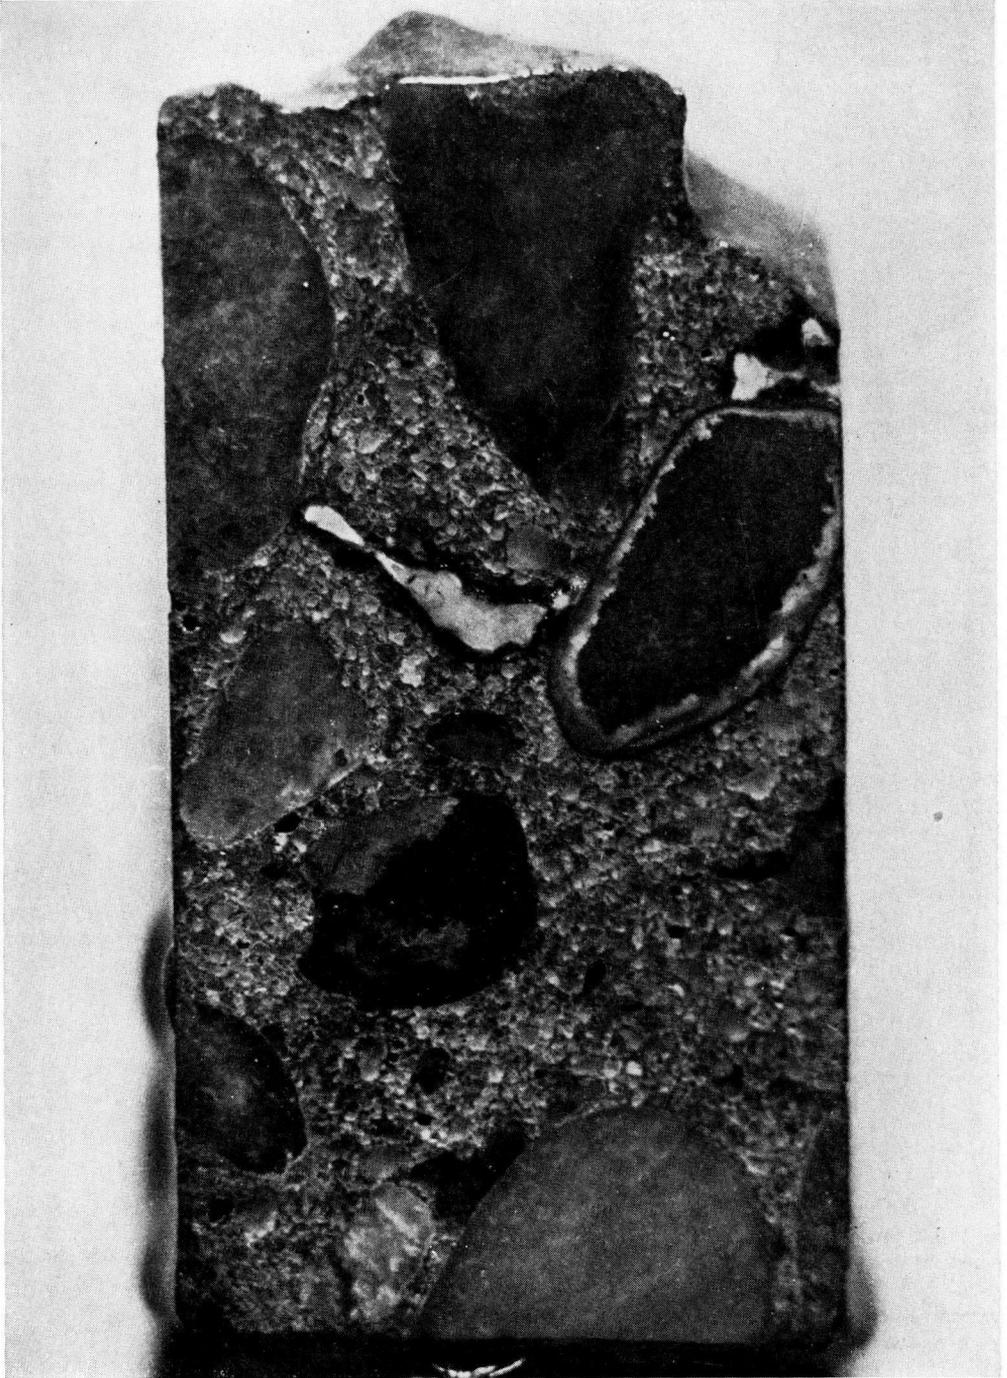
Figure 5. Thin section blank impregnated with resin, ground, exposed to warm humid air for about 35 hr. Magnification about 3X. Photographed August 23, 1949. Two large gel pockets (upper right and upper center) had taken up moisture and swelled. The chalcedonic pebble (lower-left center) had taken up moisture, and there was a wet spot on a sand grain at the lower left.

examined, it was found that three gel pockets and one chalcedony particle on the ground surface had taken up water from the air and swelled up perceptibly above the general level of the ground surface. Figure 5 is a photograph of the specimen at a magnification of about 3×, taken about August 23, 1949. On August 24, 1949, the blank was stored in a closed container over water, and left until October 17, 1949. It was then reexamined and the photograph reproduced as Figure 6 was made at the same magnification.

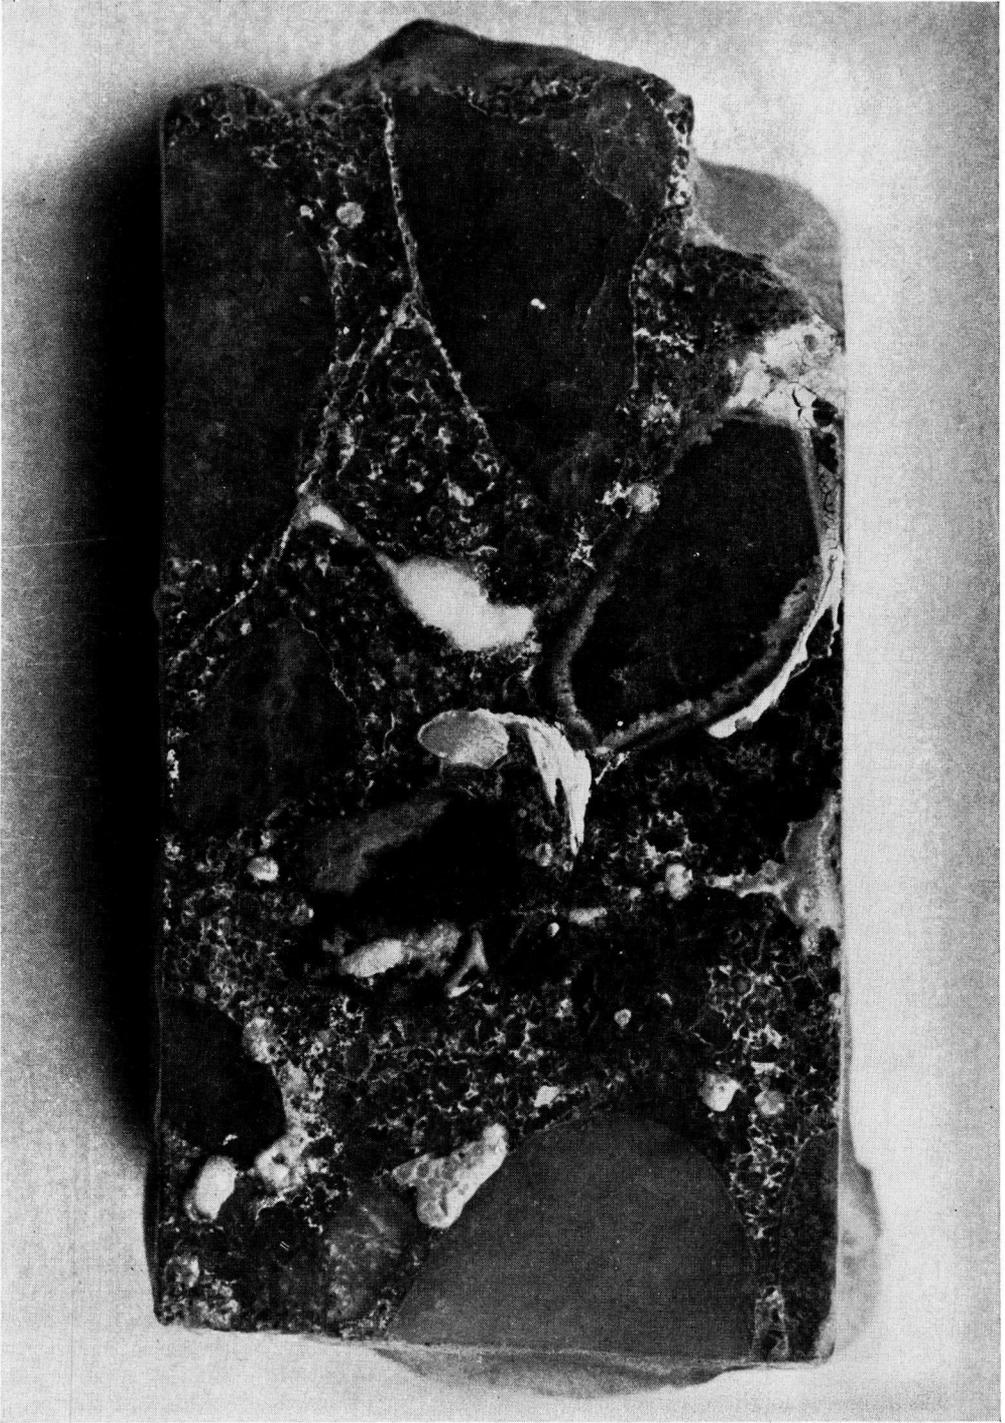
Figure 6. Same specimen after storage over water at room temperature between August 24, 1949, and October 18, 1949. The gel pockets shown in the previous photograph have enlarged; many more have appeared; cracks which were not obvious before are now traced in reaction product.

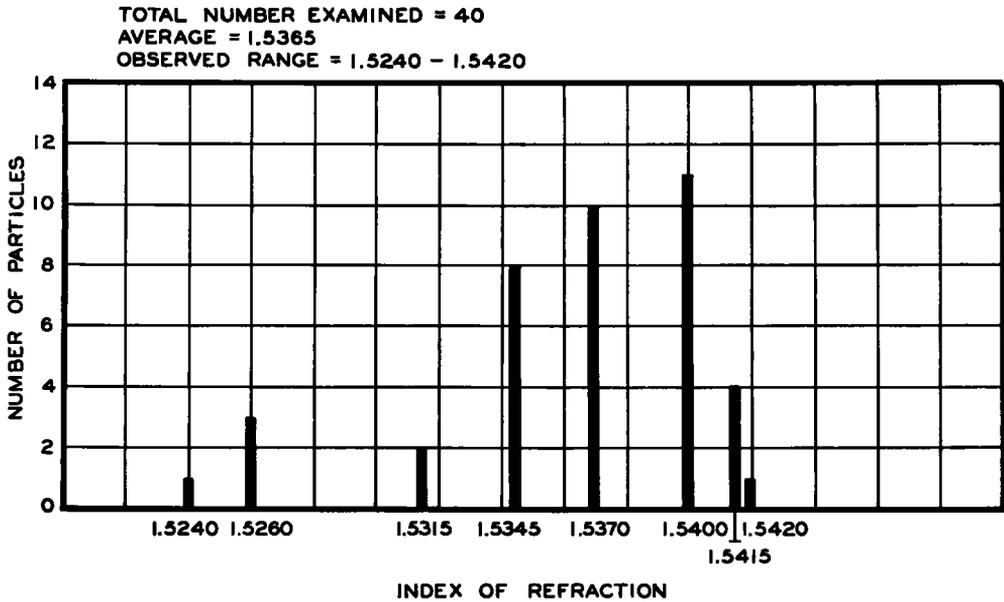
Figure 7. Distribution of chalcedonic chert coarse-aggregate particles selected from concrete from Tuscaloosa Lock, with respect to index of refraction.

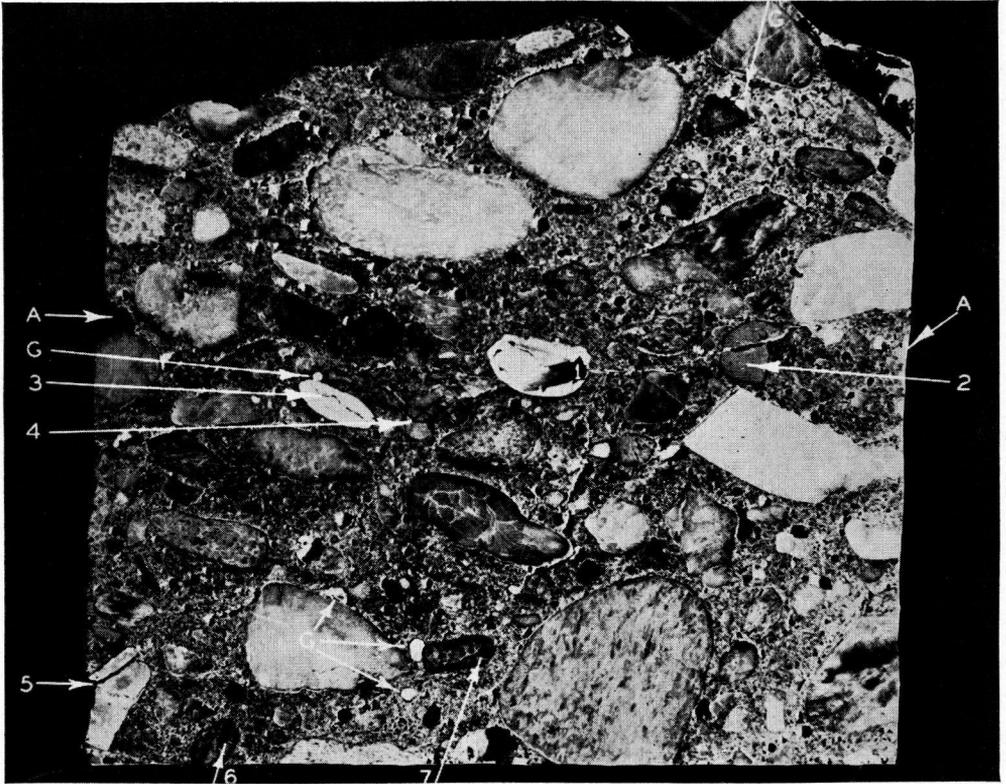
Figure 8. Sawed surface of core cut longitudinally. The direction of placement is toward the top of the photograph. A-A indicates the ends of a crack system which can be traced across the core, passing through two chert pebbles (1 and 2). The white chert pebble (1) has an outer zone very firmly bonded to the matrix and the center of the pebble separated by cracks from the outer zone. The chert pebbles indicated by arrows (2 through 7) show the wide cracks common in chert particles in this concrete. In pebble (2) the gel filling of parts of the crack system can be seen at the left and right. G indicates gel pockets.

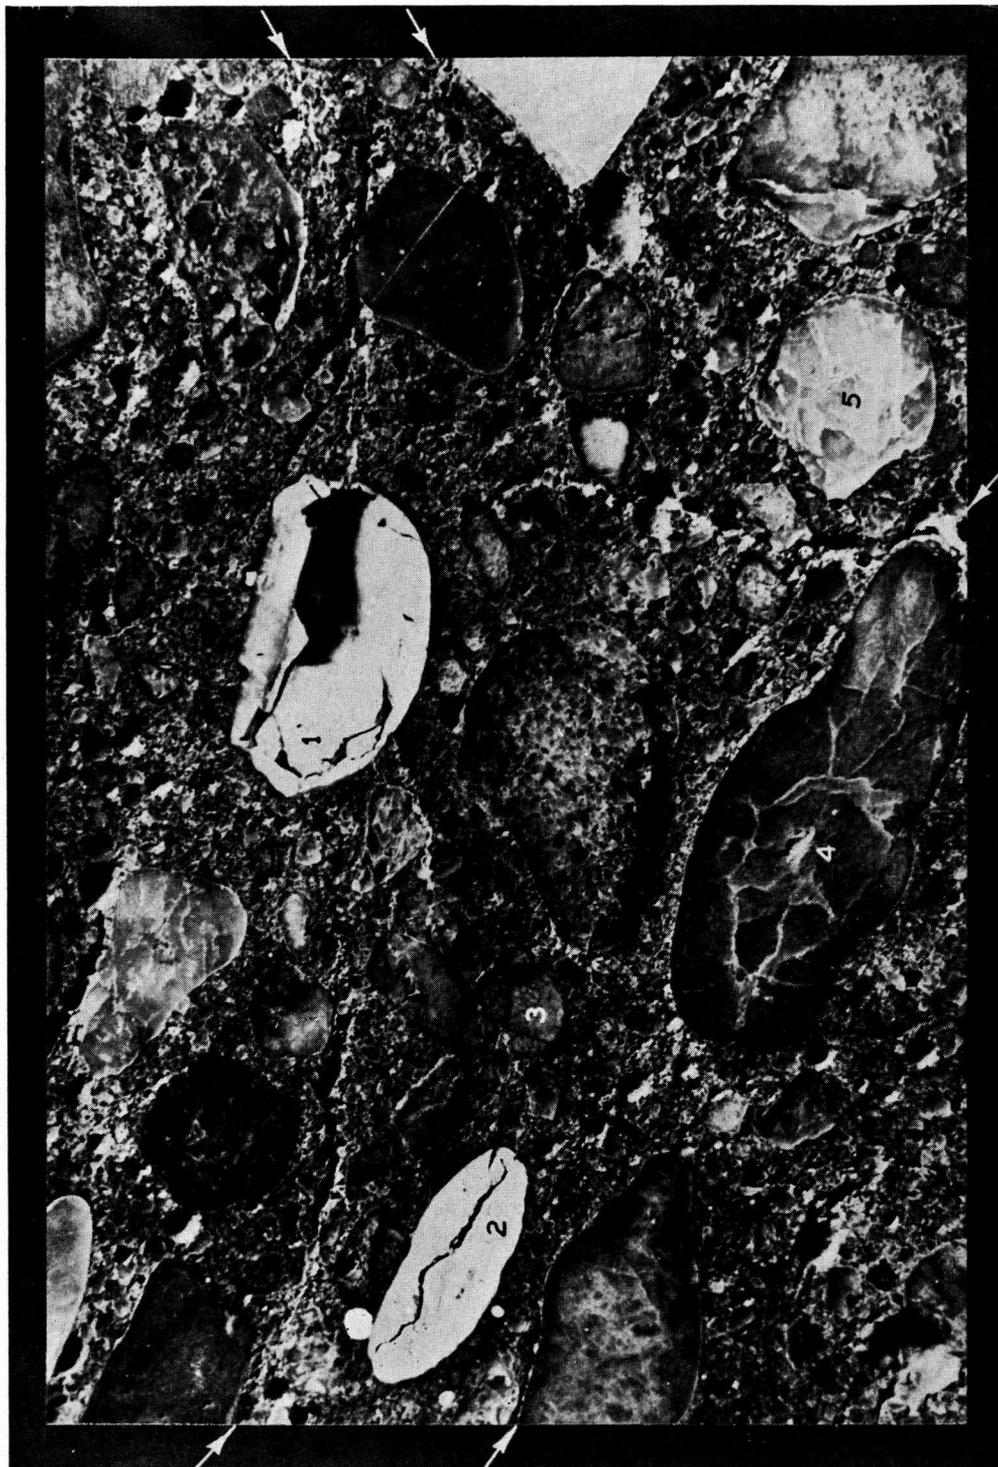
Figure 9. Part of area shown in Figure 8 magnified about 3 times. Arrows at margin mark ends of crack. 1, 2, 3 are chert pebbles with well-developed wide cracks; those in 3 are locally gel-filled. 4, 5, are cracked pebbles; the cracks are narrower than those in 1, 2, 3
