Combination Waterbound-Macadam and Dense-Graded Aggregate Base for Flexible Pavements

W. B. DRAKE, *Research Engineer*
Kentucky Department of Highways

THIS paper is concerned with a flexible base designed primarily to improve the riding qualities of high-type bituminous pavements. Difficulties in control of grades and sections with modern methods of macadam base construction have emphasized needs for effective finishing procedures.

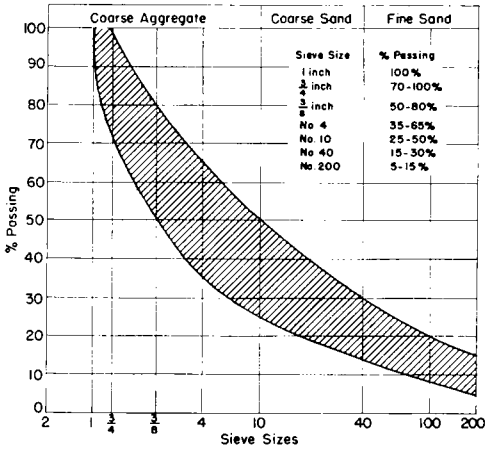
Figure 2. Aggregate gradation range for dense-graded base courses.

The gradation range of the dense-graded aggregate specification is shown in Figure 2. One-hundred percent passes the 1-in. screen with 5 to 15 percent passing the No. 200. In many instances this material can be produced crusher-run, particularly where the plant includes a hammer mill. However, for this project, as will be seen later, two separate aggregates were combined to provide this gradation. It was recognized that a high moisture content was necessary for shaping and compaction of the dense aggregate base.

The dense-graded courses were constructed of limestone for which there were special gradation requirements, as outlined in Figure 2. Because the limestone was very dense and hard, it was necessary to add fines to crusher-run stone to secure this gradation. The mixture

The results listed in Table 2 pertain to samples taken after the full amount of aggregate and the calcium chloride had been applied and the mixture worked into the windrow, or to samples cut from the completed base at the time density tests were made. None of these samples was taken for control purposes but rather to provide representative values of the gradation finally achieved. It will be noted that in several places the gradation did not strictly conform with specification requirements outlined in Figure 2; however, the per-

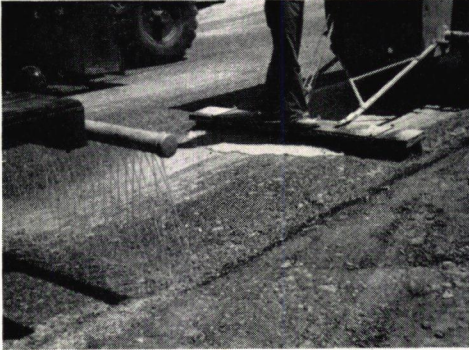
Figure 4. Watering, brooming, and rolling on the waterbound construction. Note slurry in front of the broom.

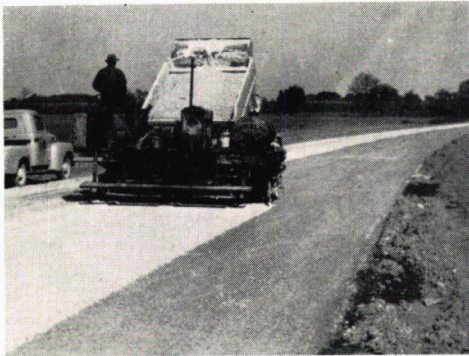
Figure 5. Spreading the coarser of two aggregates used for the dense-graded base course construction. This stone was crusher run through a 1-in. screen with approximately 3 percent passing the No. 200 screen.

consisted of 75 percent crusher-run material passed through the 1-in. screen and 25 percent fine agricultural limestone. Figures 5 and 6 illustrate the way in which the two materials were placed on the road separately.

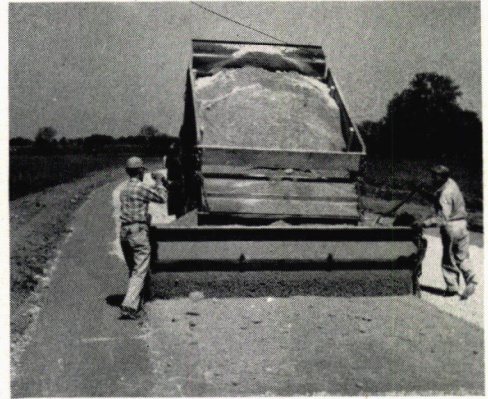
Figure 6. Placing finer aggregate for the dense-graded course over the crusher run material shown in Figure 5. Because of the insufficient quantity of material finer than the No. 200 mesh in the first stone placed, it was necessary to add fines which are normally sold for agricultural lime from this quarry. This fine fraction represented 25 percent of the total aggregate.

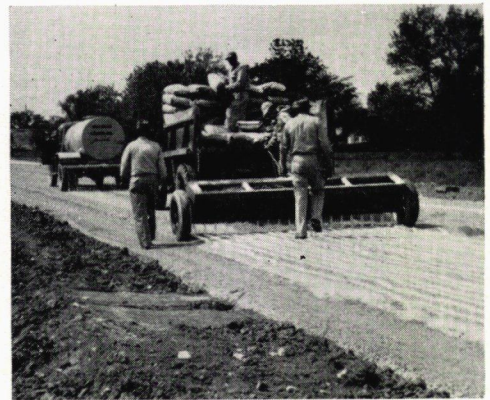
Figure 7. Water was applied to thoroughly wet the stone prior to application of calcium chloride. This was done to assure an adequate moisture content and prevent segregation as well as facilitate manipulation during the mixing process that followed.

calcium chloride was applied with a fertilizer spreader at the rate of 1 lb. per sq. yd. This operation is illustrated in Figure 7. Two passes of the spreader were made for each application, and an obviously uniform distribution was obtained by this method.

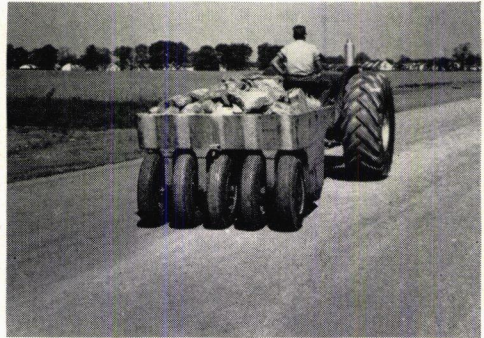
Figure 10. Pneumatic Rolling. This operation was begun during the final shaping of the blade-spread base.

10), was operated continually not only for compaction but also to emphasize irregularities that carried through from the waterbound course or developed in the placement of the blade-spread courses. Pronounced irregularities could be taken out readily by turning the blade square with the road and square blading for a short distance. Material removed from

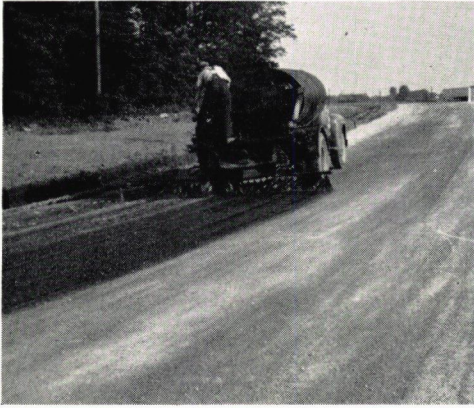
Figure 11. Appearance of the finished dense-graded base at the time priming for the bituminous pavement was started.

There was no brooming of the base prior to priming, even though there was some floater material created by the reshaping operations in a few places and by passing traffic which used the road during the waiting period. One section, about 1,500 ft. in length, had an unusual amount of floater, and in order to tack down that material satisfactorily, there was an overrun of 2,240 gal. in the prime. Application of the prime is illustrated in Figure 11.
