# DEPARTMENT OF MAINTENANCE

## Causes and Costs of Highway-Sign Replacement

ARTHUR L. STRAUB, *Highway Research Engineer,*  
*Virginia Council of Highway Investigation and Research*

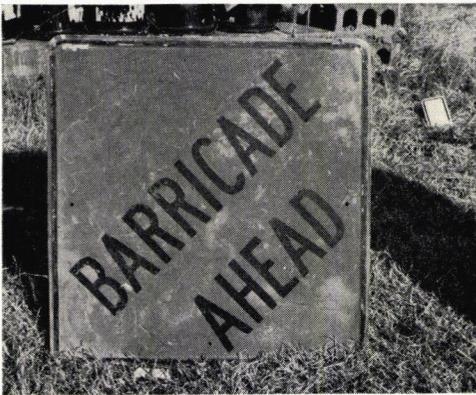
Figure 1. Example of natural failure—discolored and dull.

The four main reasons for cause of replacement are natural failure, vandalism, change in policy or law, and accidental vehicle damage. The photographs in Figures 1 through 6 show examples of signs which were replaced for various reasons indicated in the captions. Natural failure is defined as deterioration of the sign surface caused by weathering, including discolored appearance and dullness,

peeling of paint, peeling of sheeting, spalling of beads, failure of the black paint of the message, etc. Vandalism occurs when wanton damage is inflicted on signs. Examples are gunshot, scratched with hard object, bent by hand, and marked-up. A change in policy or law may cause a sign to be replaced because its message becomes obsolete, although its condition may be satisfactory in other respects. A change in policy regarding speed zoning or

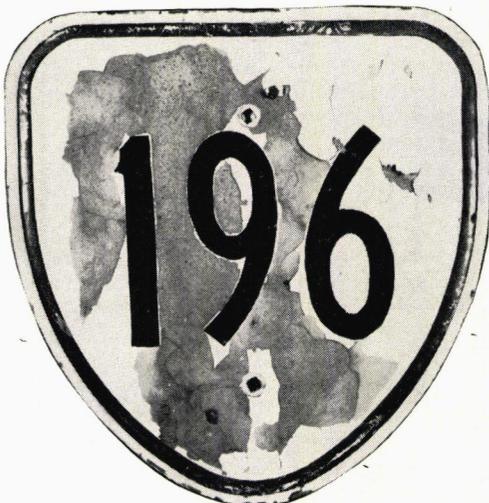
Figure 2. Example of natural failure—peeling of paint.

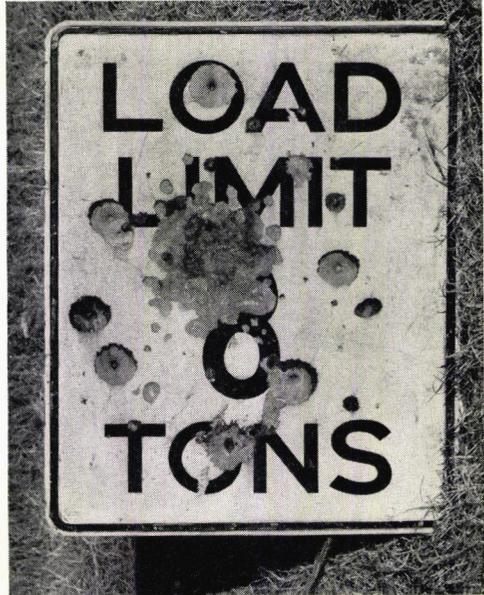
Figure 3. Example of vandalism—gunshot.

*Gunshot.* The most serious loss due to vandalism is damage from gunshot which ac-

counted for 18.9 percent of total replacements. Of signs which were gunshot, 93 percent were in open country and 7 percent were in built up areas. Since 66 percent of existing signs were in open country and 34 percent were in built up areas (refer to Table A in the Appendix), the probability of a sign being shot was 6.84 times as great if it were located in open country. A sign was 3.3 times more likely to be shot if it were away from an intersection than if it were near one. Because of their prevalence in rural areas away from intersections, warning signs (curve symbols, maximum safe speed, etc.) were three times as likely to be shot as guide signs (route markers, destination signs) and regulatory signs (speed limit, reduce speed, stop, etc.).

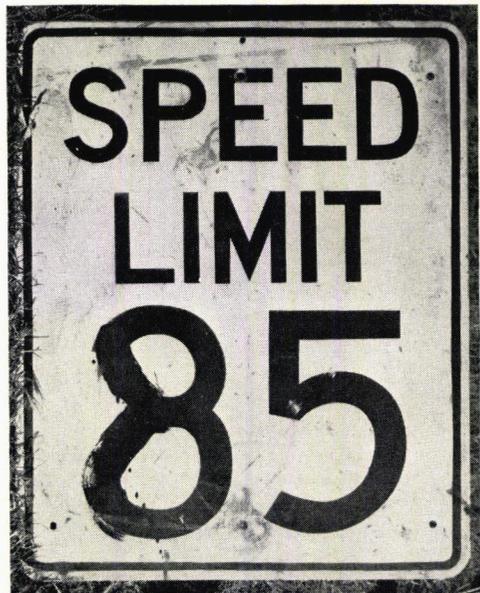
Figure 4. Example of vandalism—marked-up.

*Scratched, marked-up.* Obviously, if a sign is to be scratched or marked-up it must be within reach. The analysis showed that the probability of a sign being scratched was more

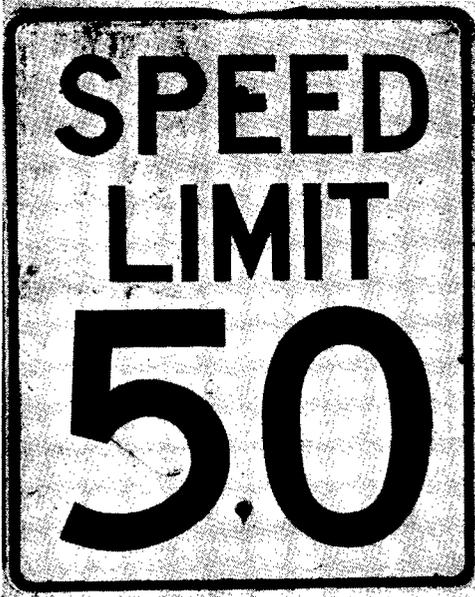
Figure 5. Example of change in policy or law—speed limit change.

law affecting weight limits are examples. Vehicle damage includes cases where a sign is struck by a moving vehicle. This is different from vandalism because the occurrence is accidental in nature.

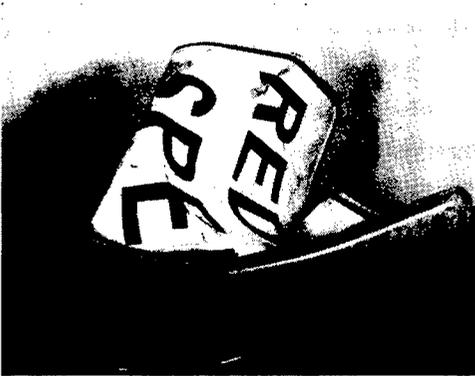
Figure 6. Example of vehicle damage.
