# Field Tests on a Prestressed Concrete Multi-Beam Bridge<sup>1</sup>

*Fritz Engineering Laboratory, Department of Civil Engineering, Lehigh University, Bethlehem, Pennsylvania*

This report describes a bridge test carried out by the concrete research group of Fritz Engineering Laboratory, Department of Civil Engineering at Lehigh University. It is part of a sponsored research program on prestressed concrete which has been carried on at the University since 1951.

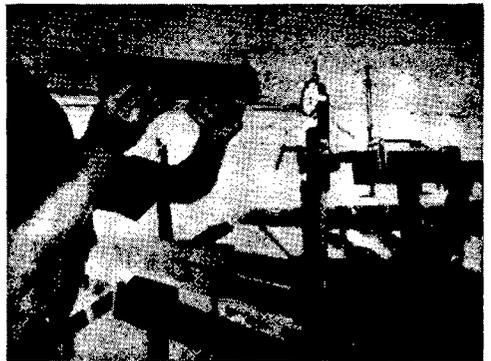
Figure 7. Detail of the installation. (From left to right: Whittemore gage for strain measurements; Ames gage for the deflection; dynamic gage.)

**Dynamic deflection gages:** One of the three dynamic deflection gages used in these field tests is shown in Figure 7. It consists of a small cantilever beam fixed to a base plate which was mounted on the timber scaffolding. A short vertical rod was connected to the free end of the cantilever and made contact with the concrete beam in such a way that the cantilever deflected with the beam. Two SR-4 strain gages mounted on the top and the bottom of the cantilever provided the means of measuring its deformation which was in proportion to the deflection of the beam determined by laboratory calibration. Figure 8
