Resurfacing and Patching Concrete Pavements with Bonded Concrete

EARL J. FELT, *Manager,*
Transportation Development Section,
Portland Cement Association, Chicago, Illinois

Resurfacing or patching of old concrete pavements with bonded concrete has been extensively studied and found to be feasible. Many factors are involved in developing the good bond between old and new concrete so essential for thin resurfacing and patching.

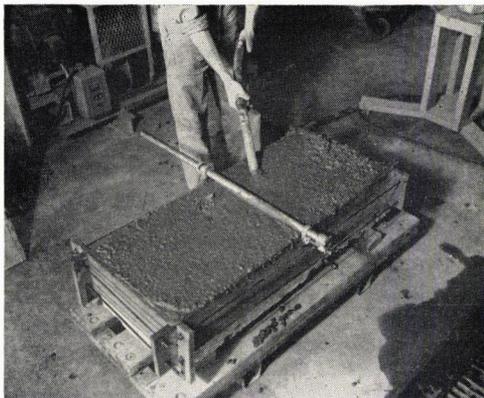
Figure 4. One 16- by 40-inch base slab being resurfaced with concrete placed by internal vibration.

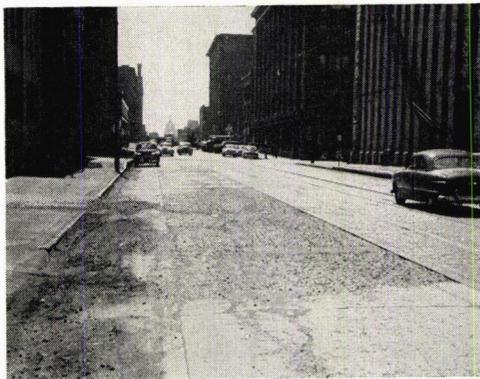
Figure 7. Minneapolis street before resurfacing.

An experimental concrete resurface from ½ to 2 inches thick was placed in June 1952 on a heavily traveled street in Minneapolis, Minnesota. The 13-year-old non-air-entrained concrete pavement on Second Avenue North, between Third Street and Washington Avenue, had severely scaled, as can be seen in Figure 7.

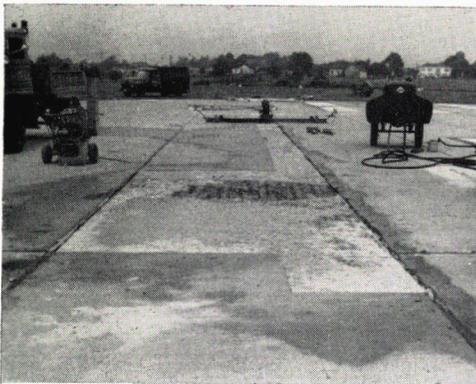
Figure 9. Area prepared for thin patching at Rhode Island State Airport (Theodore Francis Green Airport, Hillsgrove, Rhode Island).

The surface of the old concrete was prepared with an air hammer and a Tennant machine, since mechanical cleaning was required to remove incipient scale that had formed but had not completely loosened from the surface. Final cleaning was with compressed air followed by water under pressure. One of the areas ready for patching is shown in Figure 9.

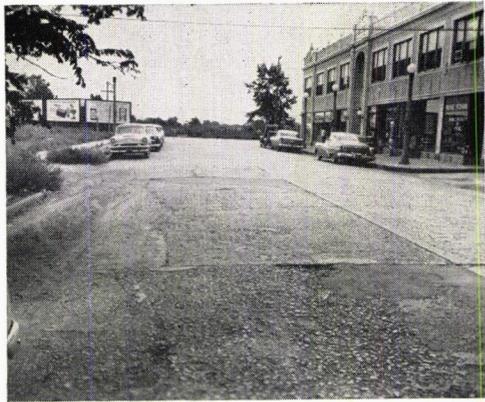
Figure 11. Scaled area of twenty-five year old Skokie street before resurfacing.

had several longitudinal and transverse cracks was severely scaled as seen in Figure 11. Commercial hydrochloric acid (27.9 percent) applied at the rate of about $\frac{1}{6}$ gal/sq yd was used to clean most of the old surface. The Tennant machine was used around the boundaries of the area. Final cleaning was with compressed air, and water under pressure.

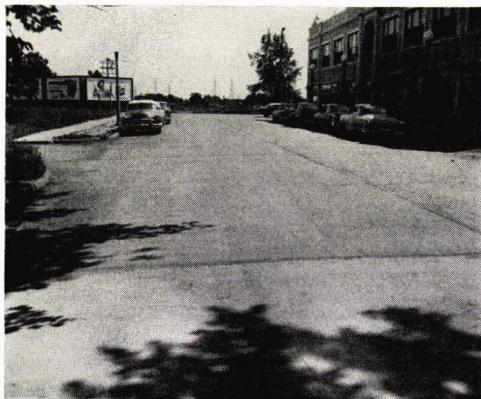
Figure 12. Skokie street after resurfacing with $\frac{1}{2}$ -inch concrete.

This resurface after going through two winters was in good condition (see Figure 12) although, as expected, a few fine cracks had developed directly over cracks in the old slab.

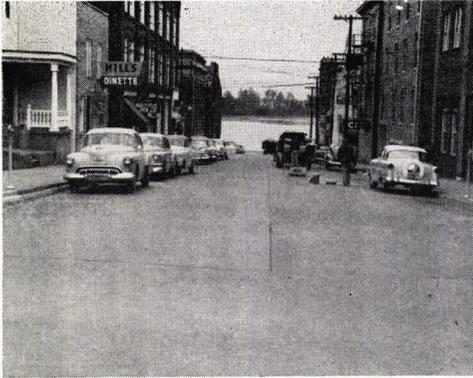
Figure 13. Cape Girardeau. Themis Street, resurfaced in 1924, looking east from Spanish Street.

Cape Girardeau. Portions of three streets, Spanish, Independence, and Themis, were resurfaced in the early 20's with 4-inch nominal thickness of mesh-reinforced concrete. Little

specific information is available on the construction. The old concrete base was built in about 1910, and a wood block surface was in place for 10 or 12 years before its removal when the concrete resurface was built. The resurfaced streets (Figure 13 shows Themis Street) have all given excellent service for the past 30 years. Three cores taken from Spanish Street showed no bond between the two layers of concrete, and two cores taken from Themis showed bond in only one. In this case the base, of rather poor-quality concrete, was 4 inches thick, and the resurface was $5\frac{1}{2}$ inches. The bond strength was 291 psi, which is rather high considering the quality of the base. Independence Street was not cored.

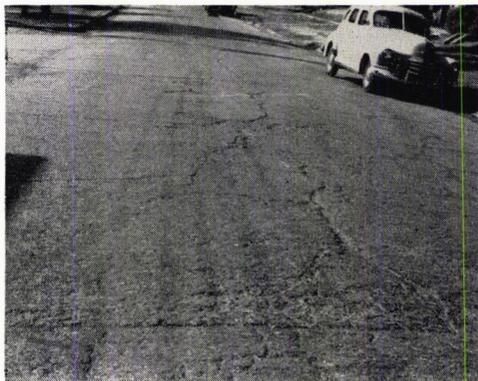
Figure 15. Savannah, Missouri. Market Street resurfacing placed in 1914. Bond still exists between the base and resurface concretes although the surface shows considerable cracking and erosion.

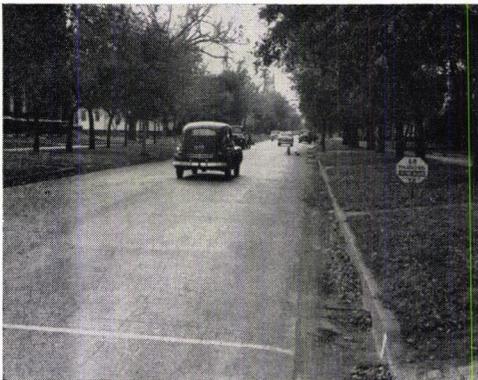
Figure 16. Hastings, Nebraska. West 7th Street resurfaced in 1948, looking from Colorado to Kansas Avenue.

The old concrete base on 7th Street, built in 1911, 4 inches thick and 26 feet wide, had a 3-inch black top which was removed in 1948 when a 4-inch plain concrete resurface was constructed. The surface of the old base was swept clean and coated with a cement slurry before resurfacing. Contraction joints were placed transversely at 10-foot intervals, and longitudinally at the center line. Two cores were taken from the job: one had a bond strength of 186 psi; the other was unbonded. In 1953, except for some longitudinal cracking, the street was in good condition, as can be seen in Figure 16.

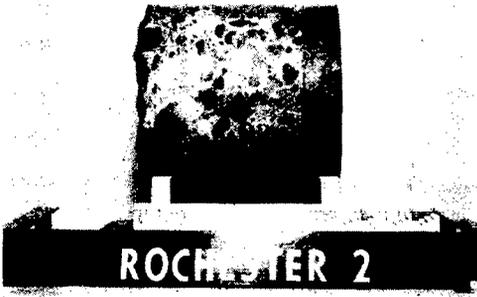
Figure 17. Core from Meadowbrook Road, Rochester, N. Y., when 11 years old.

along cracks and along boundaries of the resurface is common. Four cores were taken from the better areas; one had no bond and the other three had bond strengths of 520, 396, and 120 psi. One of the cores is shown in Figure 17.

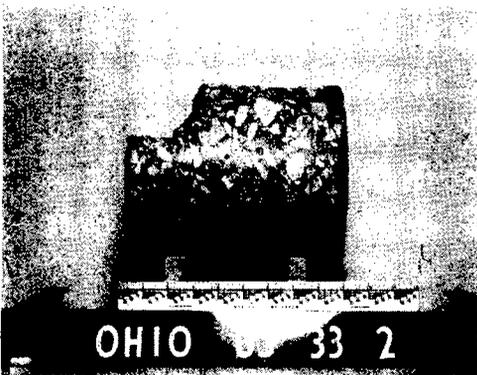
Figure 18. Core from Dublin Bridge sidewalk; $\frac{1}{2}$ -inch patch when eight years old.

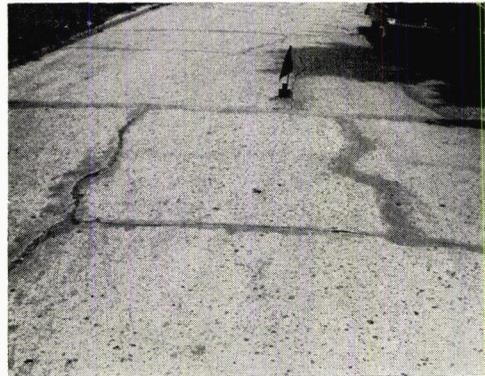
Figure 20. Warsaw Street in Toledo, Ohio. Thin resurface placed in 1913. Bond still exists between the base and resurface concretes although the surface exhibits considerable cracking.

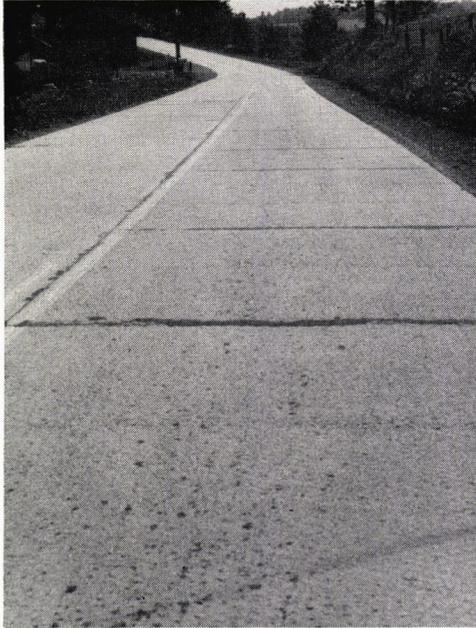
Figure 21. U. S. 322, Clearfield County, Pa. One of the best sections of vacuum processed concrete resurface placed in 1938.

showed poor durability. Numerous areas had been patched or were in need of patching. However, there were sections of the roadway, as seen in Figure 21, that were in good condition even though many transverse cracks had occurred. Most of them had developed where

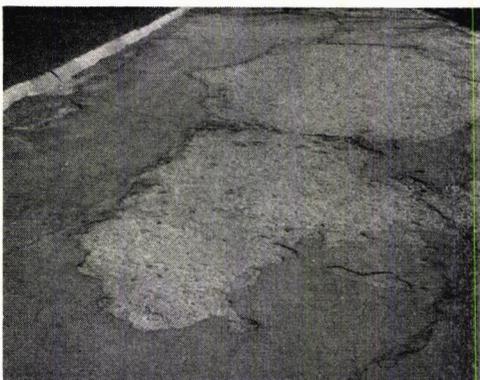
Figure 24. City street requiring resurfacing. Cracks in old pavement and questionable quality of the concrete indicate that steel mesh should be used in concrete resurface.

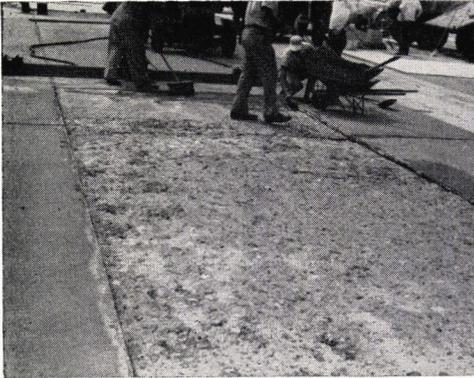
Figure 25. Grout being thoroughly broomed into surface-dry base concrete prior to placing thin concrete patch.

grout being brushed on an area just ahead of placing patching concrete. A hand brush is used to insure proper grout coverage around the boundaries of the patch. Placement of grout pneumatically (shotcrete or spray-crete process) has proved effective when sand rebound is properly controlled; in fact when steel mesh is used, pneumatic placement of grout may be advantageous.
