Soils Exploration and Design Considerations for the Greater New Orleans Expressway

II. Soil Design Considerations

JOHN R. BAYLISS, *Soils Engineer*
Palmer and Baker, Inc., Mobile, Alabama

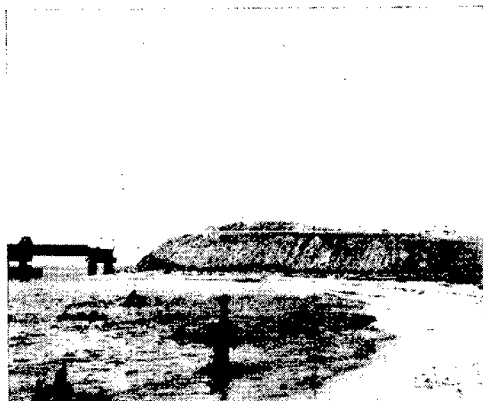
Figure 12. North plaza fill including 10-foot high surcharge and short length of 15-foot high surcharge.

North Plaza. The transition between the pile-supported bridge and the normal roadway takes place on a plaza fill area at each bridgehead. Steps were taken to develop as much of the expected fill settlement as possible during the construction period in order to minimize later roadway subsidence. At the north plaza area an additional 10 to 15 feet of surcharge fill, above finished grade, was provided. This surcharge remained in place for 90 days by which time a maximum of almost 1.5 feet settlement had occurred and further settlement had essentially ceased. Figure 11 shows a simplified diagram of the plaza area and the settlement plate records. The greater settlement on the east side resulted from a thicker layer of more recently deposited sediments filling an old dredged slip in that area. The computed ultimate settlement, based on the typical stratification as shown, which corresponds fairly well with the materials on the west side, was slightly more than 0.6 foot; a fair agreement with the observed value. Observed time of settlement was much more rapid than the computed time. This probably results from the pronounced horizontal stratification and the presence of thin sand and silt layers not disclosed by the boring. Figure 12 shows a side view of the fill, about 30 feet high at the "bump" and 25 feet elsewhere. The aerial view in Figure 13 was taken after the surcharge had been removed and the end bridge span placed.

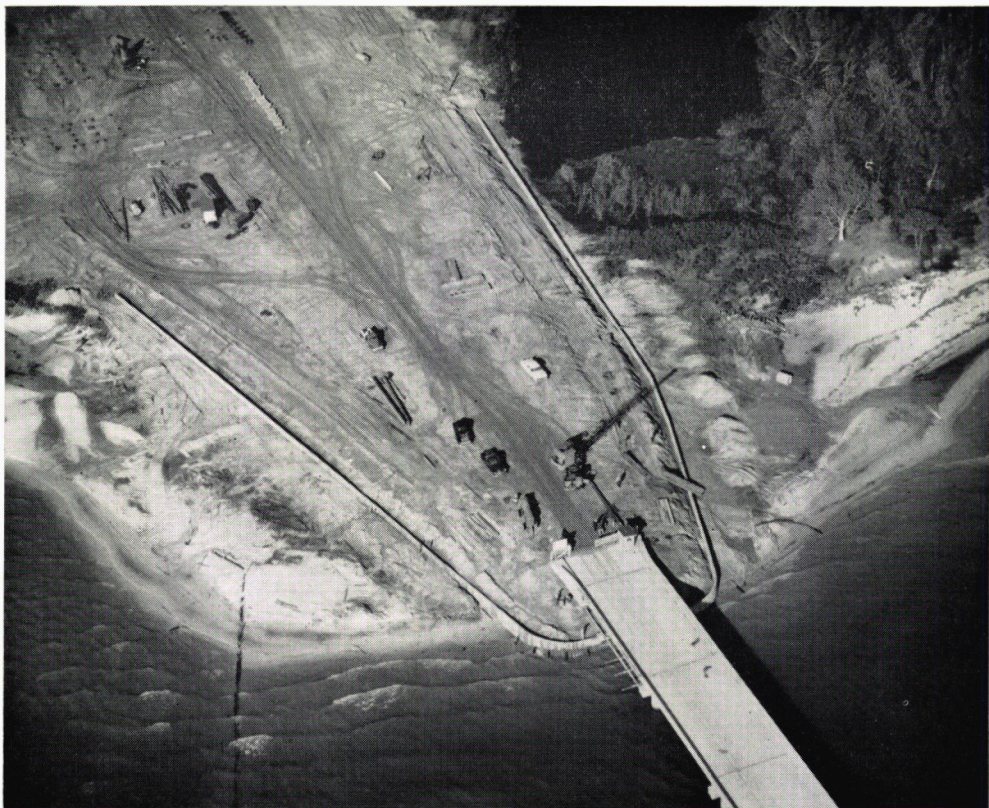
Figure 13. North plaza with surcharge removed and sea wall in place.

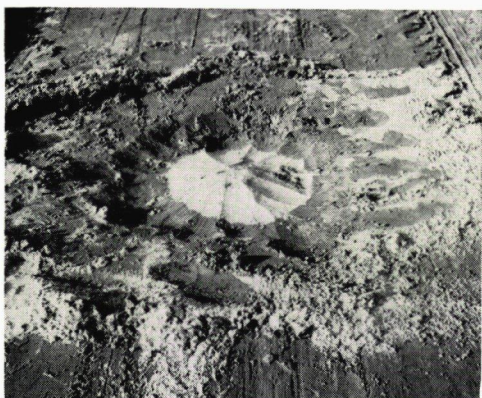
Figure 18. View of completed sand drain at fill surface.

mandrel almost dropped under its own weight through the soft clay strata—say a foot or two to the blow. Penetration resistance increased rapidly when the stiff clays near elevation -52 were reached. Driving was stopped at around 10 blows per foot to keep the mandrel from hanging up. Hardest driving, around 40 blows per foot, was encountered while driving through consolidated organic soils under the existing levee. The shell fill was penetrated at about 25 to 30 blows per foot. The sand column was held in place in the ground by 125 pounds per square inch steam pressure as the mandrel was withdrawn. Figures 17 and 18 show the final stages in driving the mandrel just before loading with sand from the tip-up hopper, and a view of a completed sand drain. The 2000 sand drains were placed at a cost of less than \$0.50 per foot.

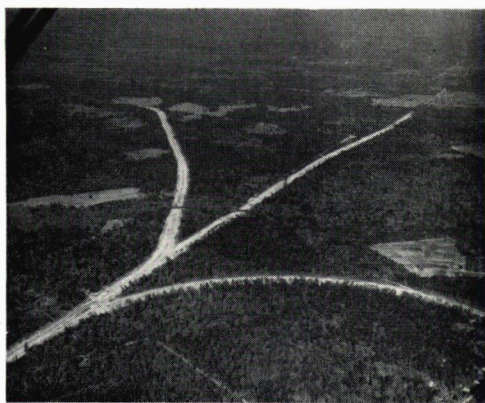
Figure 19. Aerial view of construction of "3-prong" access roads converging on north bridge approach.

On the north side of Lake Pontchartrain, in St. Tammany Parish, subsurface conditions are quite different and much better than on the south shore. The whole area lies on the exposed Prairie Terrace, the latest deposits of the Pleistocene Age, and stiff clays and sands are the soils most frequently encountered. Local materials along the right of way provided satisfactory sub-base and base course materials. A view of the general area showing early construction of the approach roads converging on the north bridgehead is shown in Figure 19.
