Final Report on Design Project, Michigan Test Road

E. A. FINNEY, *Director, and*
LEROY T. OEHLER, *Physical Research Engineer,*
Research Laboratory Division, Office of Testing and Research,
Michigan State Highway Department

This report completes the research phase of the design project on the Michigan Test Road, constructed in 1940 by the Michigan State Highway Department in cooperation with the Bureau of Public Roads for the purpose of establishing certain principles in concrete pavement design—in particular, those principles involved in joint spacing and construction methods.

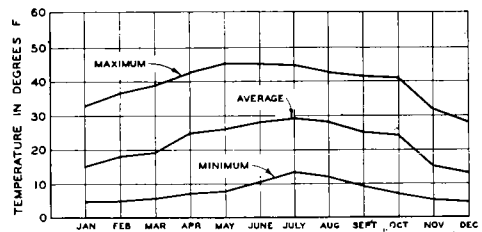
Figure 1. Average daily temperature variation, 1941-57.

Figure 1 shows average daily temperature variation from 1941 to 1957; Figure

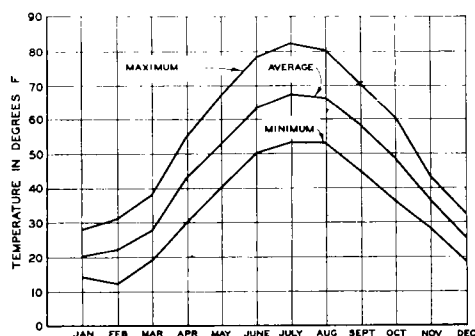
Figure 2. Average daily temperature, 1941-57.

2, the average daily temperature for the same period. Daily temperature fluctuations in the winter ranged from a minimum of 4 deg to a maximum of 39 deg, or an average of about 17 deg; during the summer, the range was from a low variation of 9 deg to a high of 45 deg, the average being about 27 deg. Average daily temperature (Fig. 2) varied from 20 F in winter to close to 67 F in summer, a total average annual change of 47 deg.

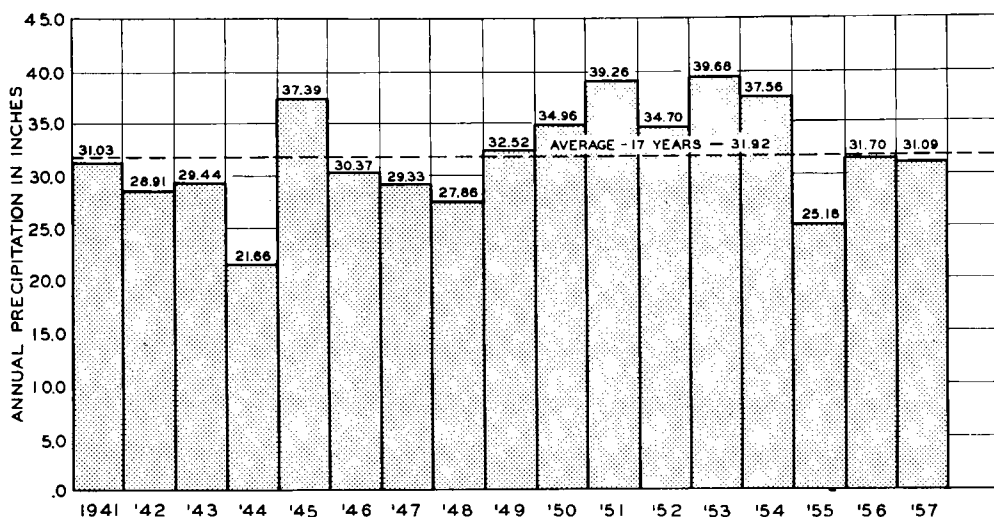
Figure 3. Annual precipitation.

inclusive, is given in Figure 3. The data indicate an average annual rainfall of 31.92 in. It may be noted that yearly variation from the 17-year average is slight, indicating fairly uniform moisture conditions through the life of the project.

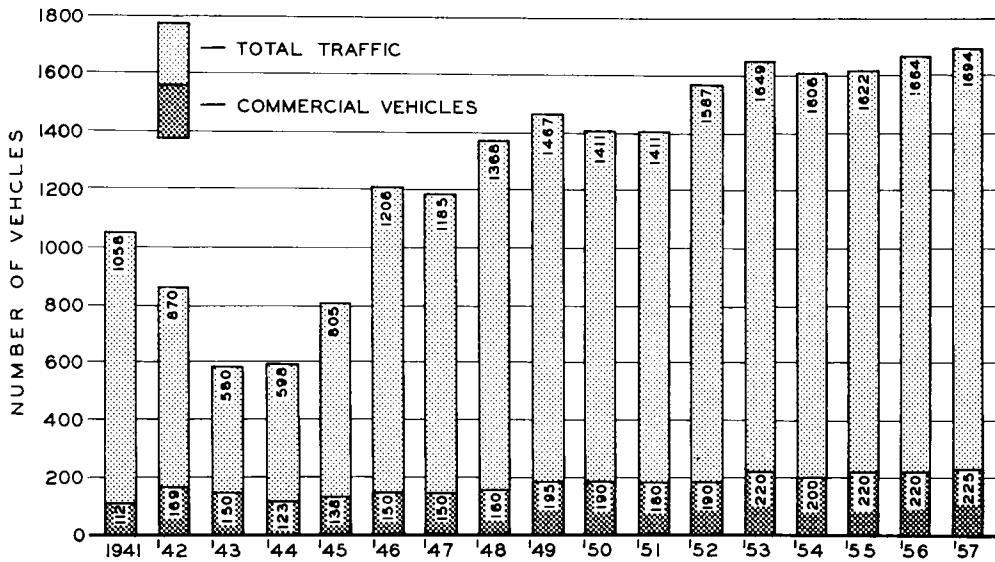
Figure 4. Average daily traffic.

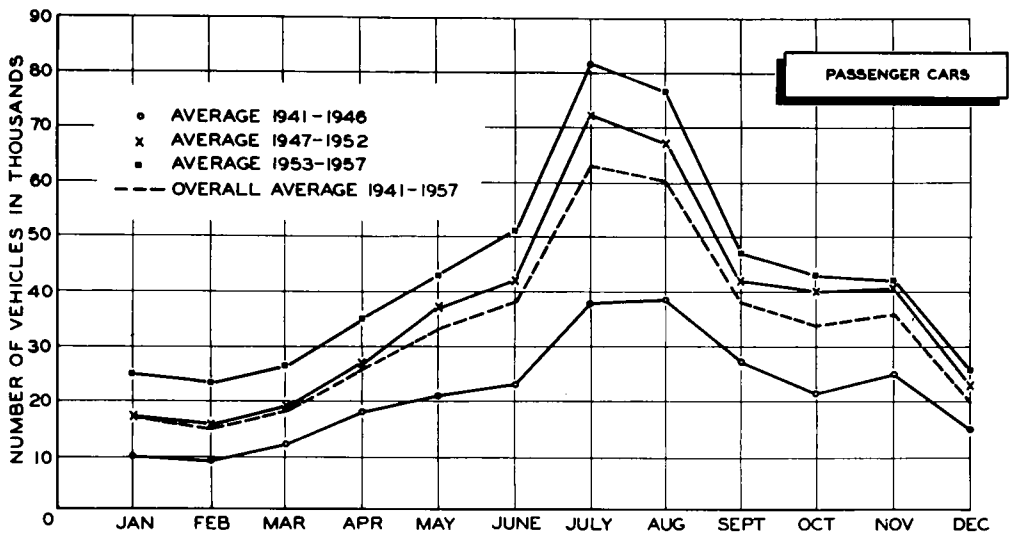
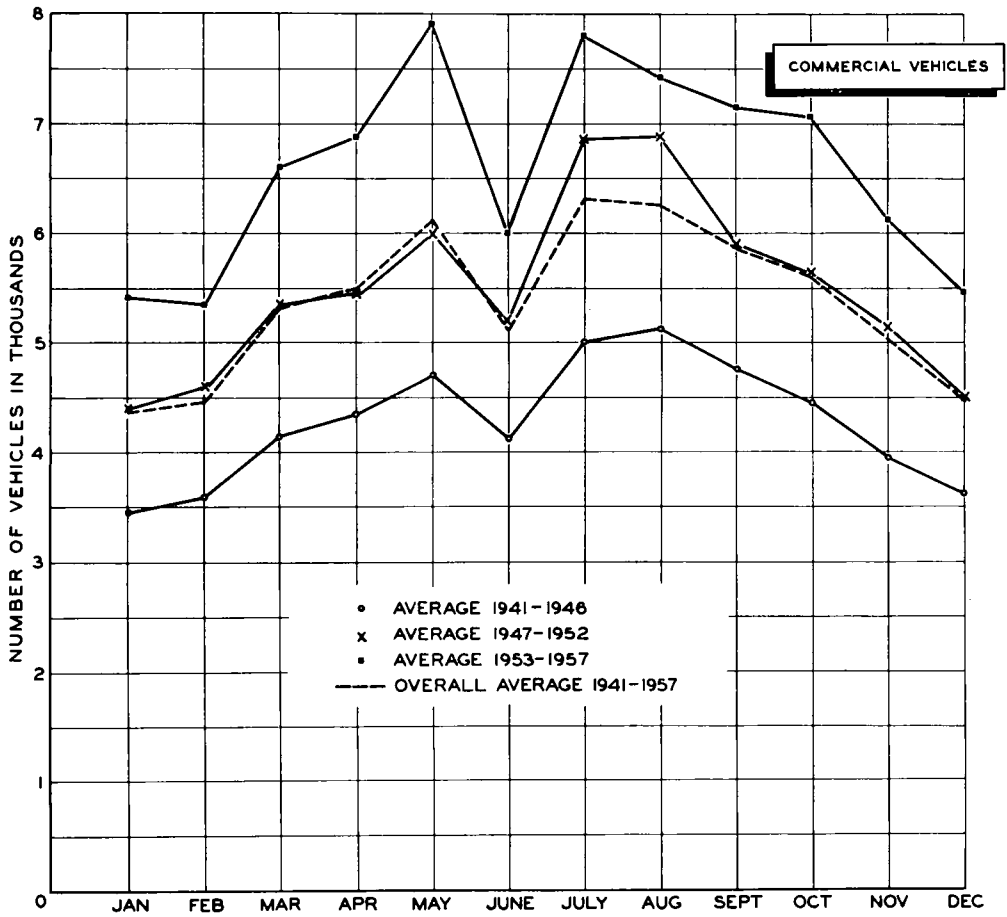
Figure 5. Average monthly traffic.

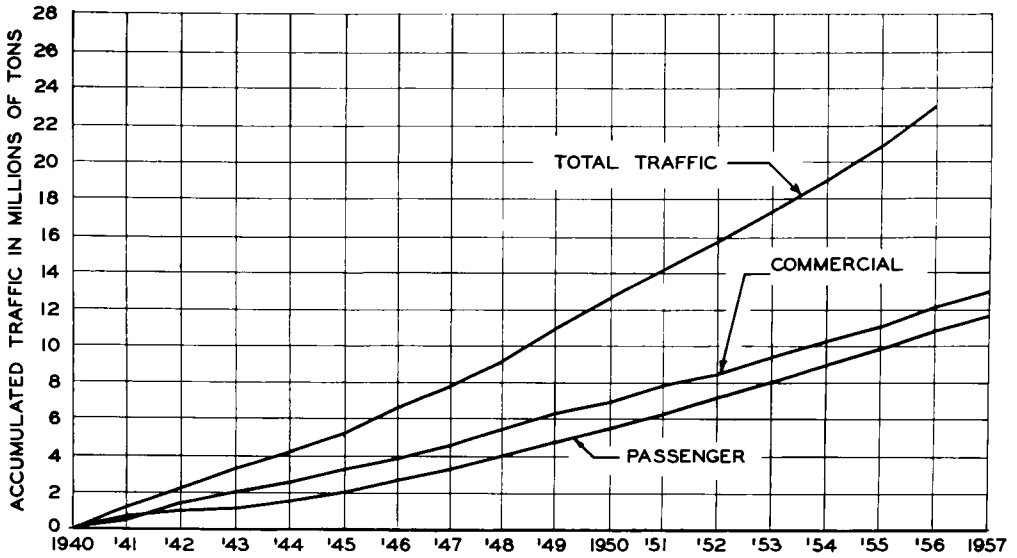
Figure 6. Accumulated tons of traffic.

The accumulated tonnage of traffic estimated to have passed over the road during 17 years of service is shown in Figure 6. If similar information were available from the other five state experimental projects, it might be useful in comparing relative traffic loads.

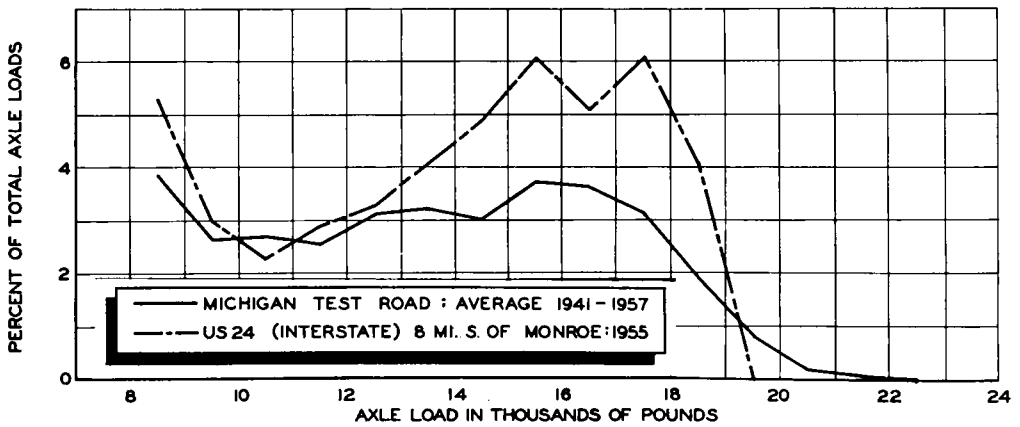
Figure 7. Axle load frequency.

The axle load frequency on the Michigan Test Road, averaged for the 17 years, is presented graphically in Fig-

ure 7. For comparison, a similar axle load frequency curve is shown for 1955 commercial traffic on heavily traveled interstate route US 24, 8 mi south of Monroe, Mich. A further comparison is made in Figure 8, showing the percentage of total commercial axle loads in excess of any given weight—one-quarter of the axle loads exceed 10,800 lb on the Michigan Test Road, whereas on US 24 one-quarter exceed 14,200 lb.

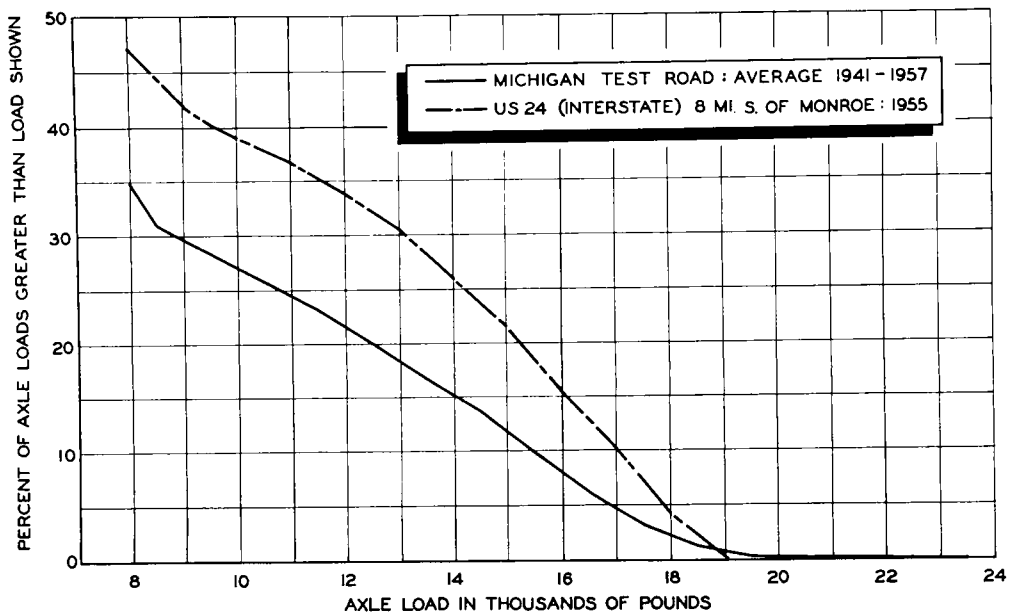
Figure 8. Percentage of axle loads exceeding weight shown.

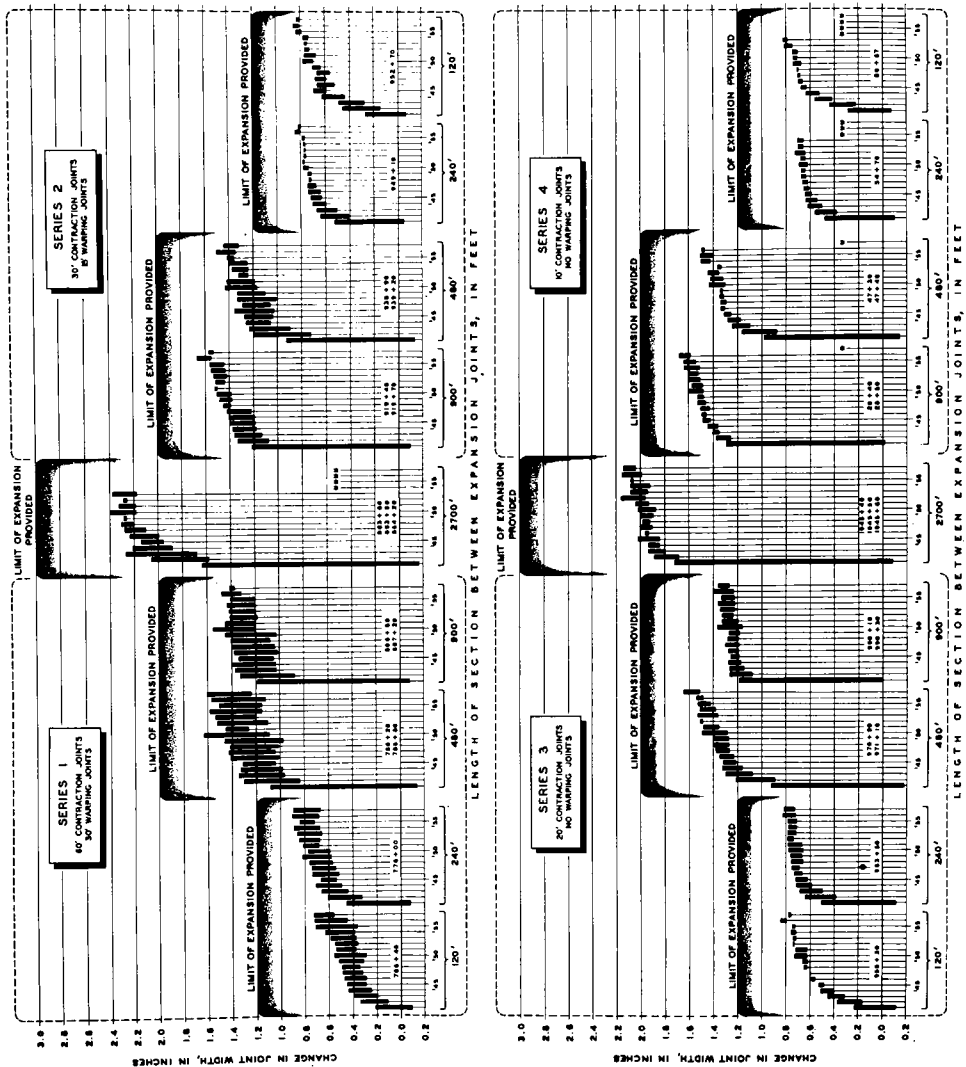
Figure 9. Annual and progressive changes in expansion joint widths.

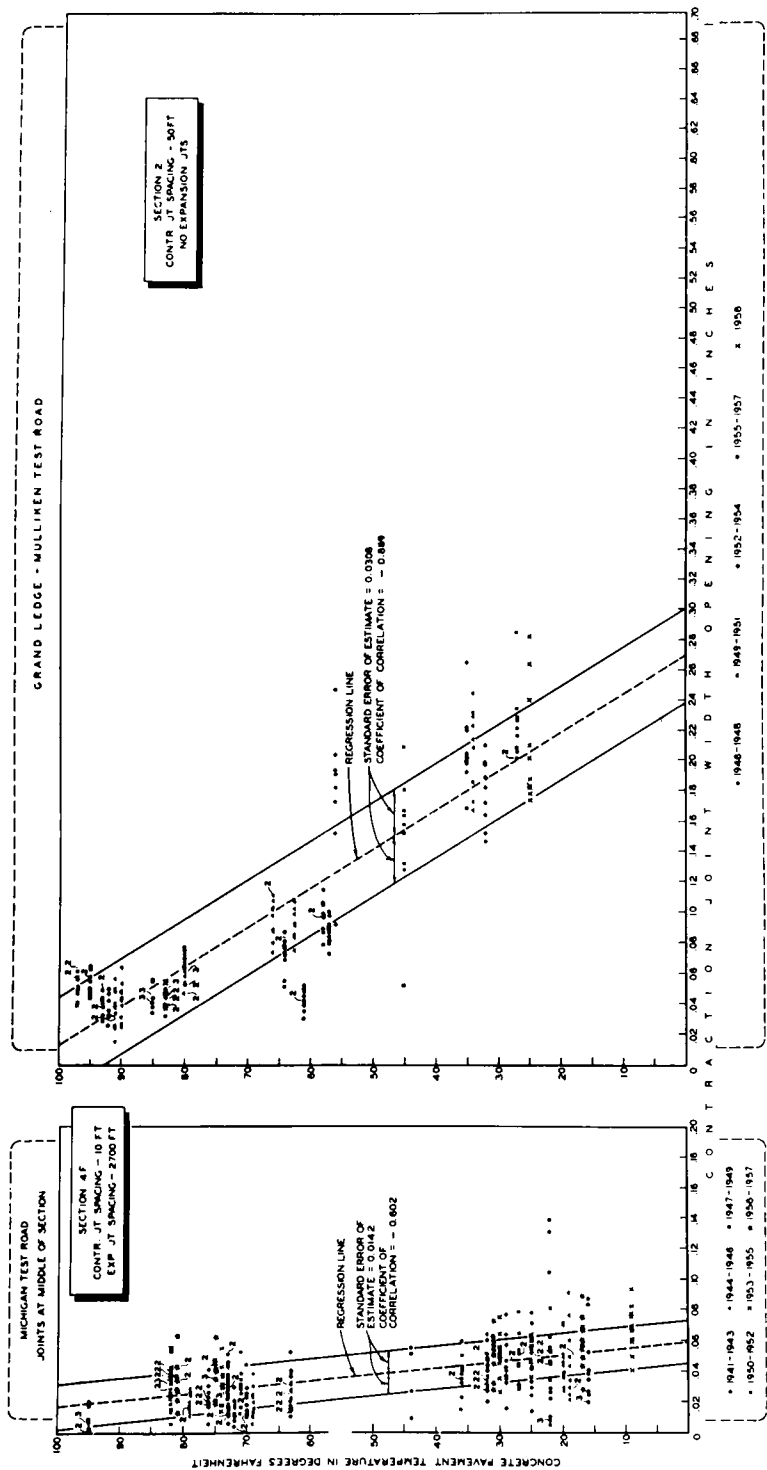
Figures 10 and 11. Joint opening vs temperature.

In Figures 10, 11, 12, and 13, the correlation coefficient for temperature and joint width opening ranges from -0.602 to -0.889 , where 0 signifies no correlation and -1 signifies perfect correlation between increasing joint width opening and decreasing temperature. It should be noted that winter (25° F) average joint openings were approximately 0.05, 0.08, 0.20, and 0.41 in. for contraction joint spacings of 10, 20, 50, and 100 ft, respectively. In general, joint opening appeared to increase slightly with age for each of the four slab lengths under discussion. This is illustrated by the fact that, generally, readings for the first few years are on the low side of the line of regression and for the last few years on the high side.

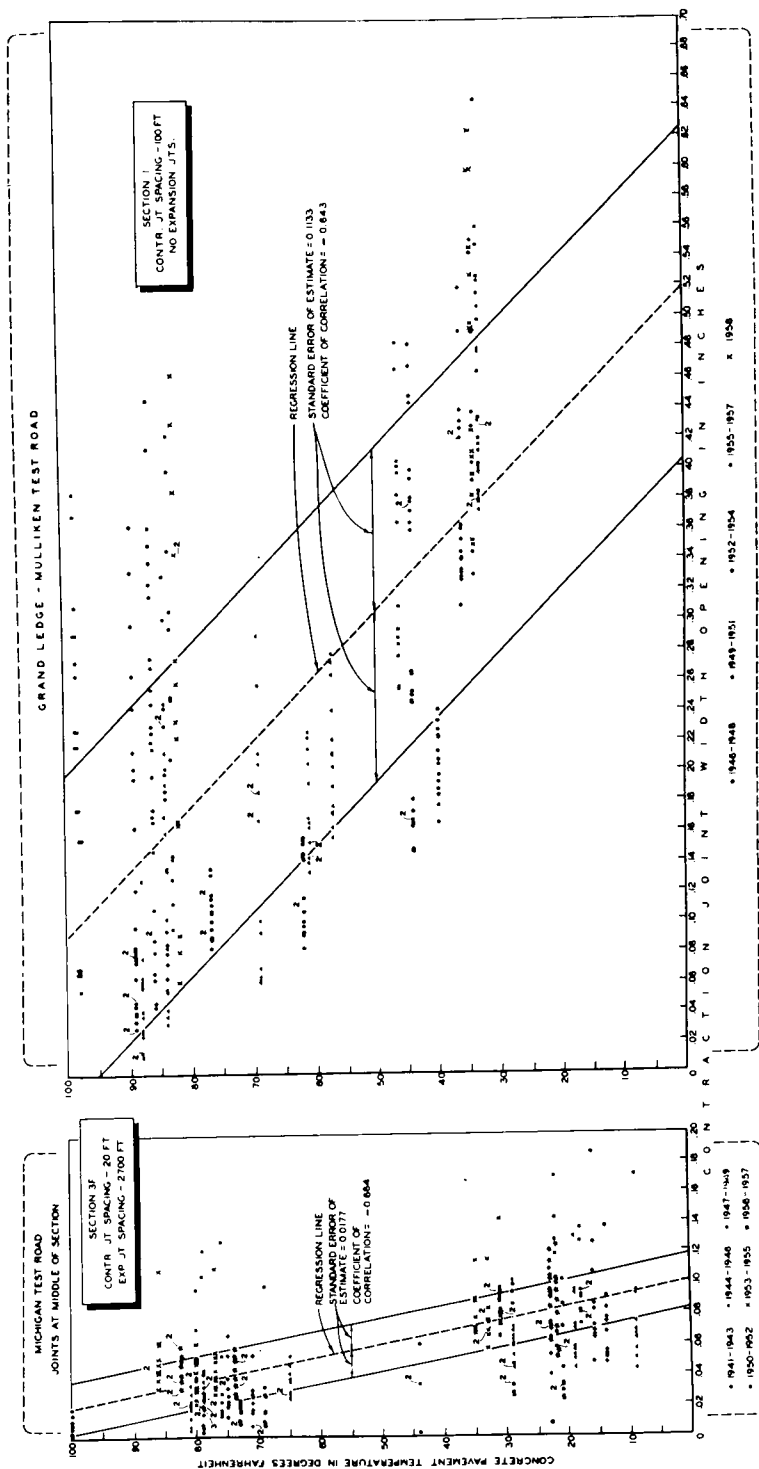
Figures 12 and 13. Joint opening vs temperature.

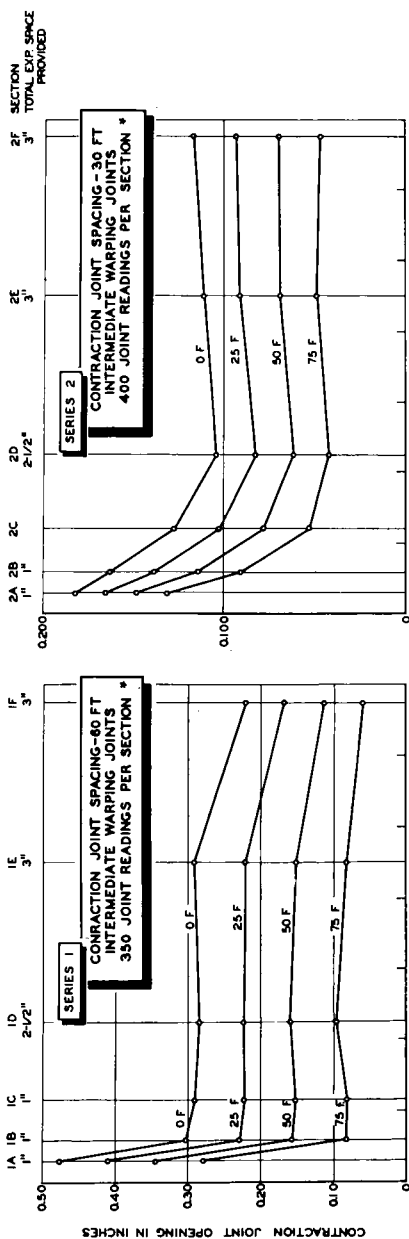
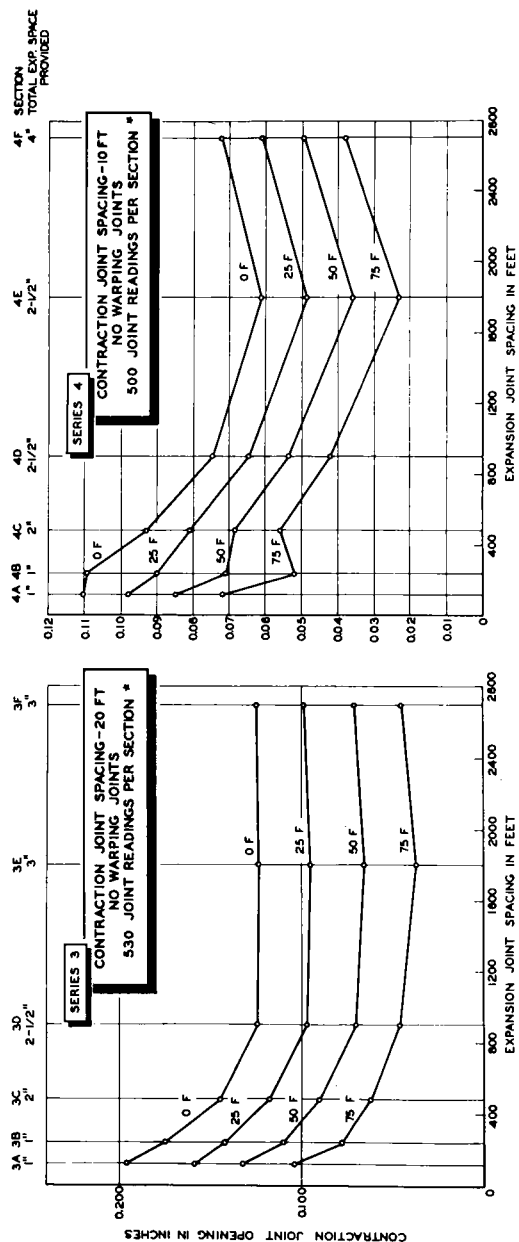
Figure 14. Effect of expansion joint spacing on contraction joint opening.

determine the effect of expansion joint spacing on contraction joint width openings for several slab lengths. In Figure 14, the data for various curves were obtained by averaging readings from all instrumented joints in each test section. There was some difference in the joint width movements near the end of a section (close to an expansion joint or relief section), and for the joints near the middle of a section. Joints near section ends had openings which averaged 2, 12, and 28 percent higher than joints in the middle of the section, for the 900-, 1,800-, and 2,700-ft expansion joint spacings, respectively. Points shown on these graphs for various temperatures were obtained from lines of regression based on statistical analysis of joint opening *versus* temperature. In every case, contraction joint opening decreased markedly as expansion joint spacing increased from 120 to 240 ft, and with 1 in. of total expansion space. Generally, the decrease in contraction joint opening continues to an expansion joint spacing of 900 ft (total expansion space of $2\frac{1}{2}$ in.), but then stays rather uniform for 900-, 1,800-, and 2,700-ft expansion joint spacings (total expansion space of $2\frac{1}{2}$, 3, and 3 in., respectively). An exception to this is Series 4, where the pattern is somewhat different, because total expansion space provided for 1,800- and 2,700-ft expansion joint spacings was $2\frac{1}{2}$ and 4 in., rather than 3 in. as in Series 1, 2, and 3.

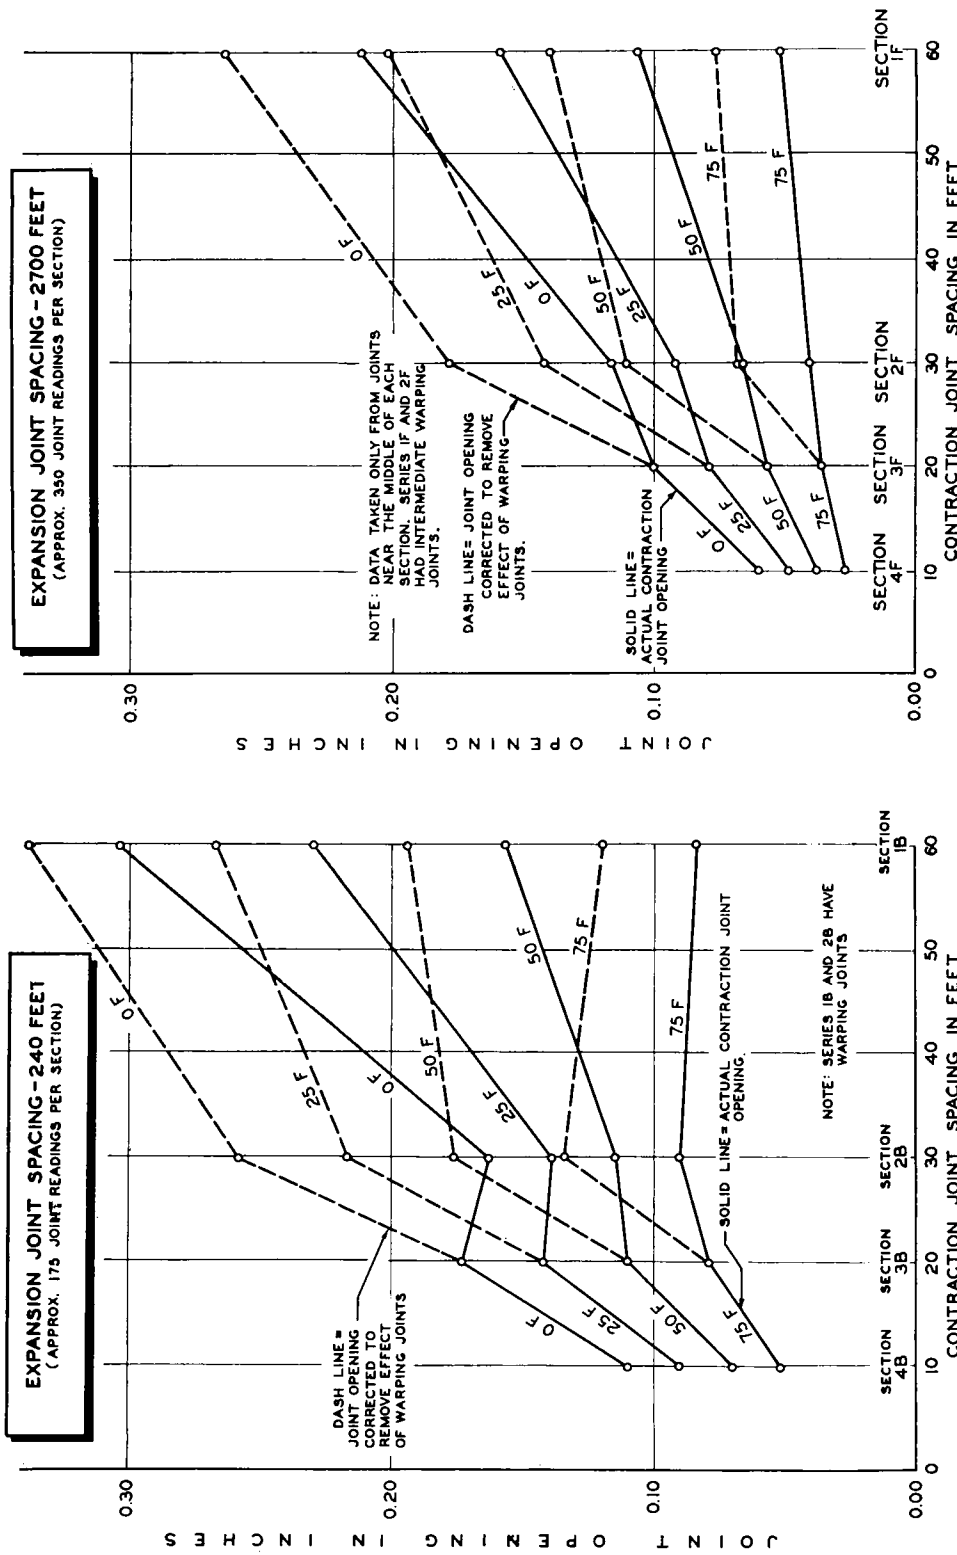
Figure 15. Effect of contraction joint spacing on contraction joint opening.

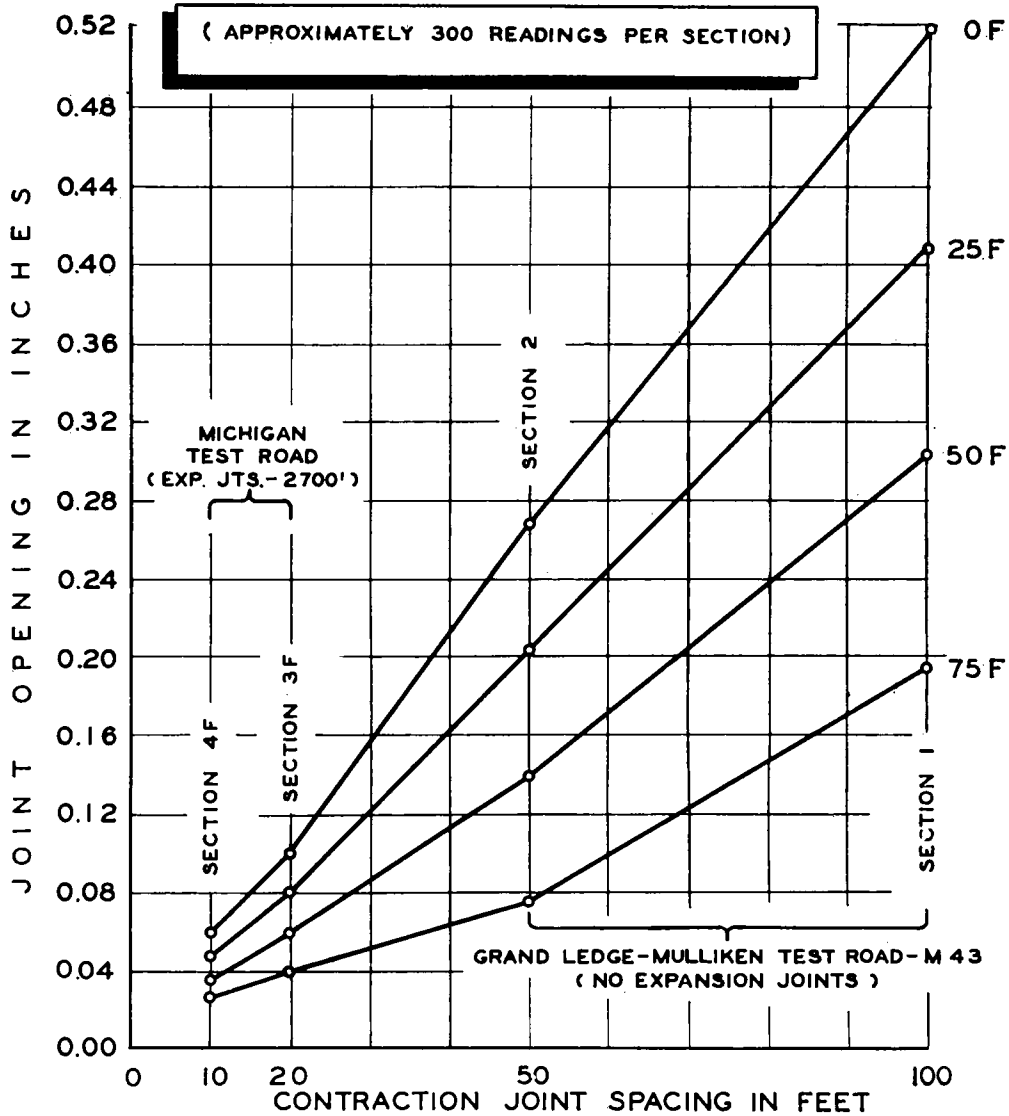
Figure 16. Effect of slab length on contraction joint opening.

Effect of Slab Length. To determine average contraction joint openings over a considerable range of contraction joint spacing, without the complicating effects of expansion or intermediate warping joints, the Michigan Test Road data from Sections 3F and 4F were again supplemented by data from 50- and 100-ft contraction joint spacings on the Grand Ledge-Mulliken Test Road. In Sections 3F and 4F (20- and 10-ft contraction joint spacing, respectively), only data on joint width opening from joints near the middles of these 2,700-ft sections were used, in order to minimize the effect of the expansion joints at the section ends. The points in Figure 16 were obtained for four temperatures from lines of regression for the various test sections. It should be noted that at 0 F joint width increased almost directly in proportion to increased slab length, but at higher temperatures the rate of joint width increase was not as rapid with increased slab length.

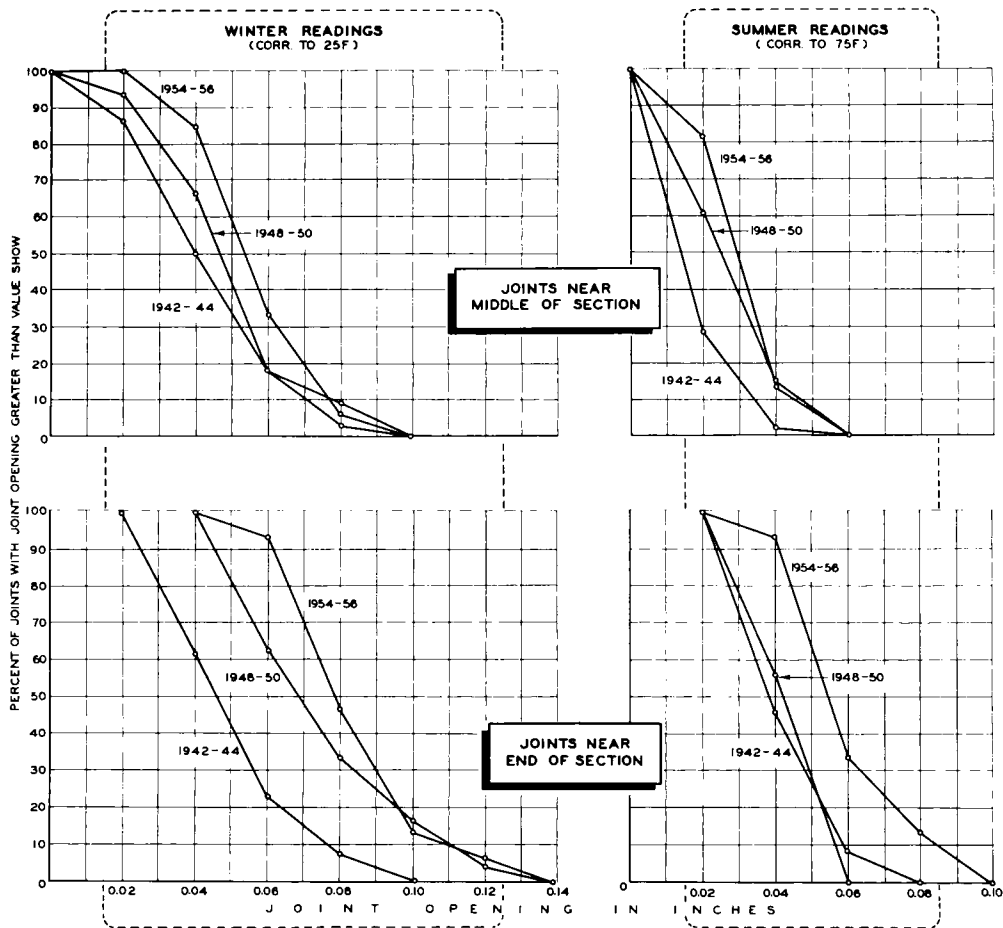
Figure 17. Frequency distribution of contraction joints with various openings, Section 4F.

Frequency Distribution of Joint Widths. Figures 17 and 18 show the frequency distribution of individual joint width measurements for Sections 4F (contraction joint spacing of 10 ft, expansion joint spacing of 2,700 ft) and 3F (20 and 2,700 ft), for joints near the ends and in the middles, under winter and summer temperature conditions. The joint width openings are adjusted to 25 F in winter and 75 F in summer, using daily joint width readings for these sections. The general progressive increase in joint width opening is also shown in these figures by plotting measurements for 1942-44, 1948-50, and 1954-56. The mean opening increased 0.018 and 0.044 between 1942-44 and 1954-56, for Sections 4F and 3F, respectively. After 15 years, a winter joint width value of approximately 0.08 in Section 4F and 0.12 in Section 3F was exceeded by 10 percent of the joints at the middles of the sec-

tions. Corresponding values for joints near section ends were 41 percent greater for Section 4F and 58 percent greater for Section 3F.

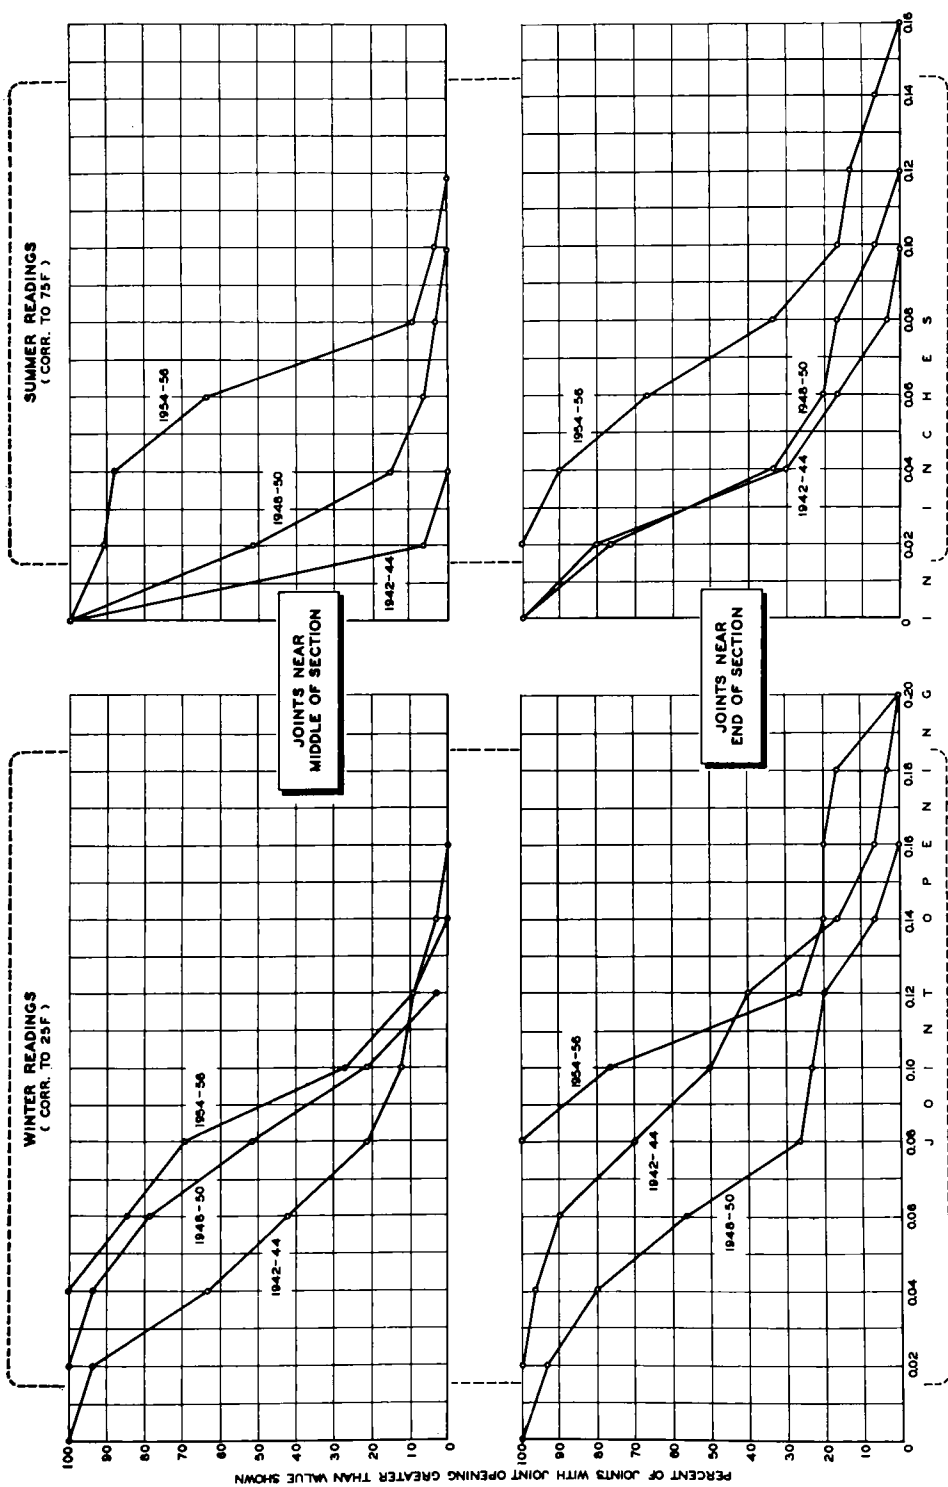
Figure 18. Frequency distribution of contraction joints with various openings, Section 3F.

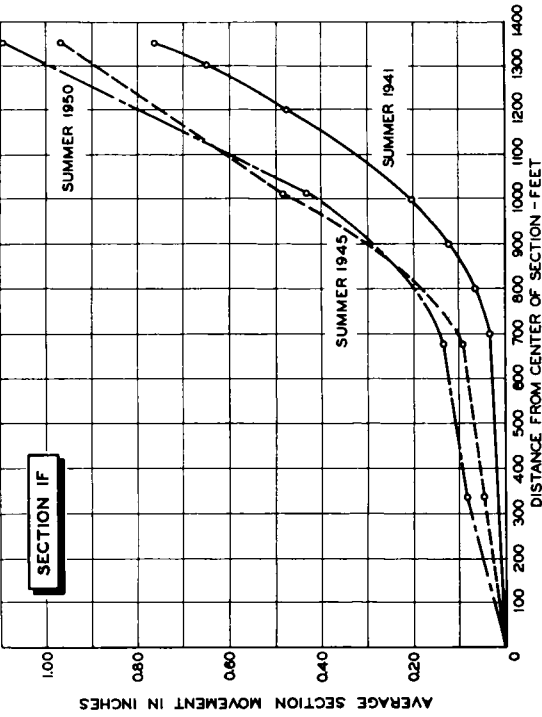
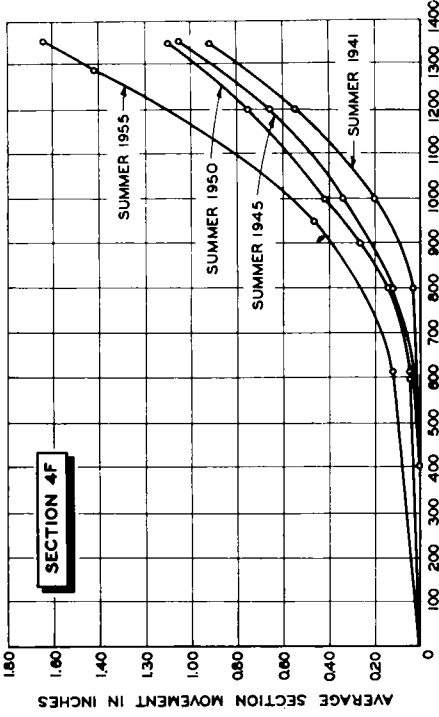
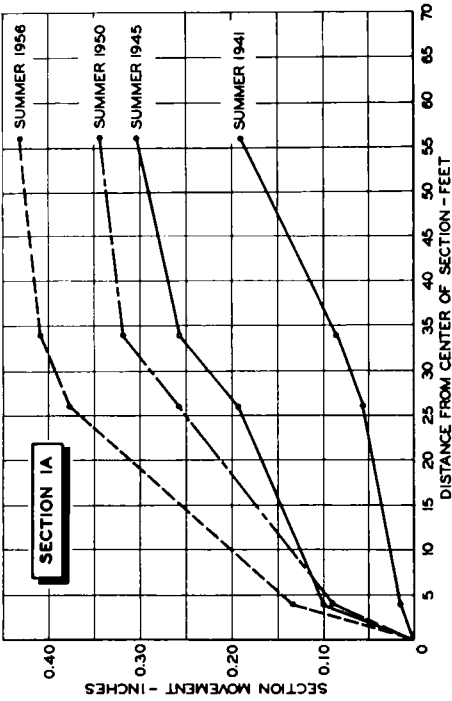
Figure 19. Relation between section movement and distance from center of section.

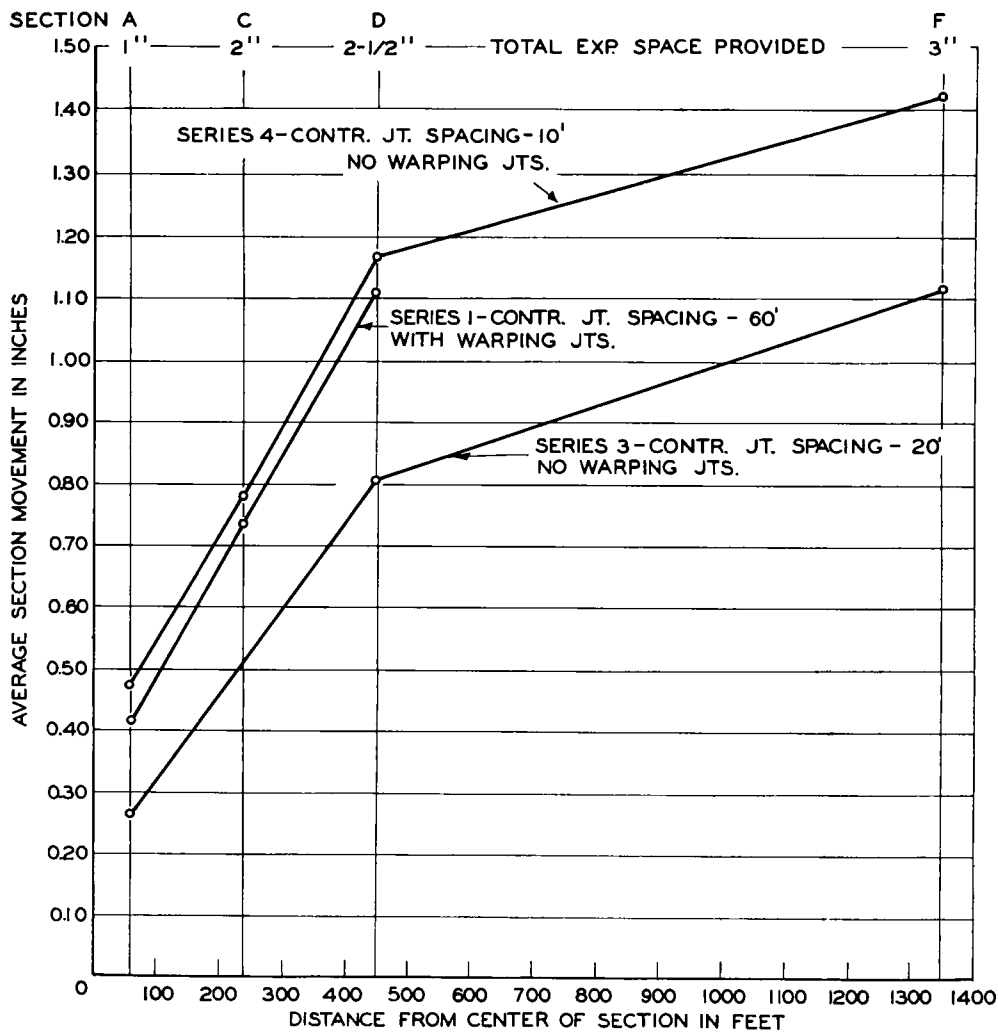
Figure 20. Effect of expansion and contraction joint spacing on magnitude of end movement, 1955.

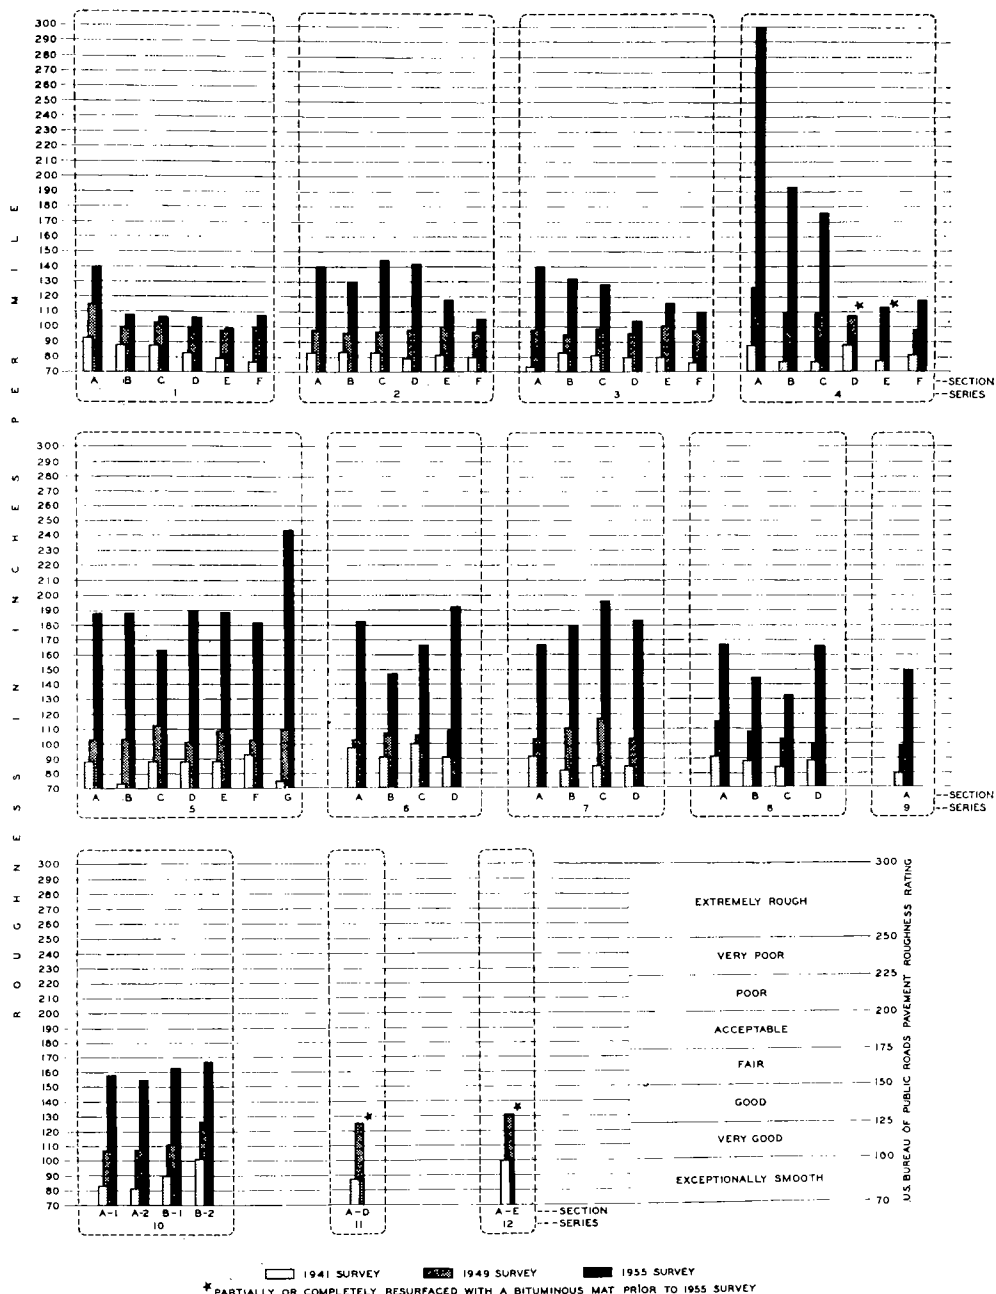
Figure 21. Pavement roughness.

In comparing roughness of Series 1 through 4 shortly after construction, it should be noted that these values were very similar, with a total range from 79 to 85 (Fig. 21). After eight years of traffic, roughness had increased about 20 percent for the first three series, but about 34 percent for Series 4. By 1955, roughness had increased by 32, 37, 67, and 132 percent for Series 1, 3, 2, and 4, respectively. This increase was largely due to scaling, especially along transverse joints and the longitudinal joint. By 1955, the percentage of the pavement surface having scaling was 1.6, 4.1, 6.2, and 39.9 for Series 1, 3, 2, and 4, respectively, indicating that shorter slabs had the greater amount of scaling. A partial explanation for this is the fact that scaling generally started at the transverse joints and then proceeded to the slab interior, the 10-ft slabs being more vulnerable to scaling because of the exceptional amount of hand finishing required.

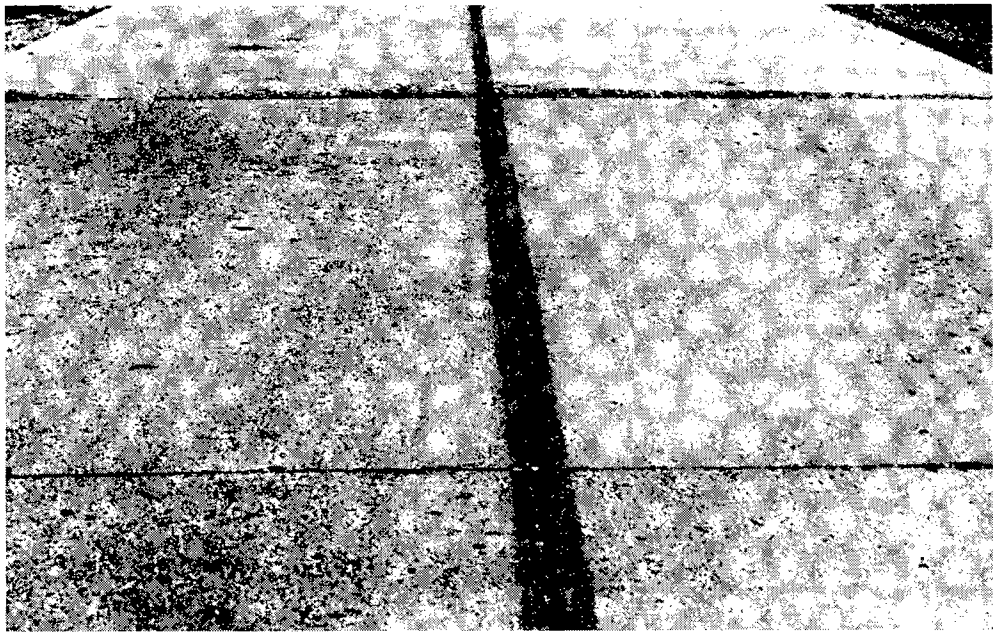
Figure 22. Good condition of pavement surface, Section 1C.

Variation in pavement condition in Series 1 through 4 is shown in Figures 22 through 25. The unscaled surface of part of Section 1C is shown in Figure 22, while Figure 23 illustrates light to medium scaling in Section 4C. More advanced scaling is illustrated in Figure 24, and typical scaling along a transverse joint in Figure 25.

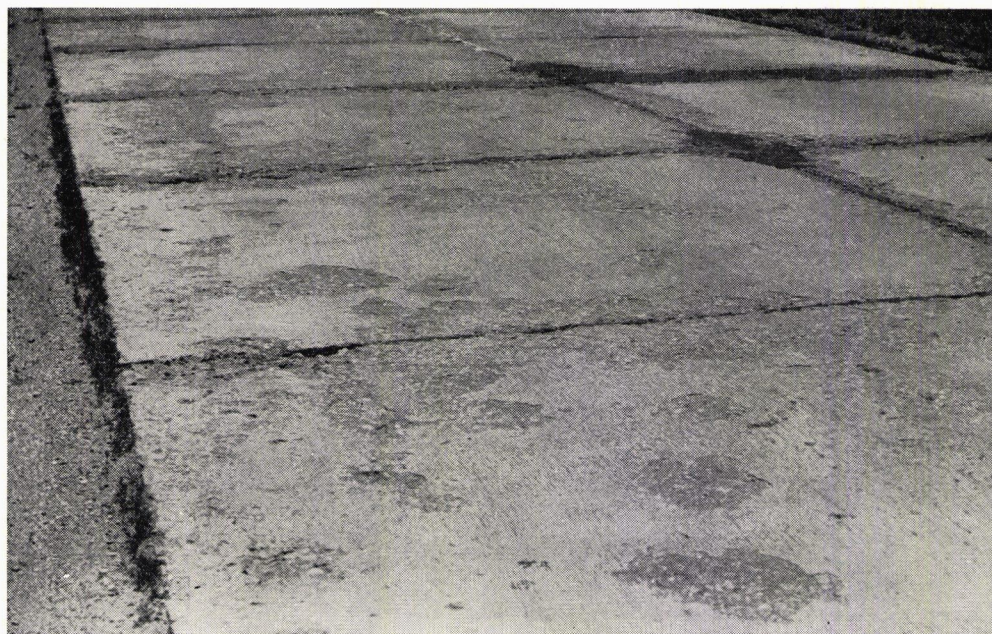
Figure 23. Medium scaling of pavement surface, Section 4C.

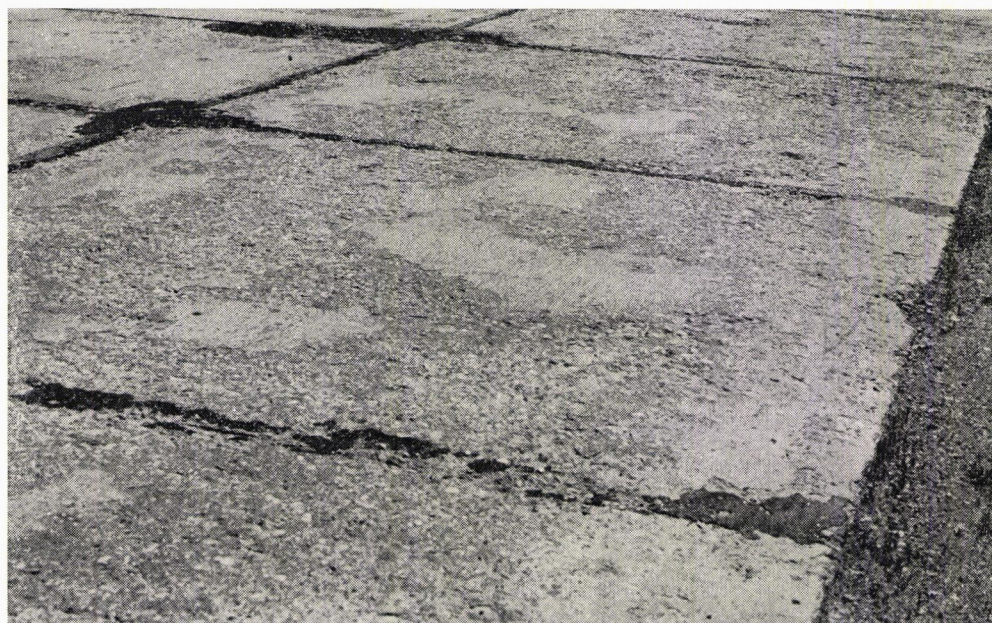
Figure 24. Heavy scaling of pavement surface, Section 4E.

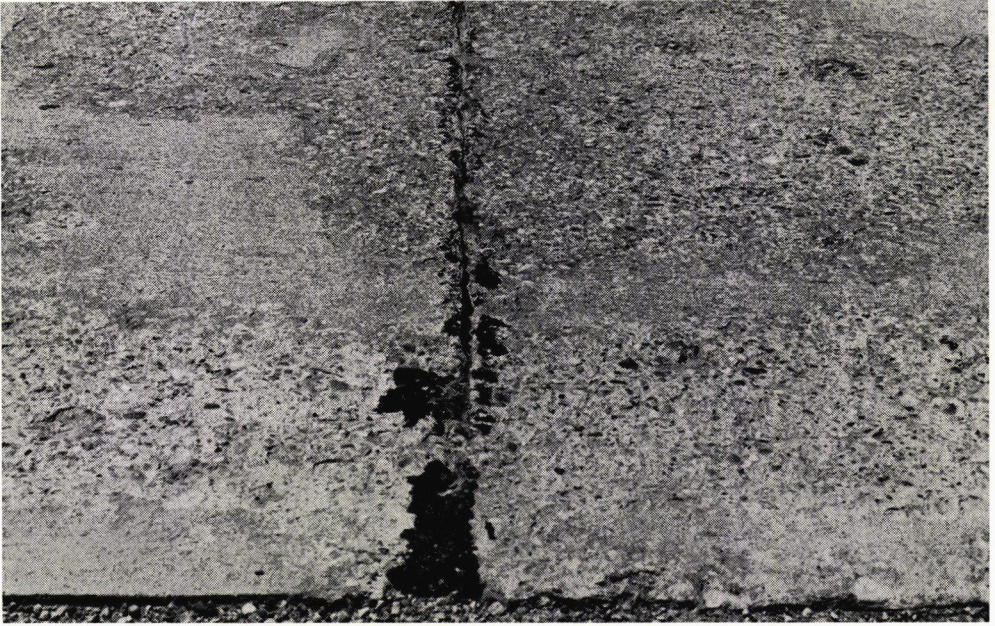
Figure 25. Typical sealing along transverse joint, Section 4E.

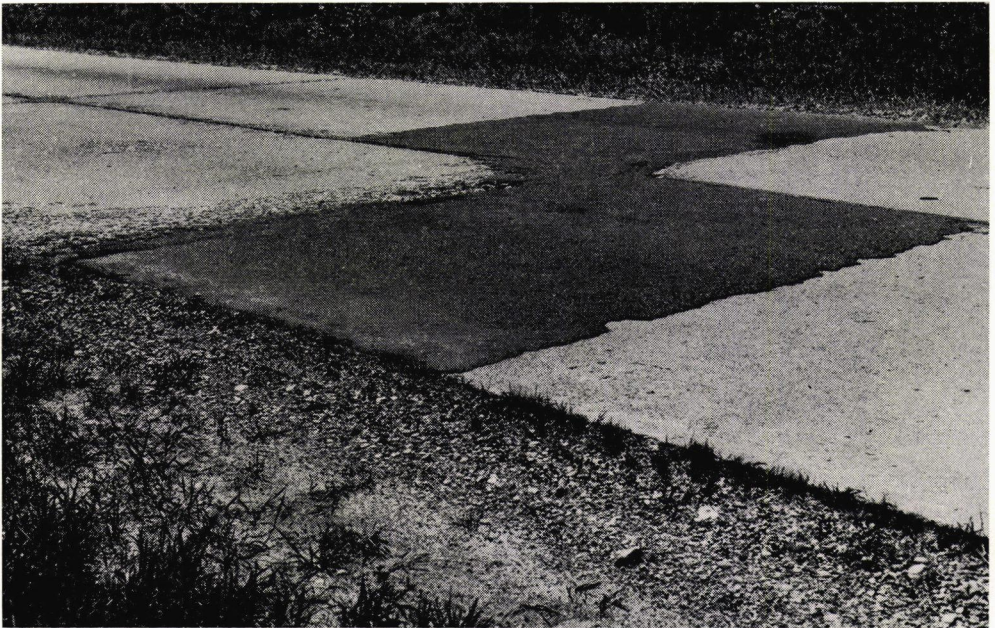
Figure 26. Pavement blow-up (Sta 841+00) at construction joint, Section 1F, 1954.
