Final Report on Design Project, Michigan Test Road

E. A. FINNEY, *Director, and*
LEROY T. OEHLER, *Physical Research Engineer,*
Research Laboratory Division, Office of Testing and Research,
Michigan State Highway Department

This report completes the research phase of the design project on the Michigan Test Road, constructed in 1940 by the Michigan State Highway Department in cooperation with the Bureau of Public Roads for the purpose of establishing certain principles in concrete pavement design—in particular, those principles involved in joint spacing and construction methods.

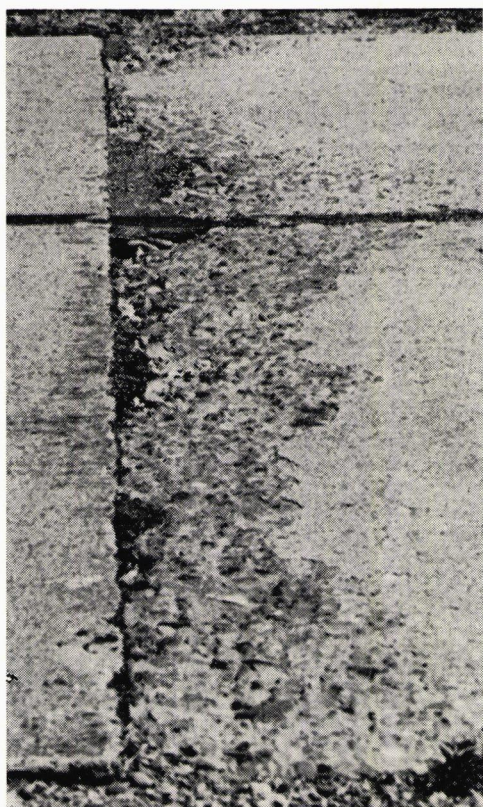
Figure 27. Typical pavement deterioration (Sta 789+32) at construction joint, Section 1C.

A common site of pavement deterioration was at construction joints. A typical example is shown in Figure 27. Twelve of 26 construction joints in Series 1 through 4 had spalling or extensive deterioration, in every case on concrete placed at the end of a day's pour.

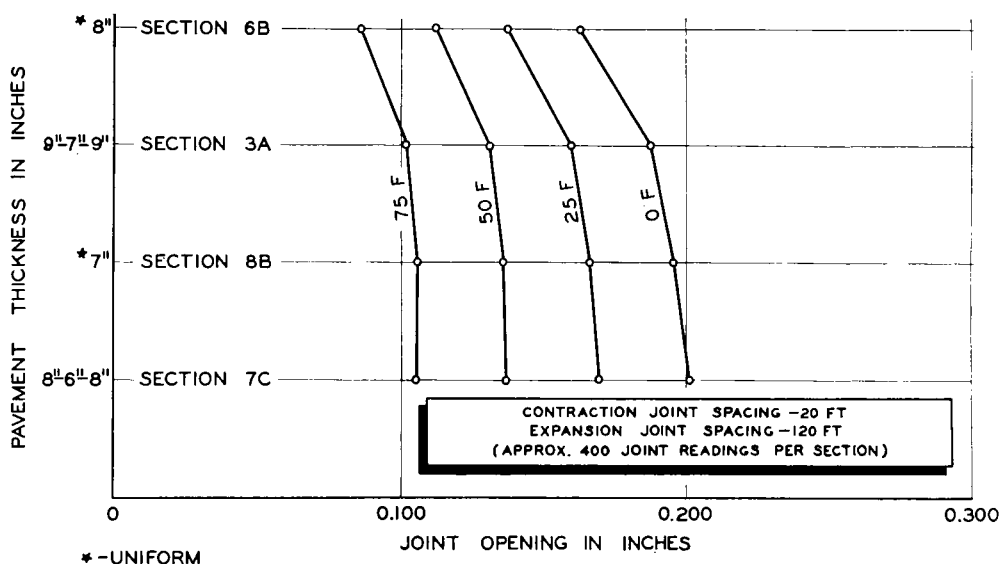
Figure 28. Effect of pavement thickness on contraction joint opening.

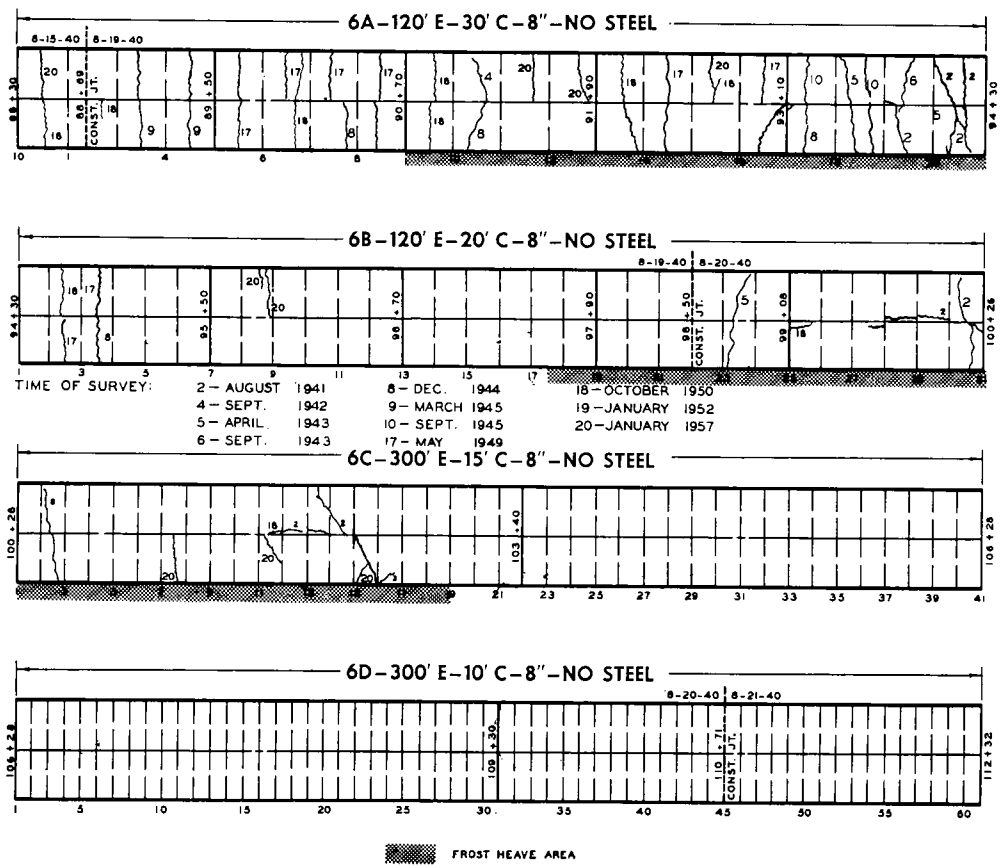
Figure 29. Pavement conditions, Series 6.

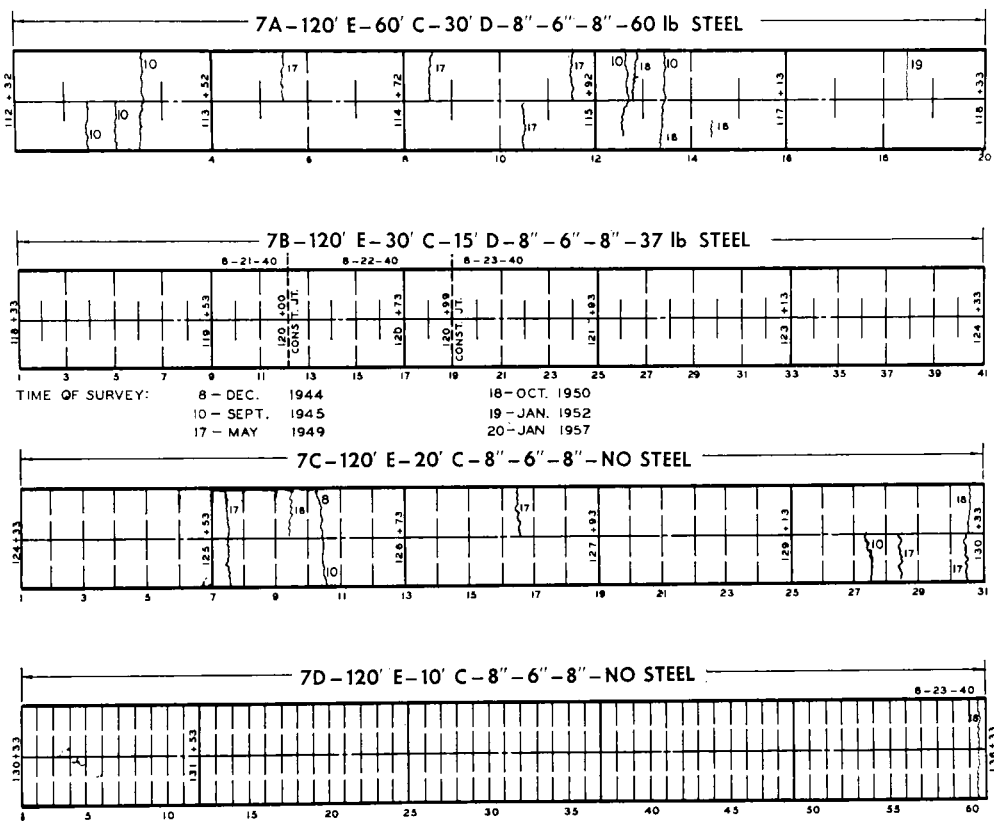
Figure 30. Pavement condition, Series 7.

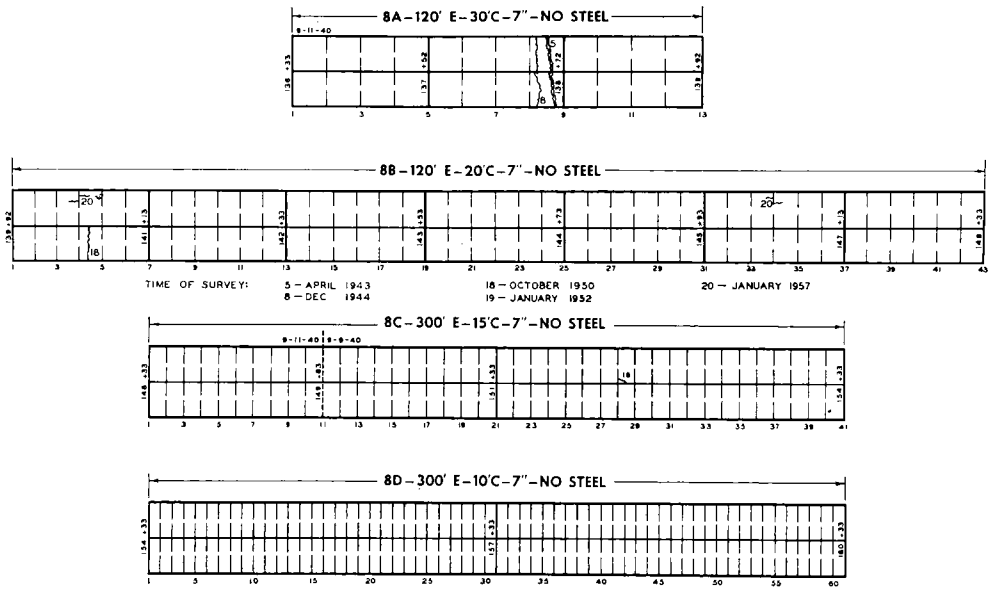
Figure 31. Pavement condition, Series 8.

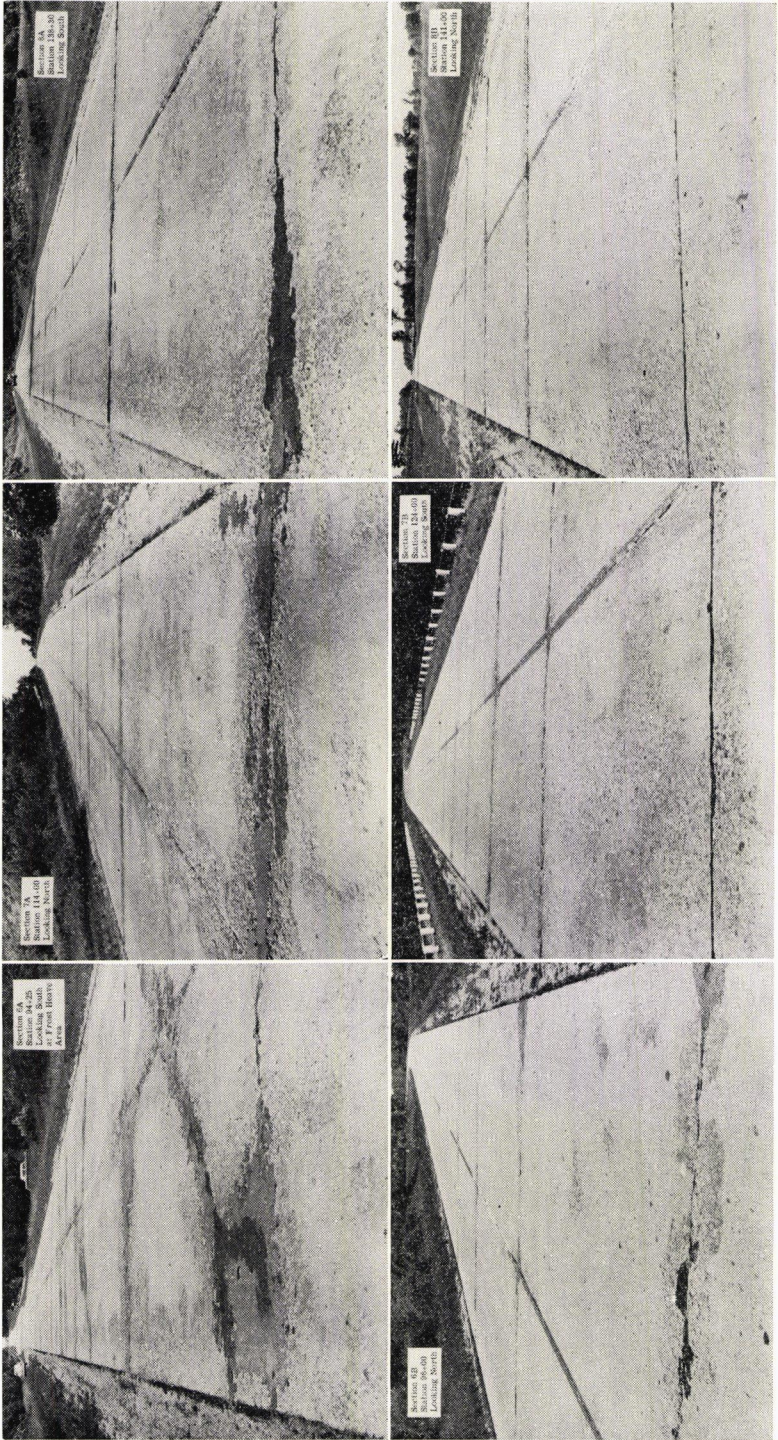
Figure 32. Pavement condition, Sections A and B of Series 6, 7 and 8.

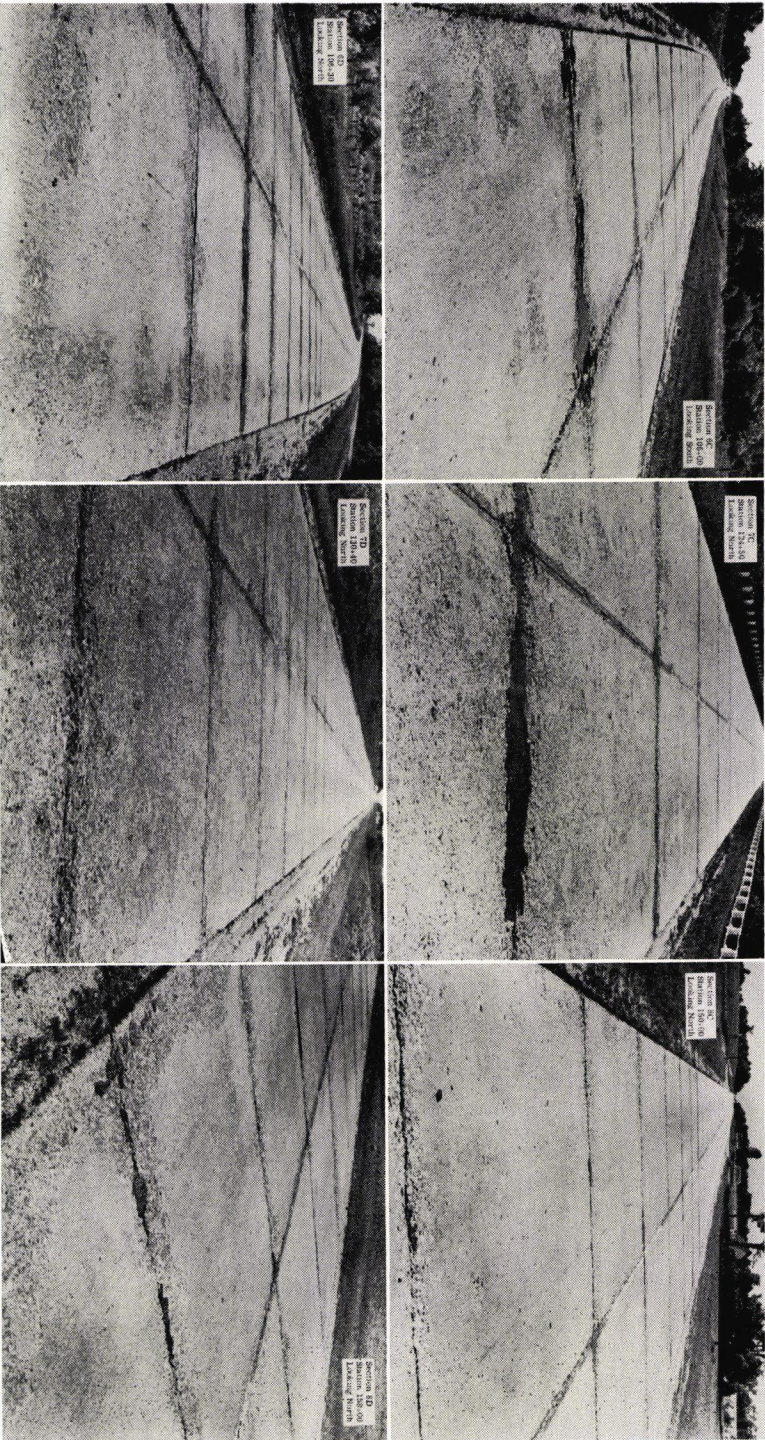
Figure 33. Pavement condition, Sections C and D of Series 6, 7 and 8.

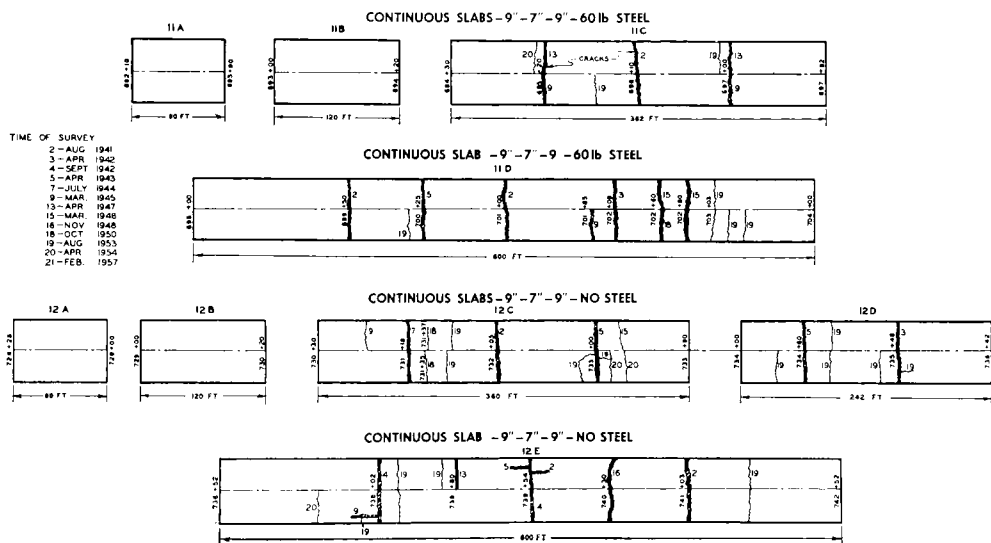
Figure 34. Pavement condition, Series 11 and 12.

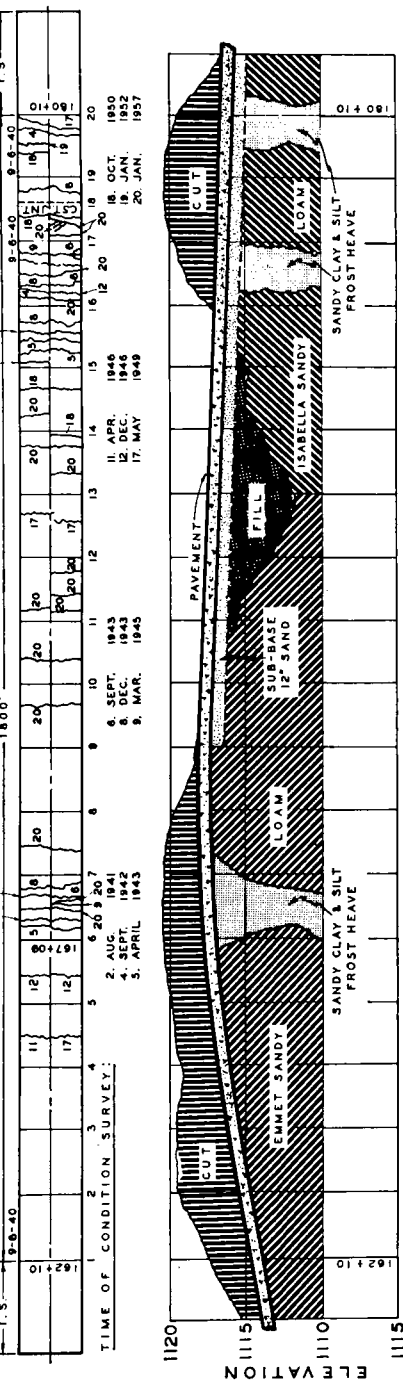
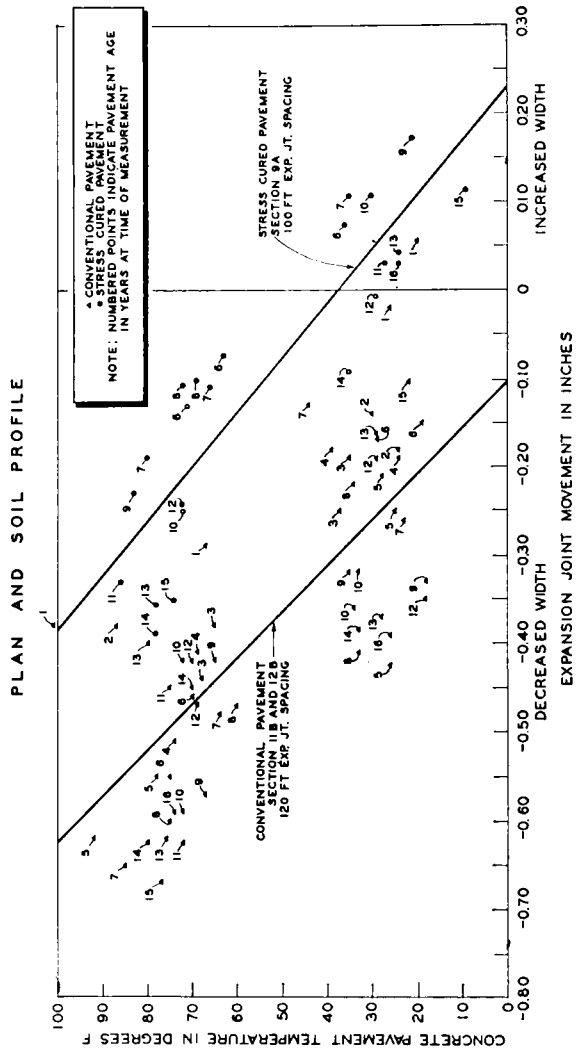
Figure 35. Stress cured concrete.

At the end of 17 years, four of the 18 original 100-ft slabs remained uncracked. The total linear feet of cracking was about 770, or 2,260 lin ft per mile of pavement. As shown in the soil profile in Figure 35, cracking in four of the slabs can be directly attributed to abnormal changes in the subgrade caused by undesirable soil conditions, and not to any factor of weakness in pavement structural performance.
