Preparing Old Pavements for Resurfacing With 50-Ton Compactor

J. L. STACKHOUSE, *Maintenance Engineer,*
Washington State Highway Commission

The paper describes in detail use of the 50-ton compactor on a 4-mi project on a Washington state highway in preparation for widening and resurfacing with asphalt concrete an old portland cement concrete pavement constructed in 1924. A resume of the methods of preparation of old concrete pavements during the past 20 years is given and the inherent faults of reflection cracks and subsidence of the new pavement are discussed as a preliminary reason for the trial of the compactor method of preparation of the old pavement.

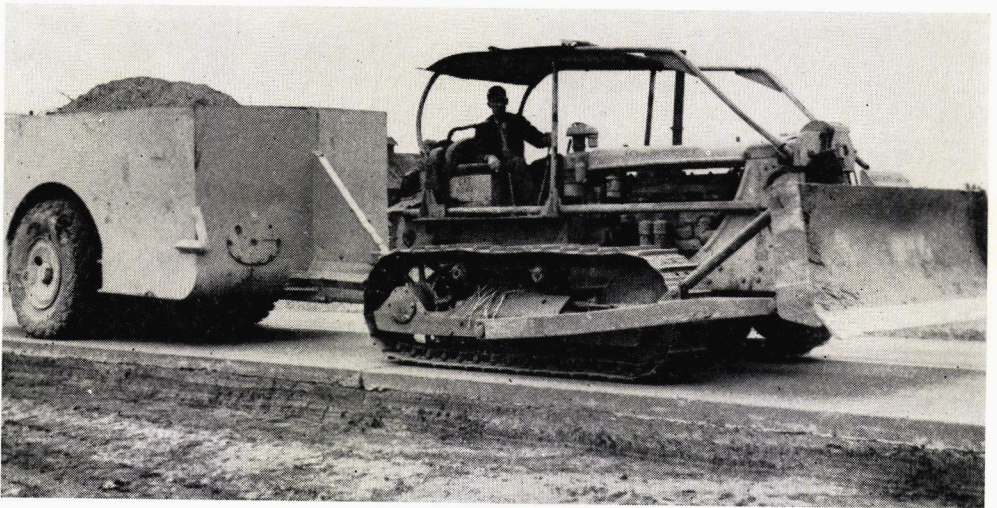
The compactor used by the contractor had a hopper capacity of 640 cu ft. The aggregate used to fill the hopper weighed 151 pcf and with the added weight of the compactor itself the total weight on the four tires was in excess of 59.6 tons, or approximately 656 lb per lin in. of tire width.

The recommended speed of 5 mph was found to be too fast for effective results and 2 mph was set for the operating speed. The number of passes over each 9-ft wide pavement slab with the compactor was found to be between six and twelve, with the average about nine to ten passes. There is danger of over-rolling, especially where the subbase under the old pavement is composed of clay-type material and is wet. Figure 2 shows the compactor and tractor units used.

Figure 2. Compactor used to roll old slabs down to the subbase.

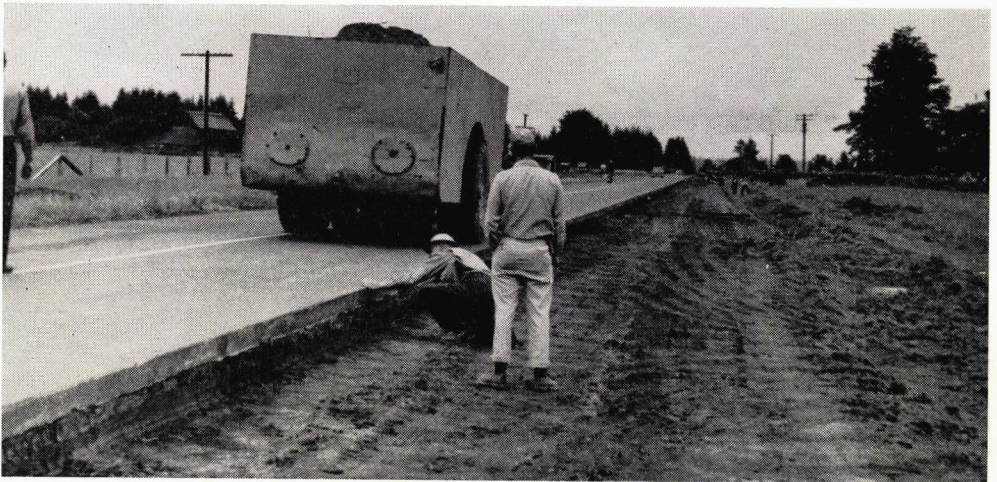
length would tilt or rock under the weight as shown in Figure 3. After the first few passes, the slabs would break, generally, at third-points both horizontally and longitudinally and lie flat on the compacted subgrade. The cracking and grinding of the slabs, as they were broken, could be heard as the compactor traveled at the slow speed. Figures 4 and 5 are close-ups of two sections of the edge of the pavement while the compactor tire rolled over the cracked slab. The movement of the broken slab edge (Fig. 4) was 0.2 in. Figure 6 shows the area and a rear view of the compactor.

Figure 6. View of widening job with compactor on slab.

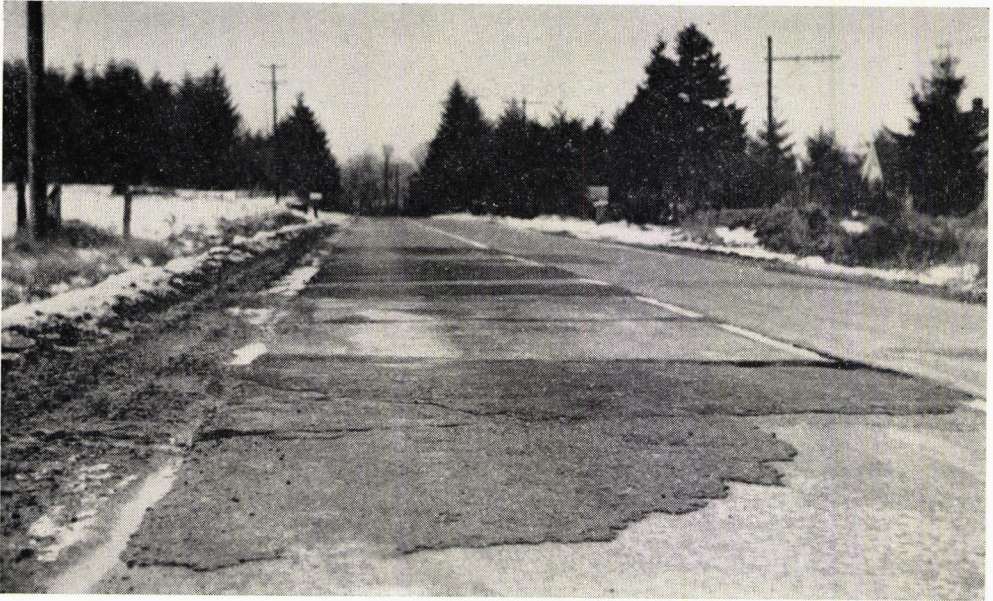
Figure 7 shows the east end of the project before work started, indicating the poor condition of the pavement in some places. Figures 8 and 9 show sections of the old pavement after rolling with the compactor. Figure 10 is a close-up of the wearing course of the finished resurfaced pavement, which was class B asphalt concrete, Washington State standard specifications.

Figure 7. Condition of pavement before start of work.

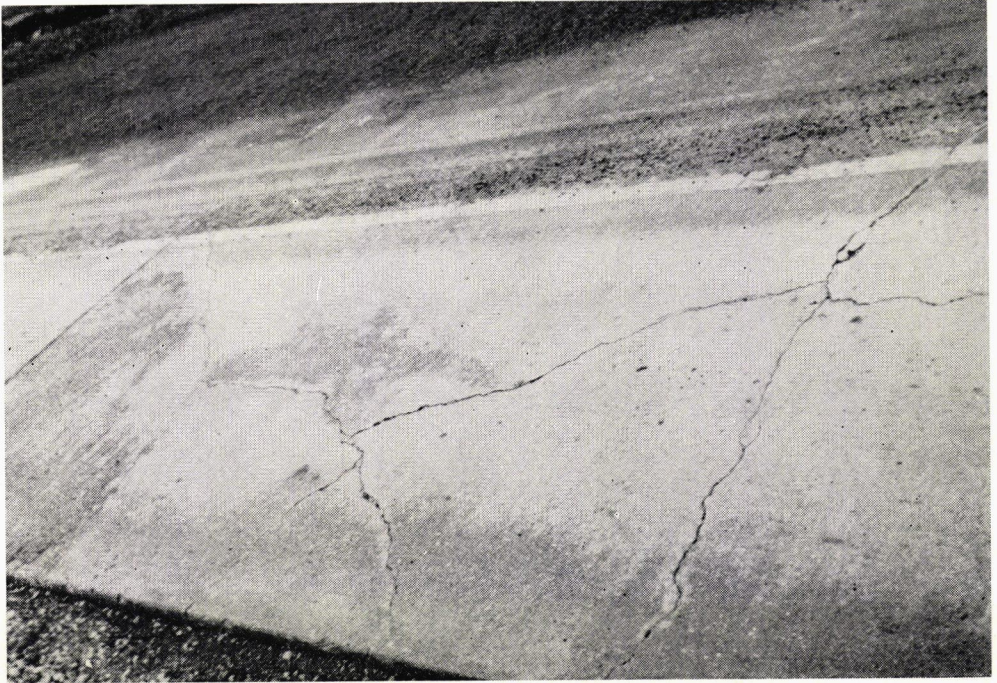
Figure 8. Section of pavement broken by compactor.

Figure 9. Section of pavement broken by compactor.

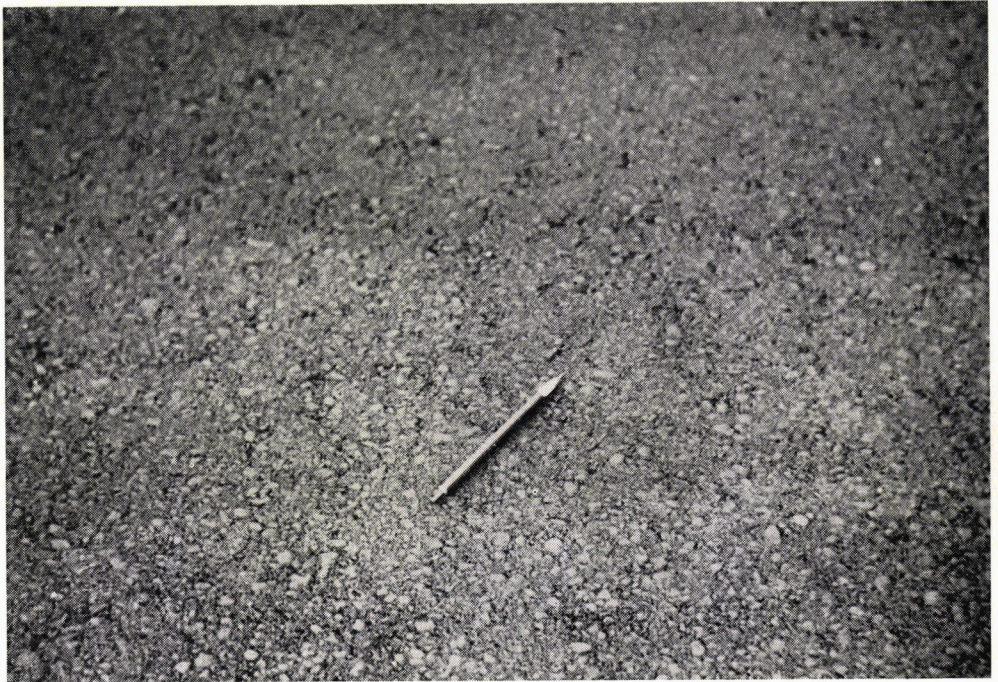
Figure 10. Wearing course of finished resurfaced pavement.
