## DISCUSSION OF REPORT OF COMMITTEE ON CHARACTER AND USE OF ROAD MATERIALS

R L MORRISON

*Michigan State Highway Department, Lansing, Michigan*

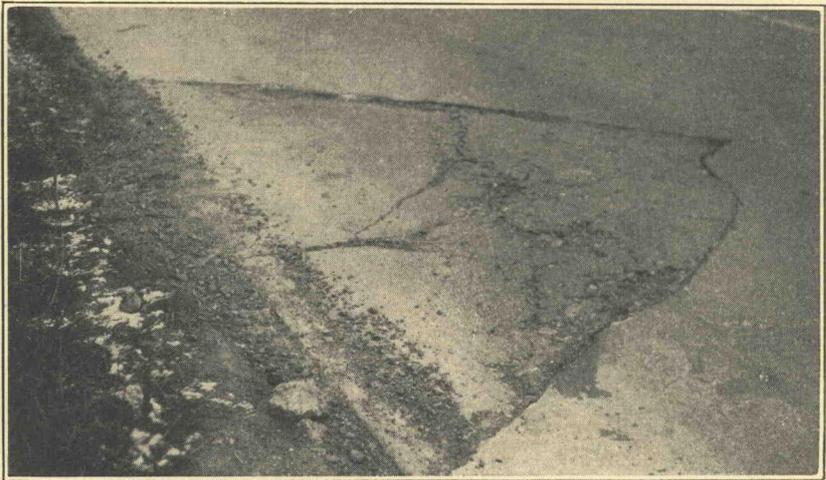
At the end of five months about 20 to 25 per cent of the patches had failed. Disintegration seemed to begin at the surface and finally the whole patch would be cracked and shattered. See Figure 1.

Figure 1—Typical failure of aluminate cement patch

An interesting point in this connection is that the failures were mainly confined to small patches, containing less than 25 square feet, the largest patches all being in excellent condition.
