# REPORT OF INVESTIGATION OF THE ECONOMIC VALUE OF REINFORCEMENT IN CONCRETE ROADS

C A HOGEN TOGLER

*Highway Research Board, Washington, D C*

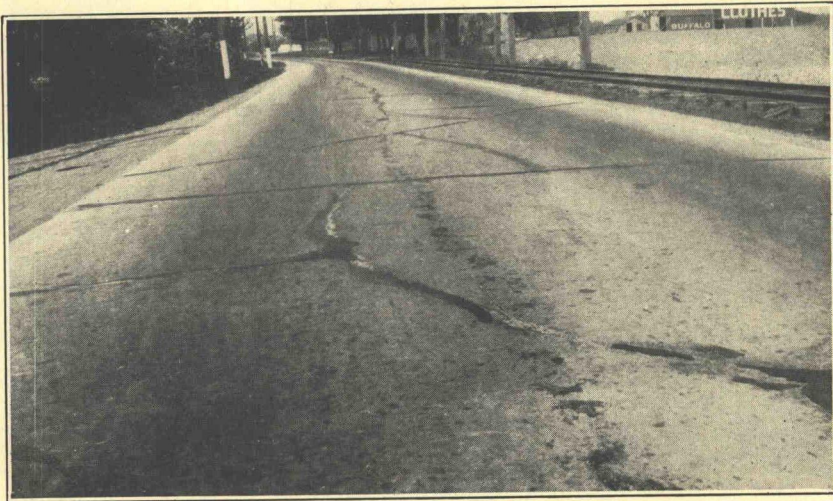
Figure 6—Cracking in Road No. 193, Pennsylvania

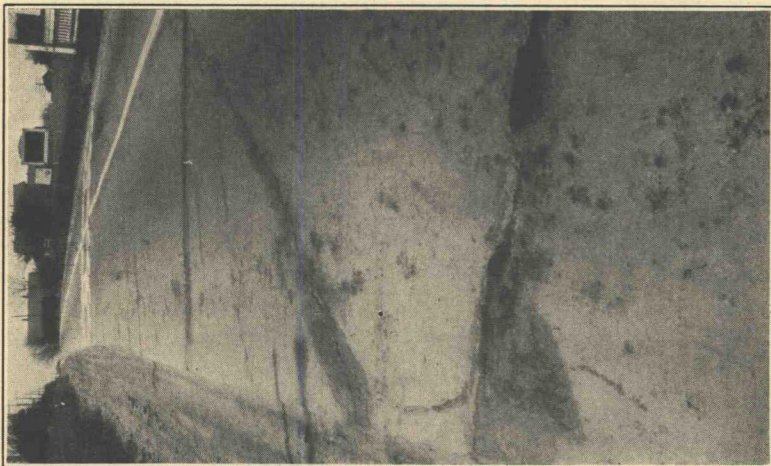
Figure 9—Raveling of crack 6-8-6 section, Road No. 193, Pennsylvania

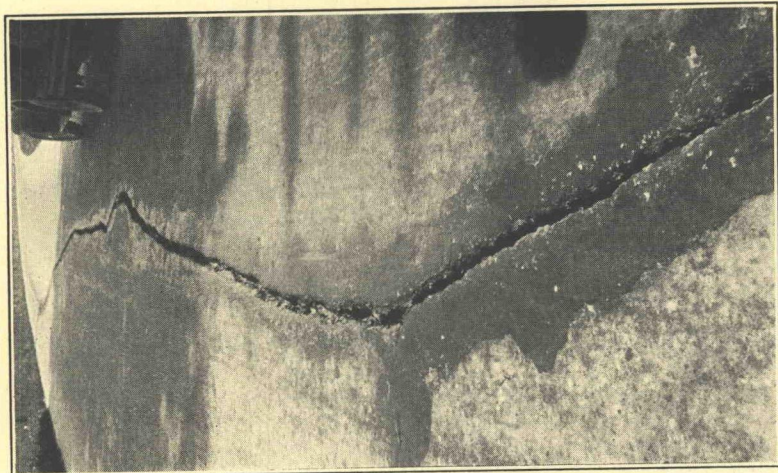
Figure 12—Separation of slabs 7 inch section, St. Clair Co., Michigan

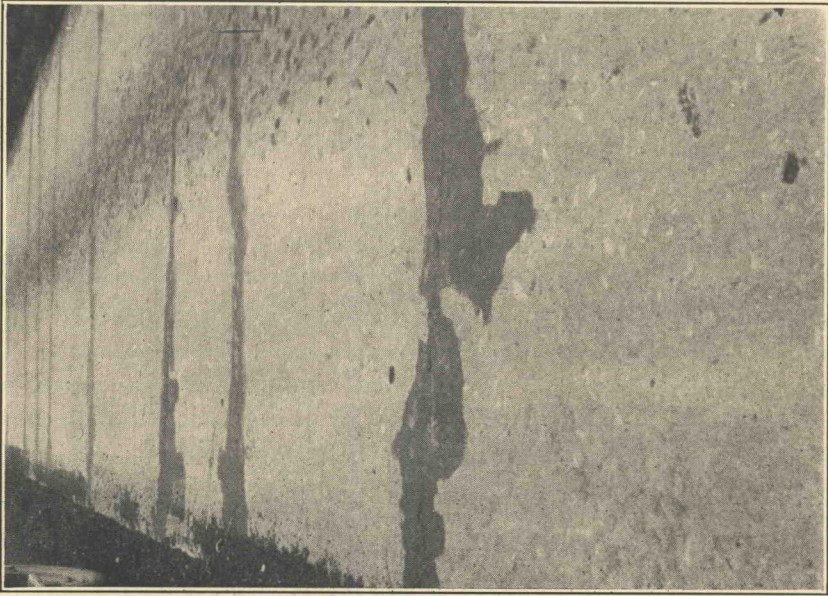
Figure 22—Excessive transverse cracking in narrow slab laid on peat bog subgrade. (Celeryville Road No. 88, Ohio.)

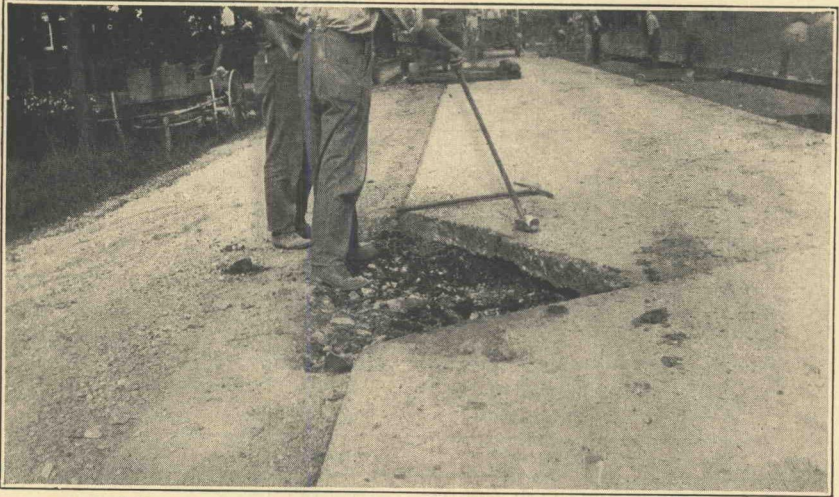
Figure 31—Maintenance on Road No. 108-DeKalb, Sycamore, Ill. Preparation for replacing corner failure with concrete

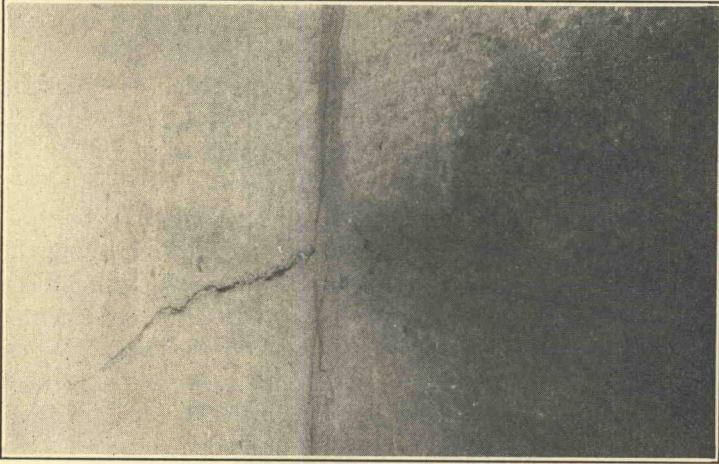
Figure 55—Meeting of closed crack in reinforced slab with open crack in plain slab, Milwaukee Co., Wis.

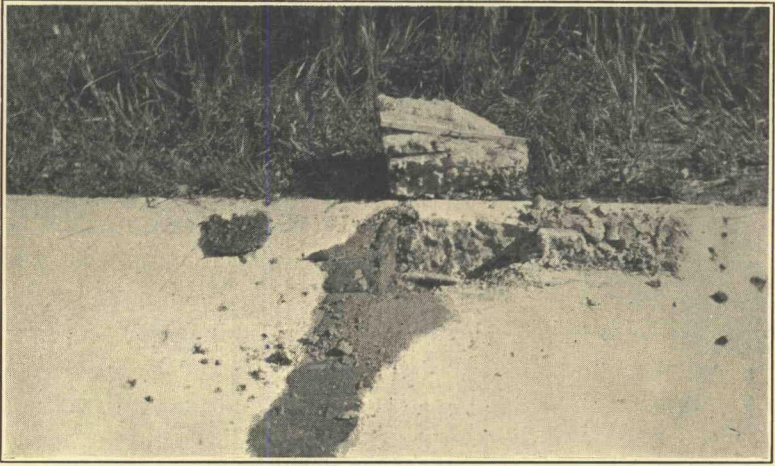
Figures 60, 61, 62—Breakage caused by placing bars across expansion joints. Photos by courtesy of Michigan State Highway Commission

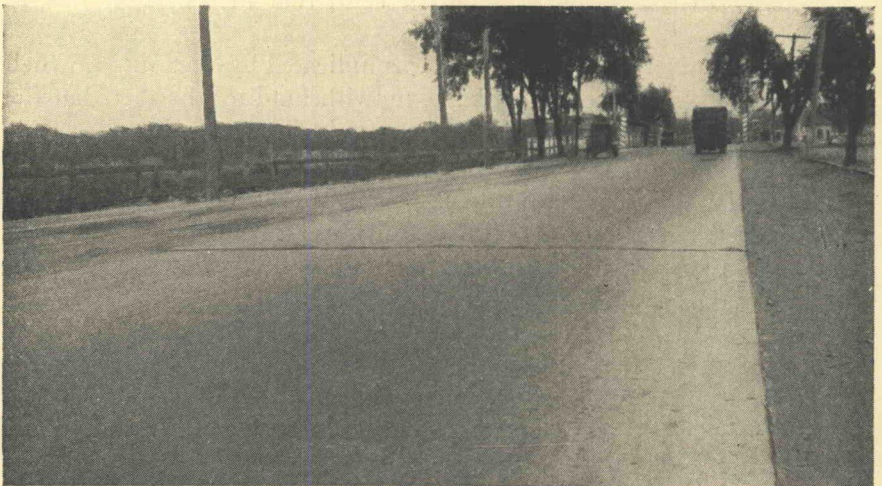
Figure 64-A—Resurfacing on Boston Post Road

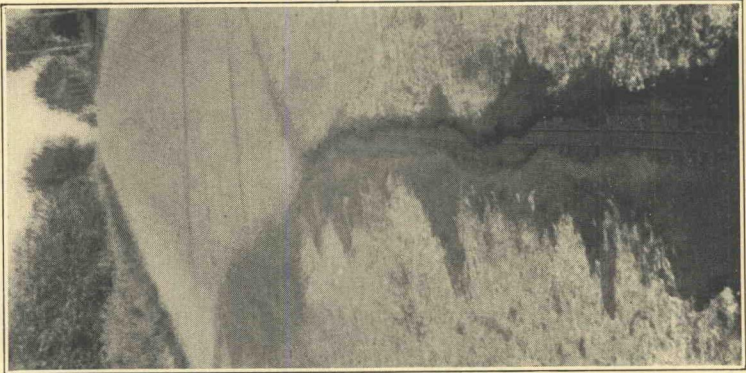
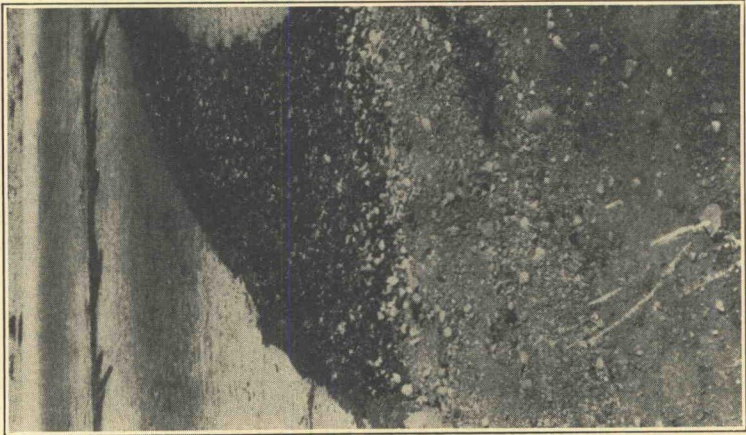
Figure 81—Open cracks in plain concrete slabs with side edge displacement
