NEW JERSEY TESTS on STABILIZED TURF SHOULDERS

Herbert C. Nikola
 Research Assistant in Soils
 Rutgers University

Cooperators: New Jersey State Highway Department; Soils Department, Rutgers University

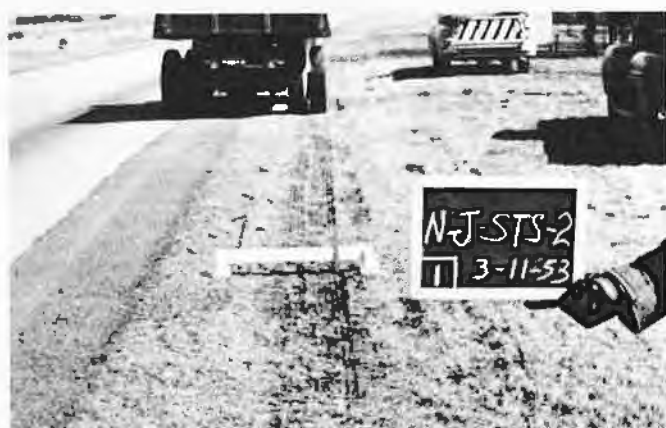
Fig. 1. Test equipment after one pass on test Area 2. Rigid bridge and graduated scale in position to measure penetration. Loaded truck in background.

Density tests were performed during the week of November 30 before start of freezing weather. Figure 1 shows the loaded truck, rigid bridge, and graduated scale in place for determining wheel penetration following one pass of loaded truck on test area NJ-ST5-2.

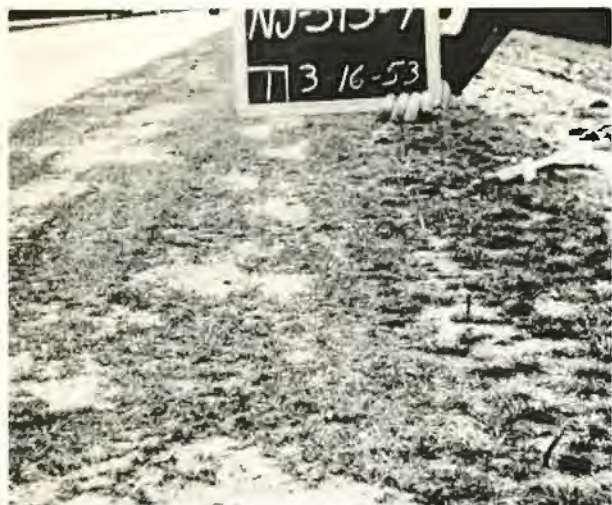
Fig. 2. Test Area NJ-STS-7 prior to traffic test.

Figures 2 through 5 illustrate the effect of the traffic test on a stabilized and a non-stabilized area. Test area NJ-ST5-7 is shown in Fig. 2 before test. Figure 3 is same area following four passes of the loaded truck. Maximum penetration had been attained after two passes. The same sequence is shown for the non-stabilized area NJ-ST5-8 in Figs. 4 and 5. Maximum penetration not attained as ruts became too deep for safe operation of the test vehicle.

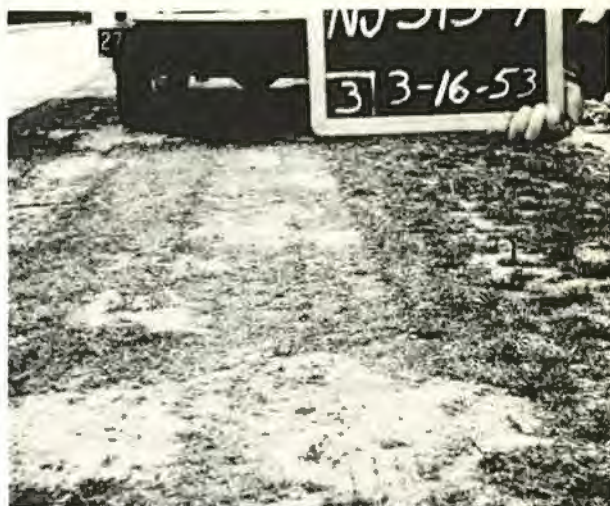
Fig. 3. Test Area NJ-STS-7 after four passes of loaded truck.

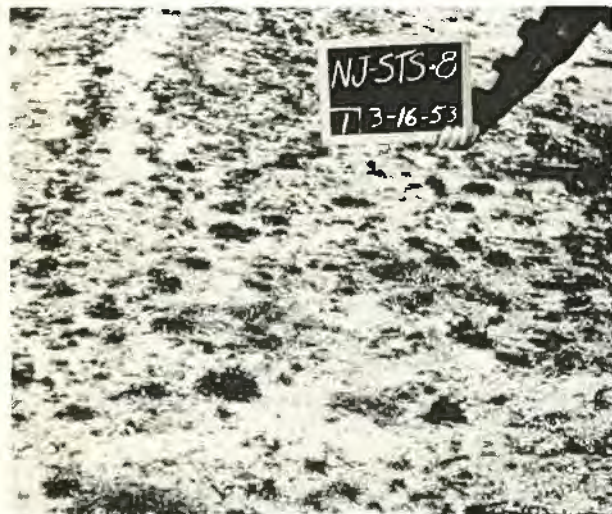
Fig. 4. Test Area NJ-STS-8 prior to traffic test.

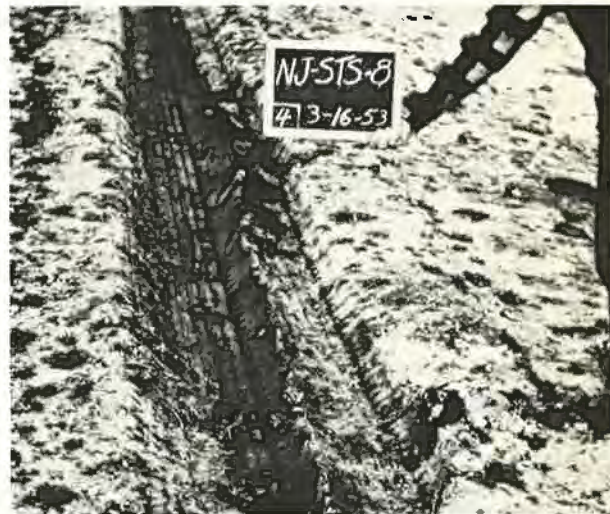
Fig. 5. Test Area NJ-STS-8 after four passes of loaded truck.

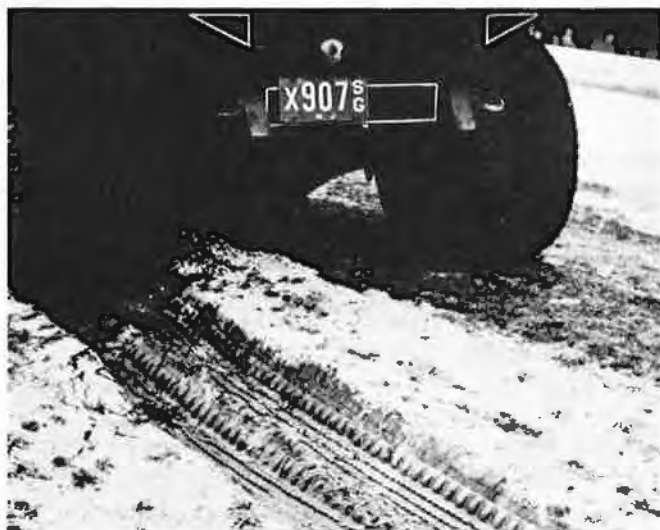
Fig. 6. Loaded truck leaving test area NJ-STS-8 and reentering stabilized turf shoulder.

Test area NJ-STS-8 was included to emphasize the need to consider stability of the soil materials before considering turf establishment. Figure 6 shows the loaded truck leaving this test area and climbing up on the stabilized turf shoulder. Turf can be established on these stable shoulders.
