EROSION CONTROL on EXTREMELY SANDY SOILS in NEW JERSEY

Clarence R. Pell, Parkway and Landscape Engineer
New Jersey State Highway Department

SEEDING and EMULSIFIED-ASPHALT MULCHING on ROAD in NORTH CAROLINA

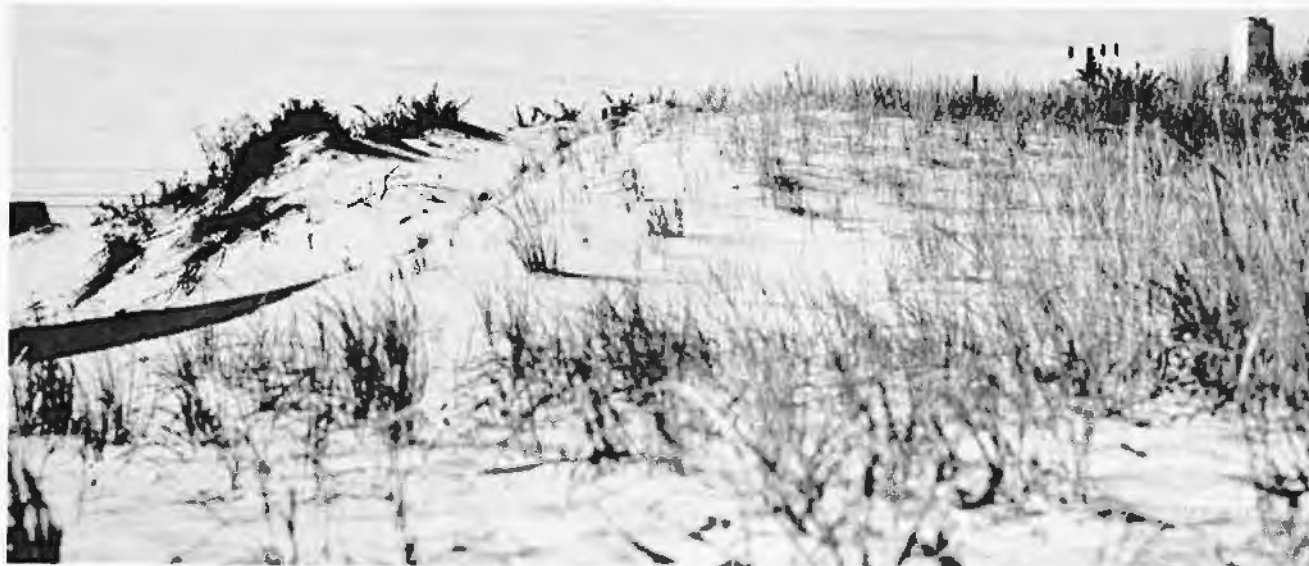
Figure 1. Sand dunes in South Jersey, showing native dune grasses and goldenrod (top left).

inhibit drifting of dune sands. Also, much drifting is prevented by an abundance of native shrubs of which northern bayberry and poison ivy predominate. Other very

important existing vegetation consists of beach grass, beach goldenrod, silverrod, and Hudsonia.

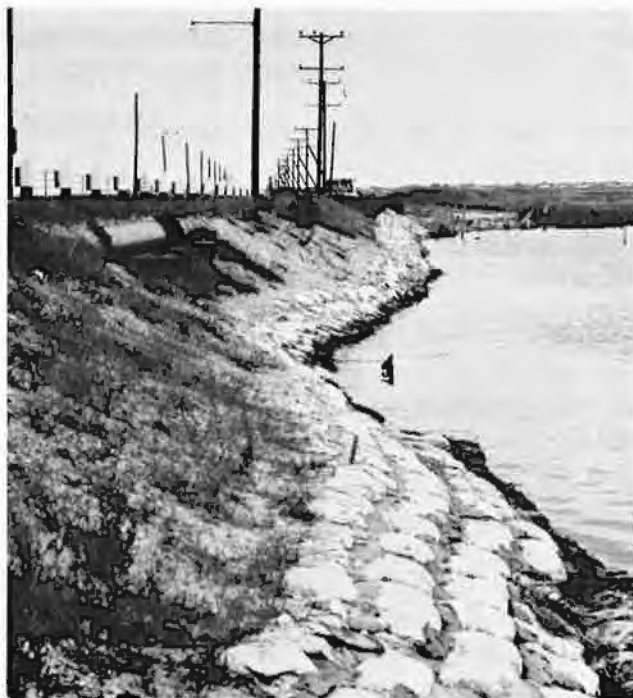
Figure 2. Riprap slope protection is used where salt water and tidal currents prevent growth of vegetation.

Treatment of surface exposed to tide action. Wooden bulkhead at points of greatest stream action. Cement-bag riprap at other places.

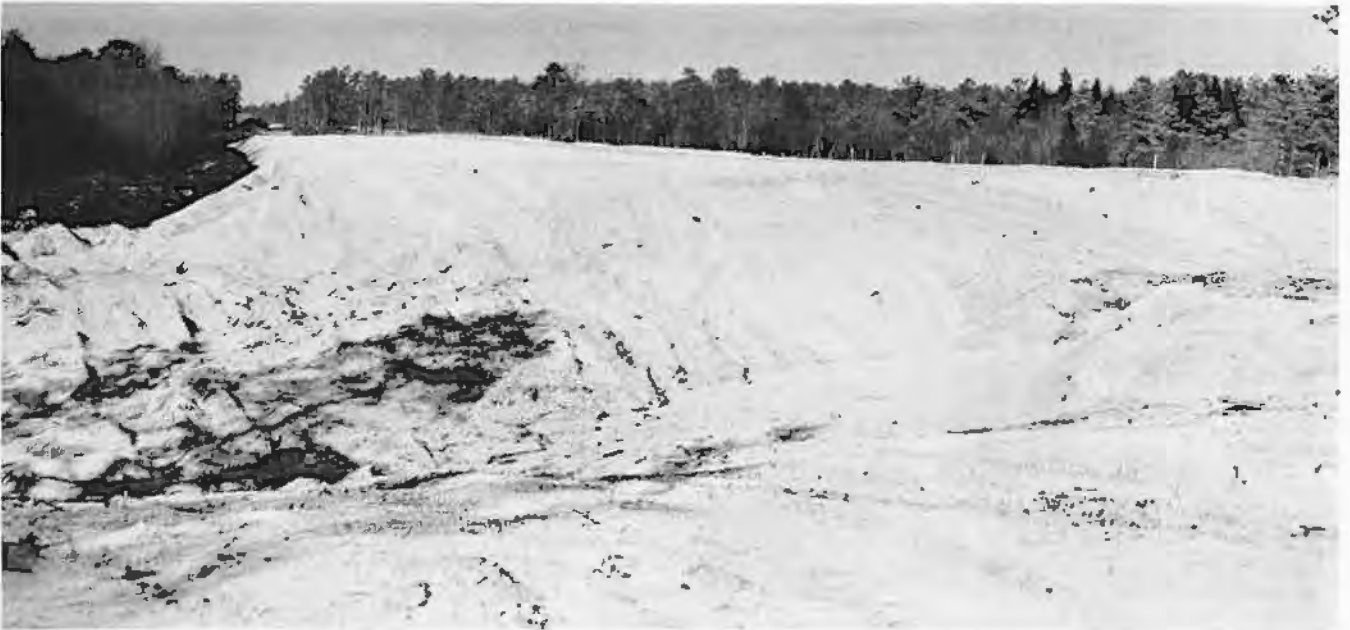
Figure 3. Early stage of construction showing the type of sand fill used in all areas shown in Figures 4, 5, 6, and 7. Note storage piles of native peat excavated as unsuitable fill material, at extreme left.

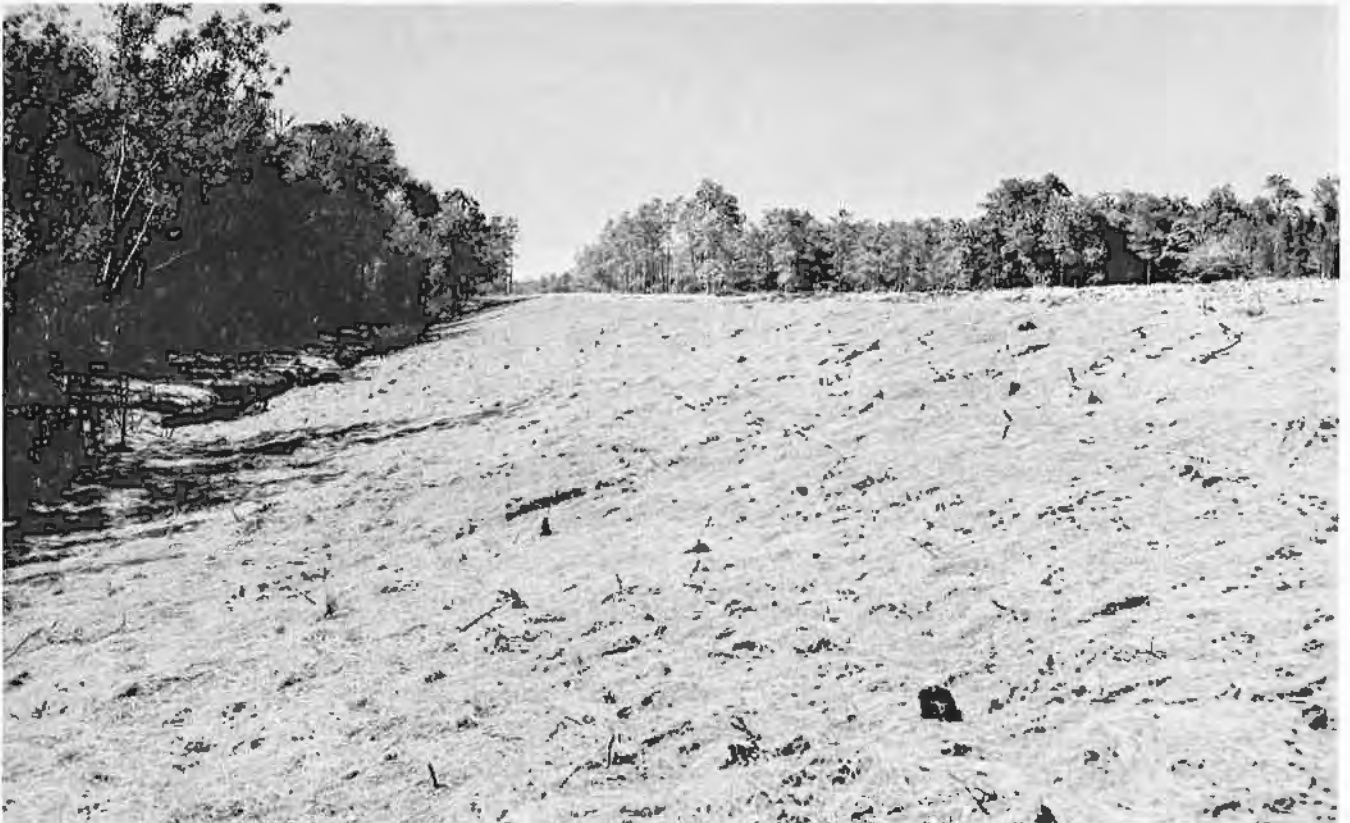
Figure 4. Peat from storage piles (see Figure 3) was disked into the surface of the sand fill which was then limed, fertilized, seeded, and mulched.

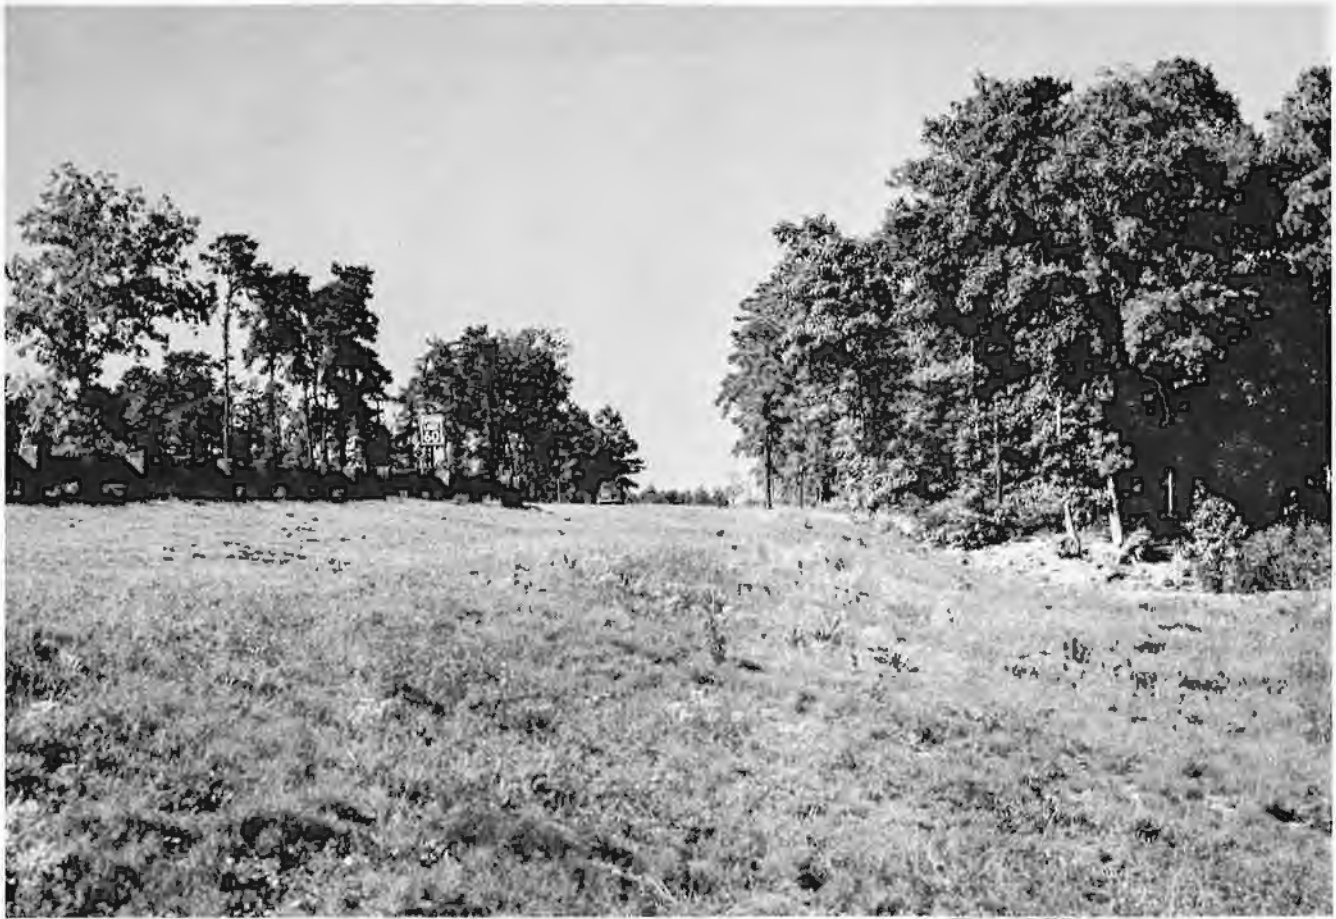
Figure 5. This slope was treated similarly to that described for Figure 4. Note the resulting stand of turf.

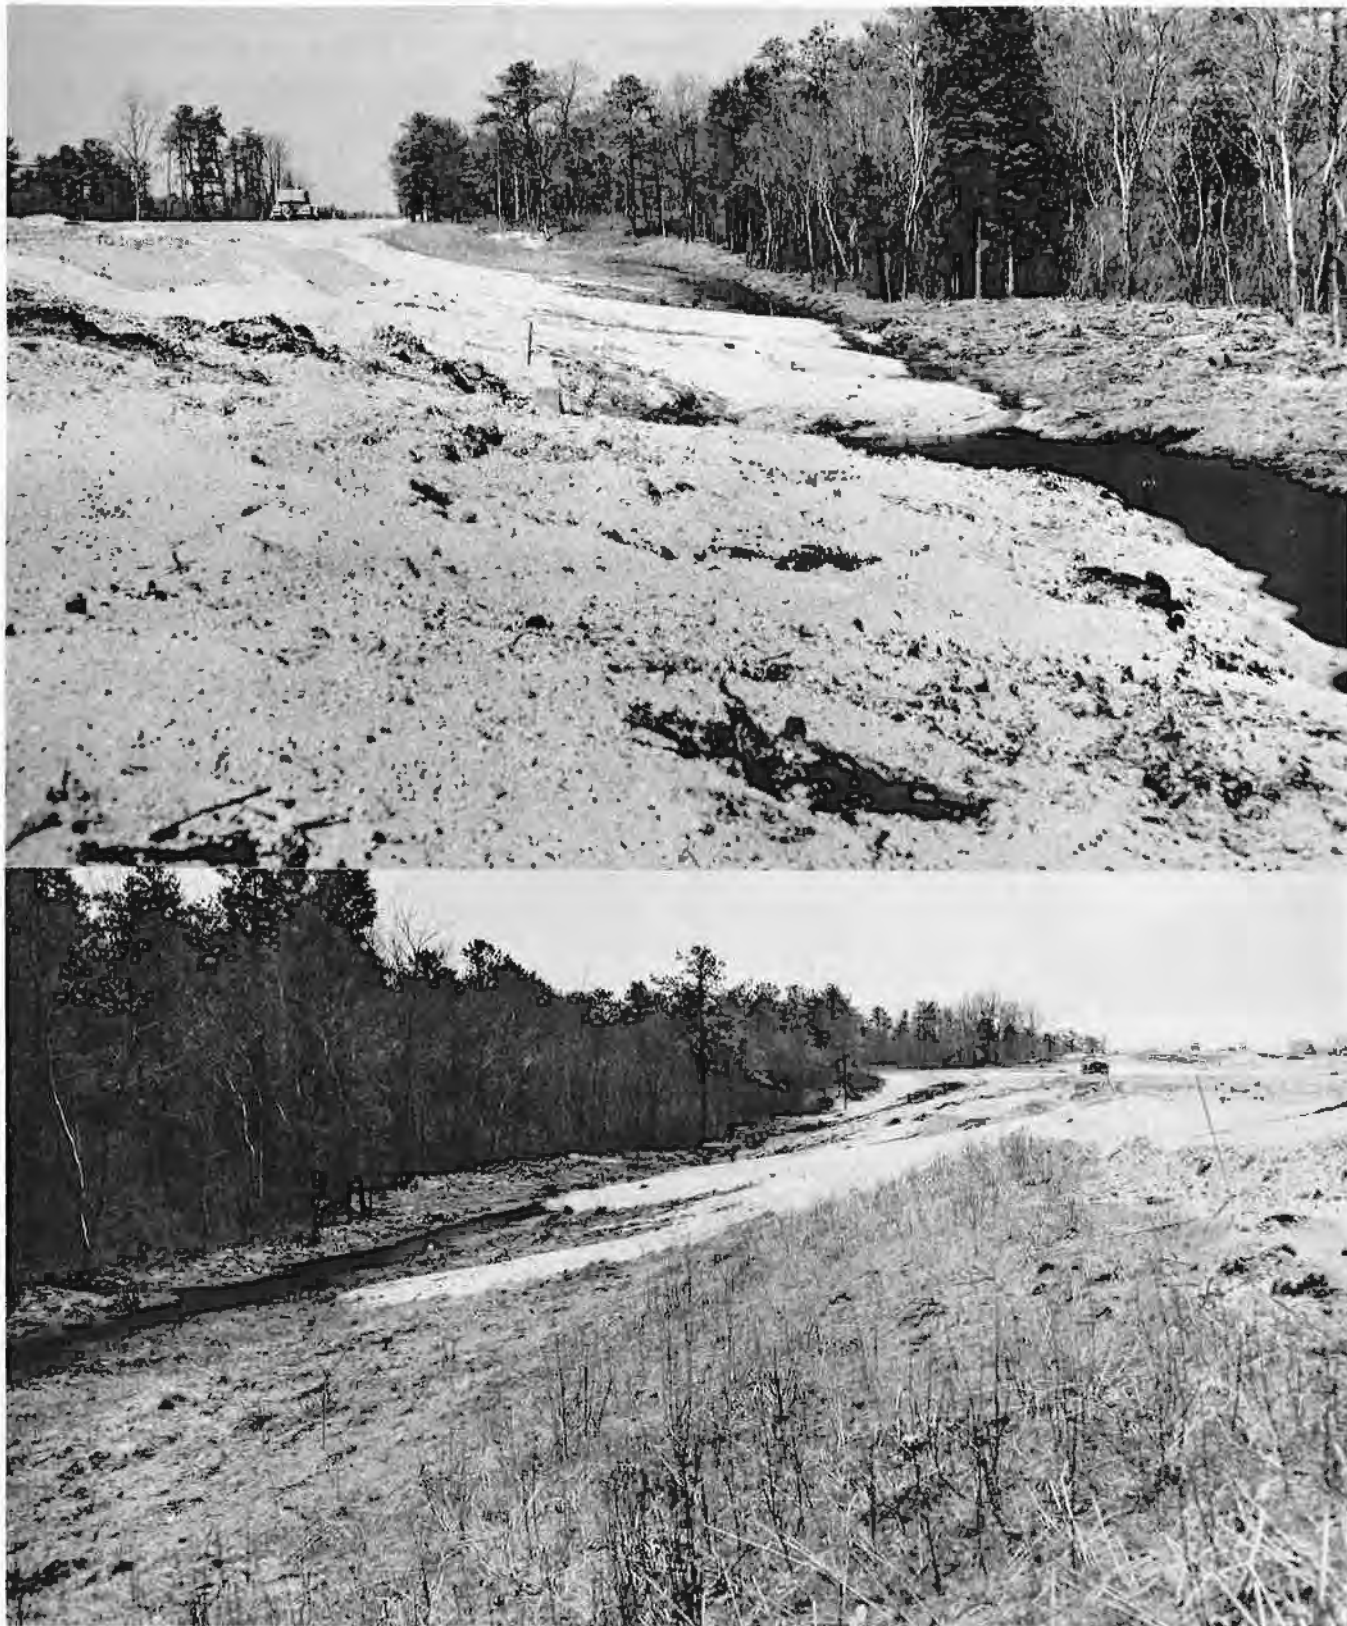
Figure 6. Contrast between finished surfaces which have been seeded and mulched as compared with adjacent areas left exposed. Note how eroded material has clogged drainage, necessitating additional grading.
