SEEDING and EMULSIFIED-ASPHALT MULCHING on ROAD in NORTH CAROLINA

James A. Saunders, Assistant Landscape Engineer
North Carolina State Highway and Public Works Commission

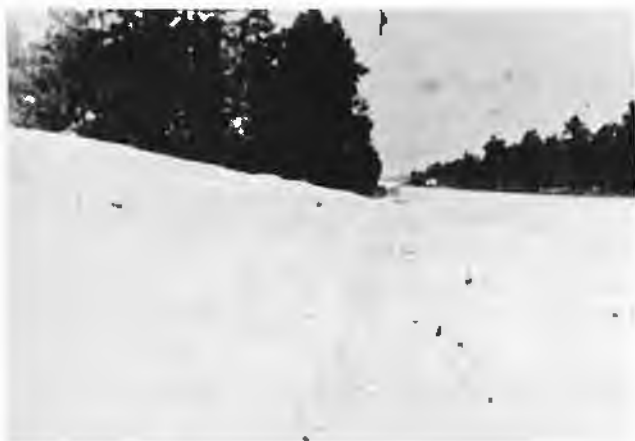
Figure 1. Sand slopes on Negro Head Road in North Carolina.

● THIS section of US 421 runs from US 17, west of Wilmington, N. C., northerly approximately 15 miles. It was completed in the latter part of May, 1953. With the exception of 2 miles on the north end, it runs through pure white sand ridges, with the height of some of the cuts exceeding 20 feet.

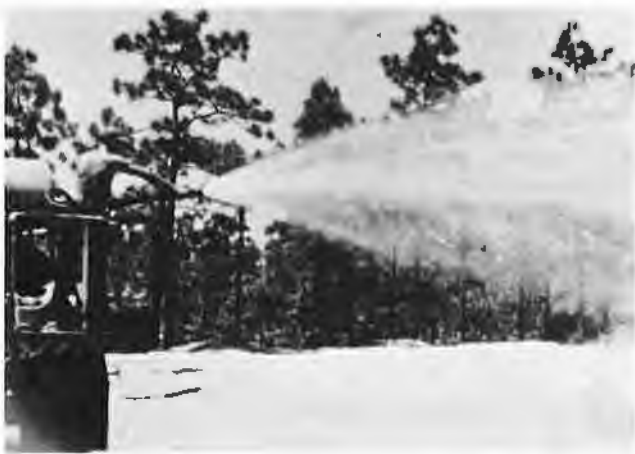
Figure 2. A hydraulic seeder was used for seeding and fertilizing.

Seeding of this road was started on May 25, 1953, using the hydraulic seeder. Sudan grass at $1\frac{1}{2}$ lb. Korean lespedeza at 1 lb., and 6-8-6 fertilizer at 20 lb. per 100 sq. yd. were applied to all areas. The hydraulic seeder spread this mixture of seed and fertilizer over the areas very evenly, and in wide areas, it was able to seed 100 feet from the edge of the pavement.

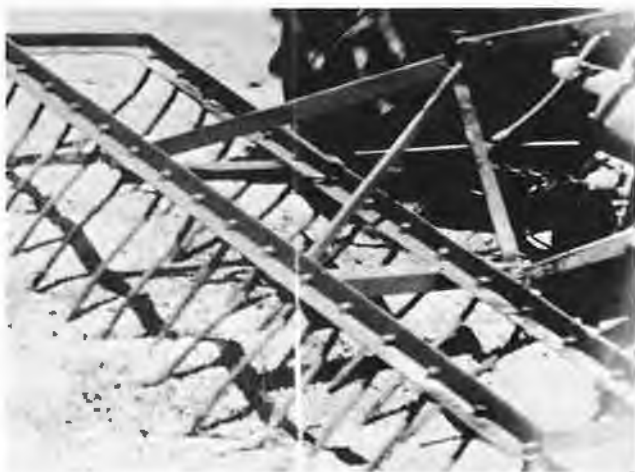
Figure 3. This type of weeder, pulled by a Ford tractor with crawler treads, was used to cover the seed.

No seedbed preparation was necessary because of the sandy soil. The seed was covered by using a Ford tractor (with crawler treads) pulling a heavy section harrow, or weeder. After starting to apply the mulch, it was found that on the cut slopes the ridges left in the sand by the section harrow were undesirable, as the mulch covered the front side of the ridge but the back was not covered. Thereafter another crawler-type tractor was used to pull a heavy board drag to smooth the soil before applying the mulch.

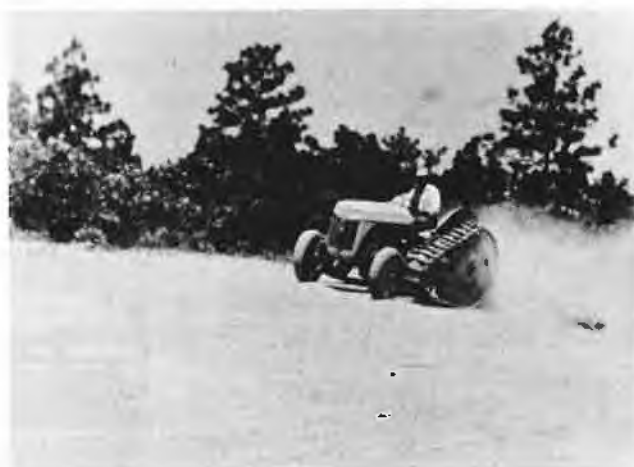
Figure 4. A board drag smoothed the sandy area before asphalt emulsion was applied.

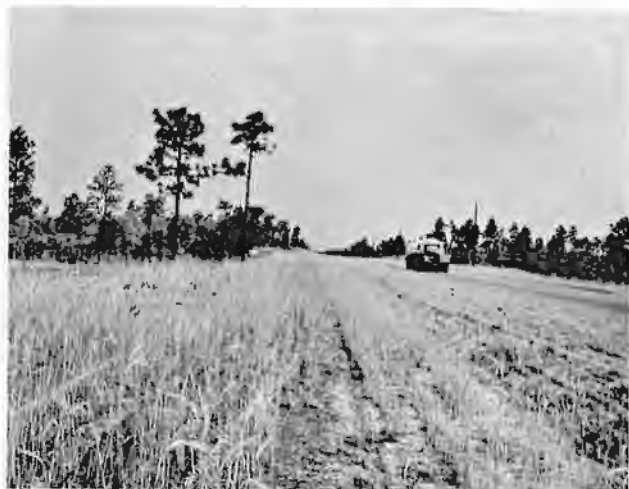
Figure 7. The rye cover obtained, following winter reseeding and remulching.

A weekly inspection of this work was made to observe results. Good germination was obtained on all areas, and it began to look as if a perfect cover was going to be obtained. During the second and third week after germination it was noticed that the rye on the cuts seeded by the hydraulic seeder was dying, while the rye seeded with the drill was doing fine. A study of this condition was made and it is believed that this was caused by the following conditions: Since these seeds were planted in sterile sand, the only plant food obtainable was the fertilizer applied at time of seeding. This fertilizer was dissolved when applied by the hydraulic seeder and spread evenly over the ground. When harrowed in, it was scattered even more. Any rain that fell carried it deeper into the ground, thereby reducing the amount

available for the plant roots. After germination and before the roots developed enough to collect this scattered plant food, it is believed that the plants starved. The cover on the areas seeded with a drill, where the seed and fertilizer were placed together in the ground, continued to grow well for eight weeks, at which time it started browning. These areas were topdressed with 6-8-6 fertilizer at 20 lb. per 100 sq. yd. The grass started growing again and has gone through the following seven months in good condition. As of October 18, 1954, all areas seeded with a drill have practically a 100 percent cover.

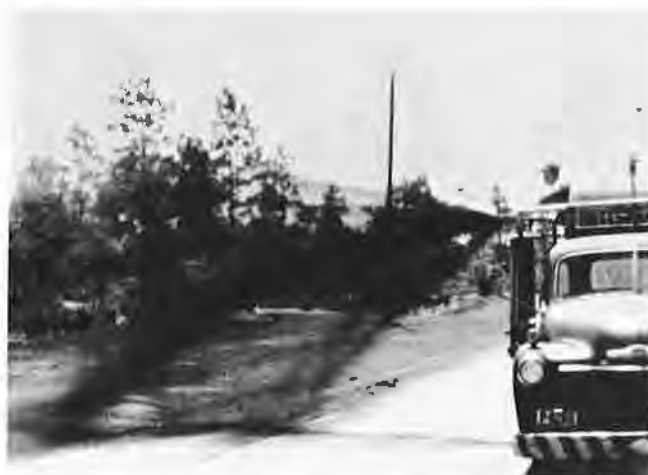
Figure 6. Asphalt emulsion is applied to areas nearer the highway.

Emulsified asphalt was obtained from the same source as during the summer, and the water was added at the plant. Mulching was started using a 50-50 mixture of water and AE-5 emulsion and applying 0.4 gal. of the mixture per sq. yd. It was found that this mixture was forming a crust, and so the mixture was cut to 25 percent asphalt emulsion and 75 percent water. The same rate of application of 0.4 gal. of mixture per sq. yd. was continued; the mixture penetrated 1 inch and did not crust. All seeded cut slopes were mulched, plus the areas of the unseeded cut slopes that look weak.
