STUDED TIRES VERSUS PAVEMENT MARKINGS

A Collision Course

JOHN M. DALE*

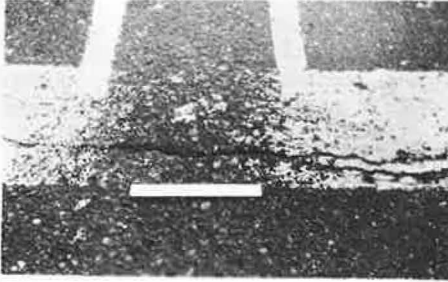
Figure 1. Wheel track area after 7,027 repetitive crossings of an automobile equipped with four studded tires (courtesy of the Minnesota Department of Highways).

section of Interstate highway with a test car equipped with studded tires on all four wheels. Figure 1 shows the damage in the wheel track area to a transverse stripe of traffic marking paint after 7,027 repetitive crossings by the test car moving at a constant speed of 50 mph. Since this was not a test of traffic marking materials, no controls were applied. Thus, it is impossible to estimate what amount of this wear is attributable to the studs and what amount of it might have occurred under regular tires. On the other hand, to have experienced this

amount of damage after only 7,027 repetitions is significant in that there are many miles of pavements in the country that have average daily traffic densities per vehicle lane that are much in excess of this. Prior to the advent of the studded tire, the average useful life of traffic marking paint in longitudinal markings has been determined to be as shown in Figure 2.

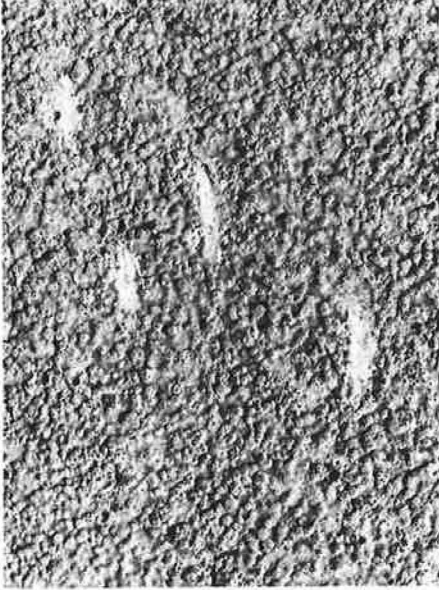
Figure 4. Closeup of tire stud gouge marks in a beaded paint line.

found that for a free-rolling tire, i.e., one that was neither accelerating nor decelerating, the stud action was primarily down and the bead damage was of two general types. If the substrate was soft, the beads were pushed in and buried. If the substrate was hard, the beads were crushed. If the tires were accelerated, gouge marks were obtained. Five mildly accelerated starts with one studded tire produced the gouge marks shown in Figure 3. Figure 4 shows a closeup of the stripe and the character of the gouge marks.
