Variations in Performance of Concrete with Carbonate Aggregates in Iowa

THEODORE L. WELP and CLARENCE E. DE YOUNG

Materials Department, Iowa State Highway Commission, Ames

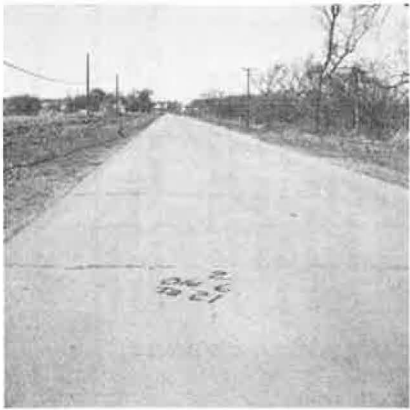
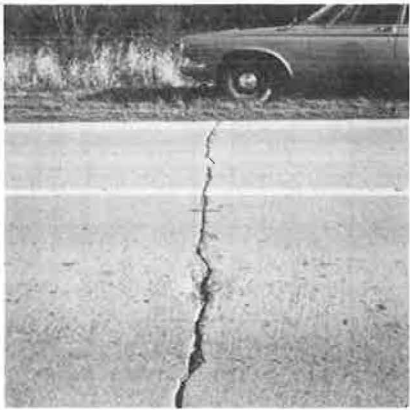
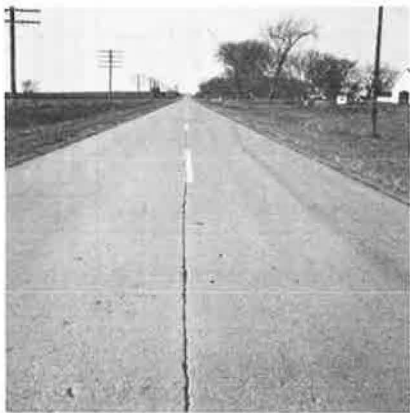
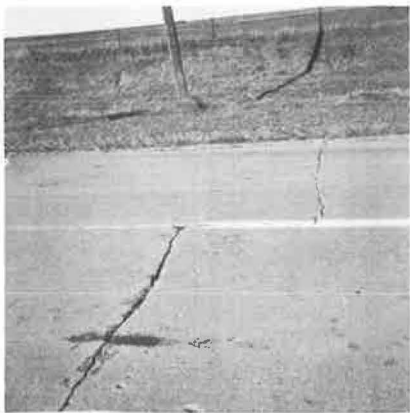
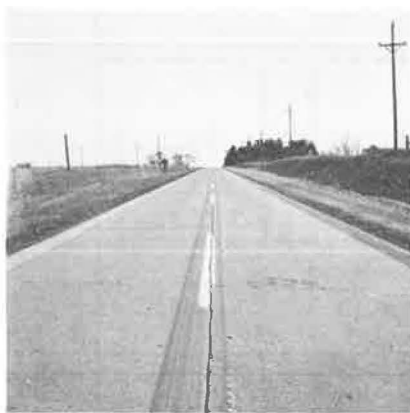
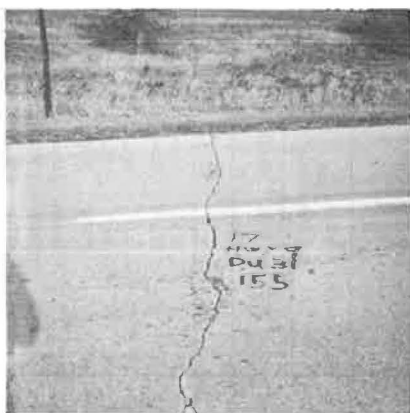
Figure 1. Concrete pavements with satisfactory service: (a) project 52-7, 42 years old, Iowa City stone; (b) project 52-5, 36 years old, Davenport stone; and (c) project 3-4, 32 years old, Dubuque stone.

Figure 1 shows the general condition of pavements ranging from 33 to 42 years old containing satisfactory aggregates. For pavements constructed before 1929 with no transverse joints, the transverse crack spacing varies from about 20 ft to more than 100 ft. The concrete is in excellent condition with no evidence of progressive deteri-

oration. Some patching has been necessary where slabs are broken. The area of old concrete adjacent to patches 17 years old is in excellent condition.

Aggregate from this geologic source has been used in pavement with satisfactory results since 1921. Figure 1a shows a typical pavement constructed in 1921.

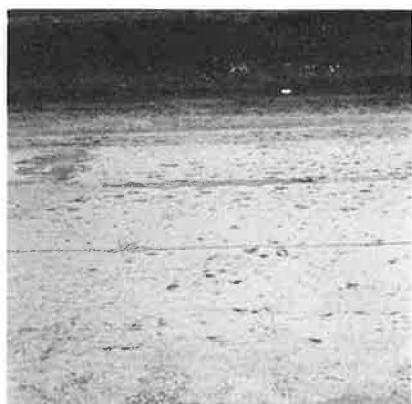
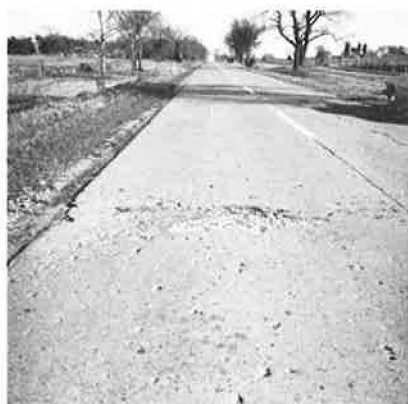
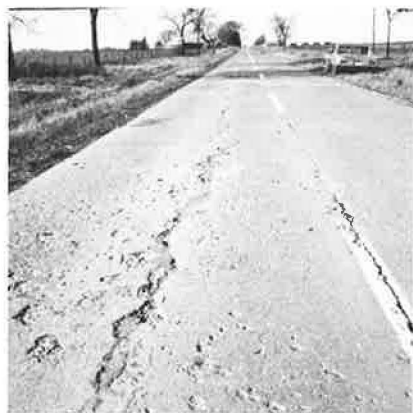
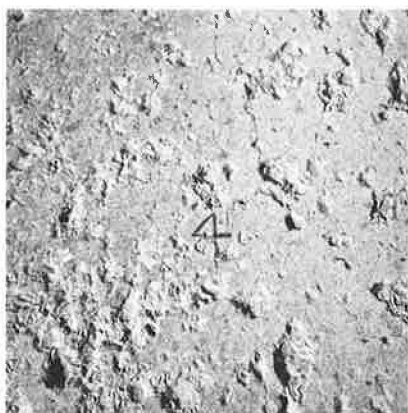
Figure 2. Typical condition of concrete containing aggregate from the Rapid member; (d) is close-up of area shown in (c).

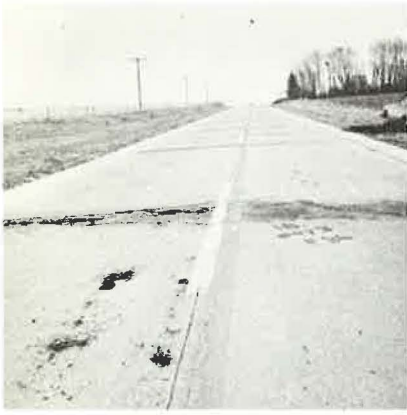
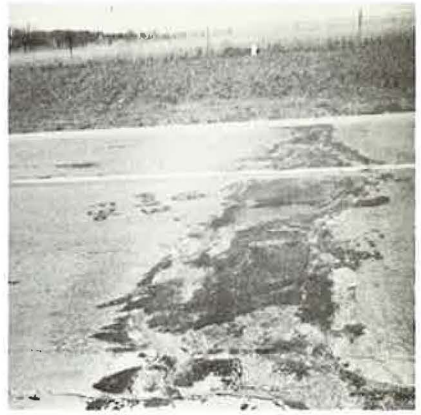
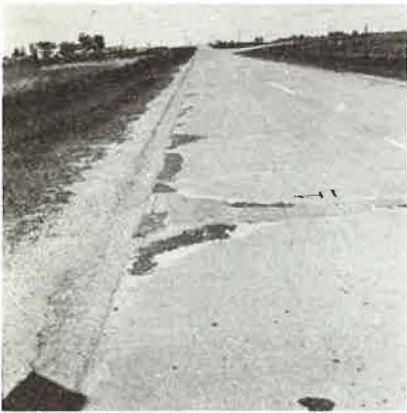
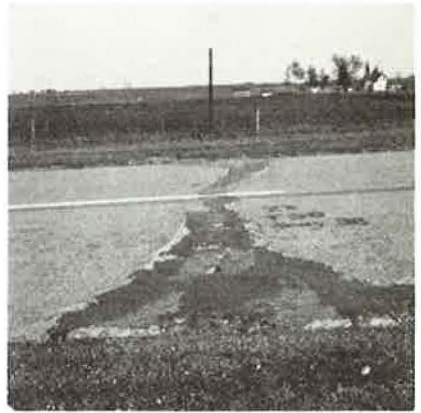
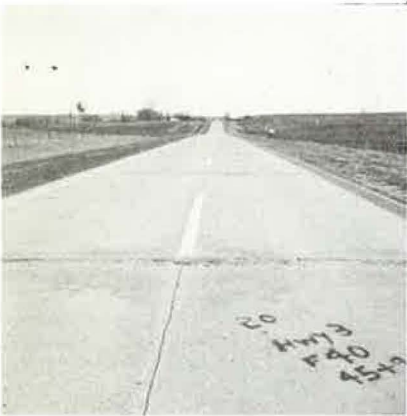
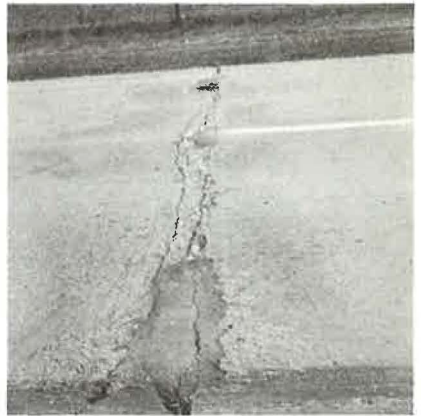
Figure 3. Typical condition of concretes of various ages containing Fayette stone: (a) project 28-10, 27 years old; (b) project 28-11, 24 years old; and (c) project 28-14, 23 years old.

The general pattern of deterioration, at whatever age it begins, is similar for aggregates meeting and for those failing to meet specifications. Significant variations are noted in the age at which deterioration is first observed, the rate at which it progresses, and the area of slab affected. Deterioration in all cases is progressive. The first noticeable sign is a general discoloration in the vicinity of the joints and cracks, and sometimes along the edges of the slab. The border of the discolored area is generally slightly concave toward the long axis of the crack or joint (Fig. 3c, left).

Pavement, made with Fayette stone, remains in excellent condition without any signs of deterioration for at least 20 years. Sometime between 20 and 25 years of age deterioration begins and progresses very rapidly. Figure 3 shows the general condition in 1963 of highways ranging in age from 23 to 27 years. Table 3 shows that most of the 23-yr-old pavement has only a few patches, whereas the number of patches increases very rapidly for progressively older pavements. Several of the projects in Table 3 have been under observation since 1957. In 1957 the concrete on project 28-11 was in excellent condition. Photographs of this project taken in 1958 are shown in Figure 4. In 1960 this pavement appeared similar to that in Figure 3c with several patches per mile. By the fall of 1963 deterioration had progressed in the original concrete adjacent to the older patches and the number of patches per mile has greatly increased.

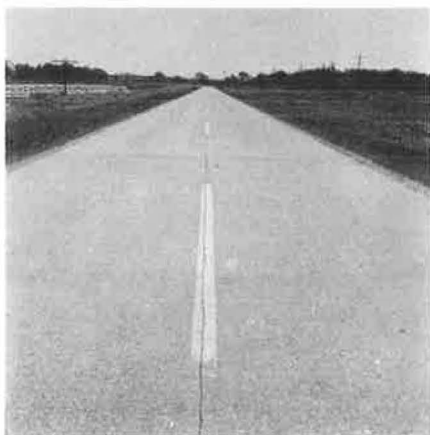
Figure 4. Project 28-11 in 1958, 20 years old. Compare with Figure 3b (left).

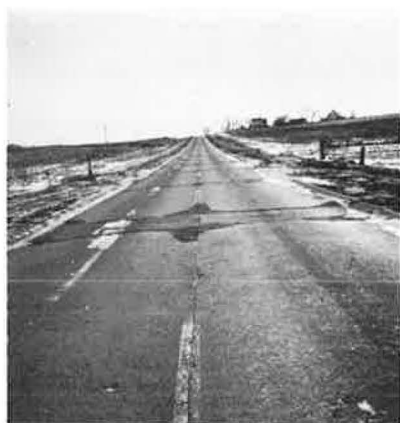
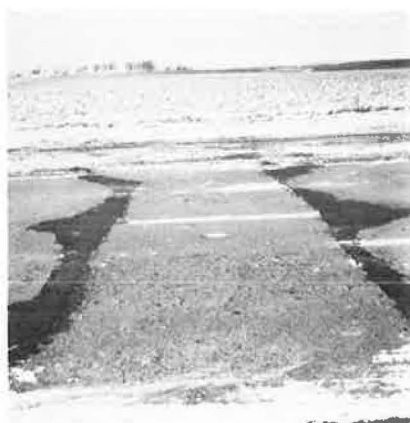
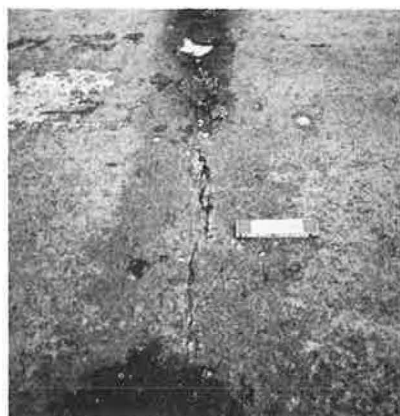
Figure 5. Typical condition of concrete containing LeGrand stone, project 85-11.

The LeGrand aggregate was the first aggregate meeting test limits to be associated with early concrete deterioration. The rock was used extensively from the late 1920's to the late 1930's. Deterioration of the concrete did not appear as early as with Glory aggregate. Generally, deterioration was first noted when the pavements were about 10 years old and became severe when the concrete was between 15 and 20 years of age. The general pattern of deterioration (Fig. 5) is much the same as that seen on pavements containing Glory aggregate. Photographs (Fig. 5) were taken in 1963 of 25-yr-old pavement that has more than 500 patches in five miles.

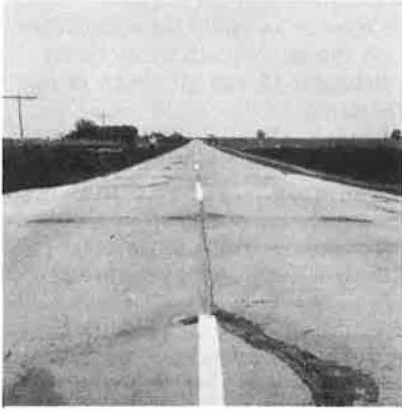
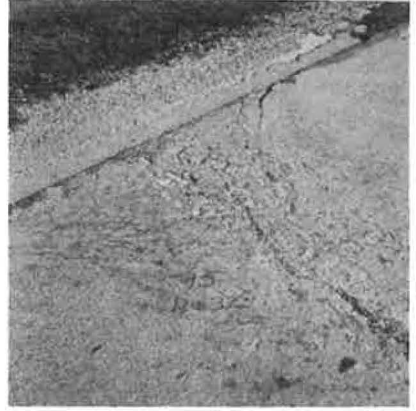
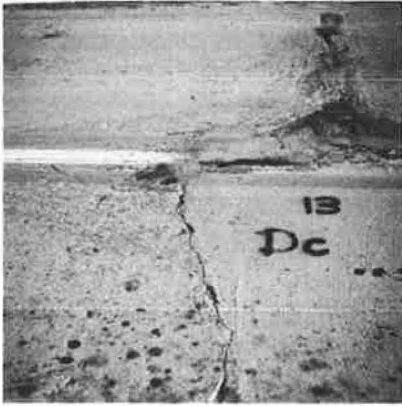
Figure 6. Typical condition of concrete containing Decorah stone, project 96-18.

The deteriorated area is deepened by progressive scaling (Fig. 6d). The concrete in these areas is easily disintegrated by a light hammer blow. The matrix is generally chalky, and cavity walls may be coated with a white powder. This material has been identified by Lemish (1) to be predominantly calcium carbonate. During the early stages of deterioration, the central portion of the slab (Fig. 3) between cracks or joints shows no indication of distress. In extreme cases the entire slab may be affected (Fig. 2). In the final stage the concrete deteriorates to a condition resembling loosely compacted gravel. Any one pavement will generally show all degrees of deterioration. Variations in the severity of deterioration are greater in a horizontal direction away from joints and cracks than from top to bottom in the vicinity of joints or cracks.

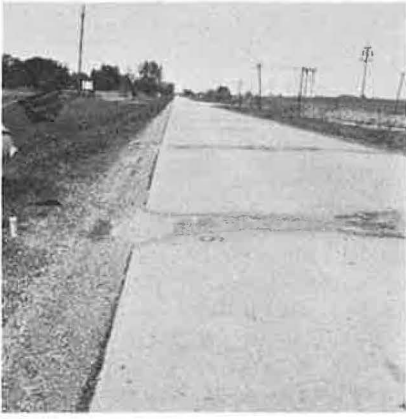
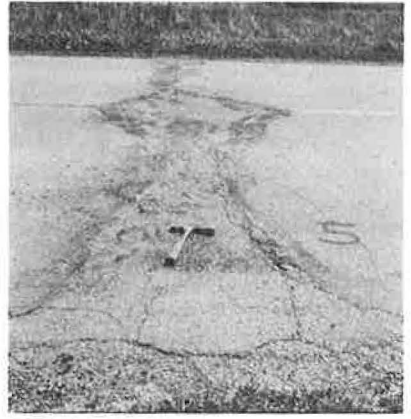
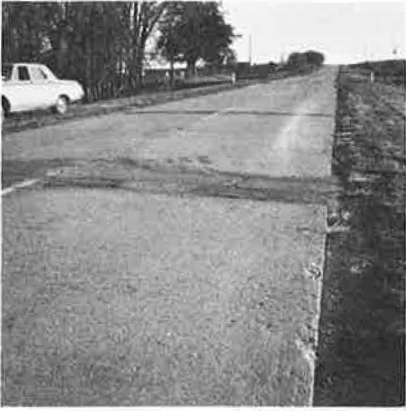
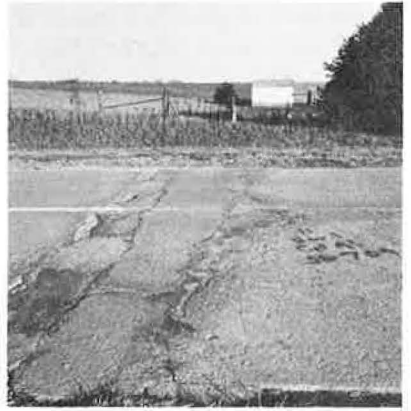
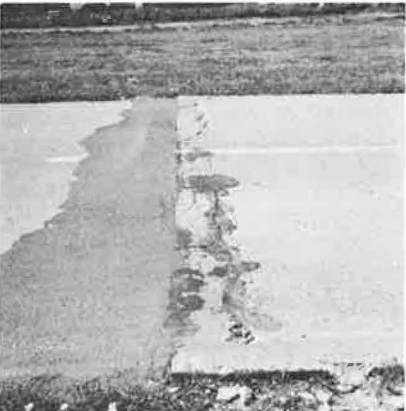
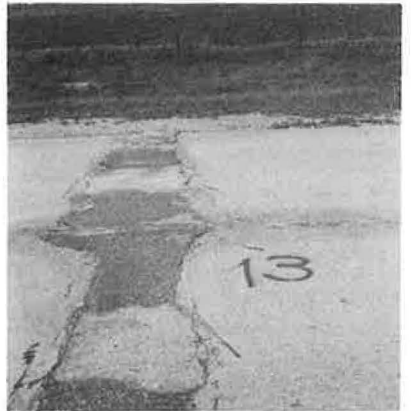
Figure 7. Typical condition of concrete of various ages containing Otis stone: (a) project 53-11, 25 years old; (b) project 52-25, 22 years old; and (c) project 57-38, 18 years old.

Blow-ups or eruptions of the concrete similar to that illustrated in Figure 7c (left) have been observed on pavements containing both satisfactory and unsatisfactory aggregates. These eruptions may be caused by any number of factors and may or may not be related to the properties of the coarse aggregate. Once an area has been patched it is difficult to determine the reason for the failure.

Deterioration was first noticed in 1958 on pavements ranging from 14 to 20 years of age. In 1957 and 1958 the condition of most Otis pavement was similar to that tabulated for project 28-17 (Table 3). Joints showed evidence of spalling near the quarter point and one to two joints per mile had been patched. Some discoloration was noted but no "D" cracks were seen. During the next few years periodic observations were made of many sections of Otis pavement ranging from 5 to 23 years of age. Deterioration of varying severity was noted in all pavements exceeding 14 years of age. In general, deterioration was more severe on pavements more than 16 years of age. Photographs taken in 1963 of several pavements containing this aggregate are shown in Fig-

ure 7. These pictures show the typical but variable pattern of increasing deterioration and patching with increasing age beyond 15 years. Some failures (Fig. 7c, left) were noticed where there appears to be displacement of the concrete.
