Some Effects of Fabrication Practices on Strength Characteristics of Reinforced Concrete Culvert Pipe

ROBERT C. DEEN and J. H. HAVENS

Respectively, Assistant Director of Research and Director of Research,
Kentucky Department of Highways, Lexington

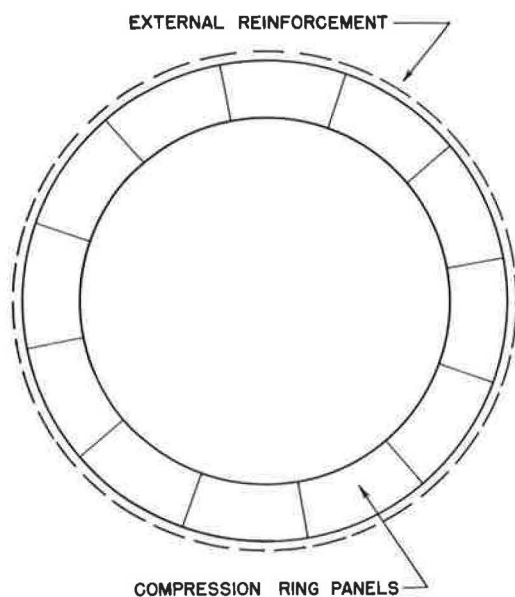
Figure 1. Pipe consisting of compression panels and external reinforcement.

The reinforcement steel in a concrete pipe is more or less inactive or passive so long as the pipe is subjected to a uniform radial loading. In this case, the annular shell of the pipe is uniformly in compression. Any unbalance in imposed loads produces tensile stresses in the outer portion of the concrete, and inasmuch as the concrete is inherently weak in tension but strong in compression, the function of the reinforcement is to provide a tensile reactance to the compression borne by the concrete. Thus a pipe could be fabricated from individual concrete panels with external steel bands in much the same manner as wood-stave barrels (Fig. 1). It follows then that one or more damaged panels could be replaced and thereby restore the continuity of bearing and compression in the shell.

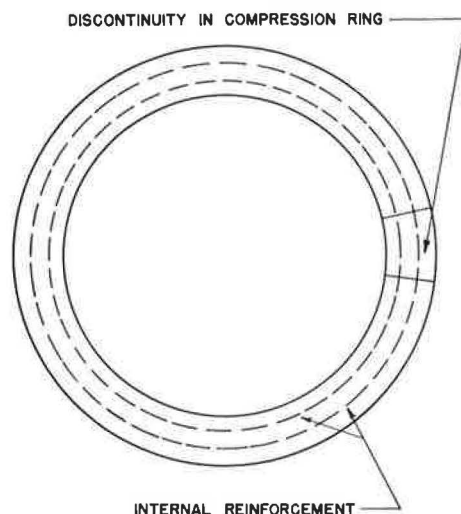
Figure 2. Concrete pipe with discontinuity in compression ring.

However, if the shell were cast monolithically about the steel and were then fractured to such an extent that continuity of compressive bearing in the concrete was lost (Fig. 2), it follows that routing of the damaged concrete and replacement with new concrete, even though a high degree of bond was not achieved, should restore the pipe virtually to its original strength (Fig. 3). This idea assumes, of

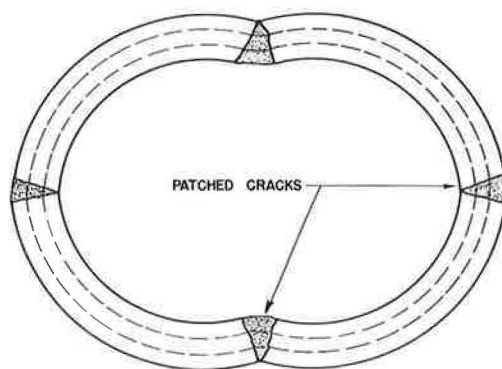
Figure 3. Pipe with compression ring patched and restored.

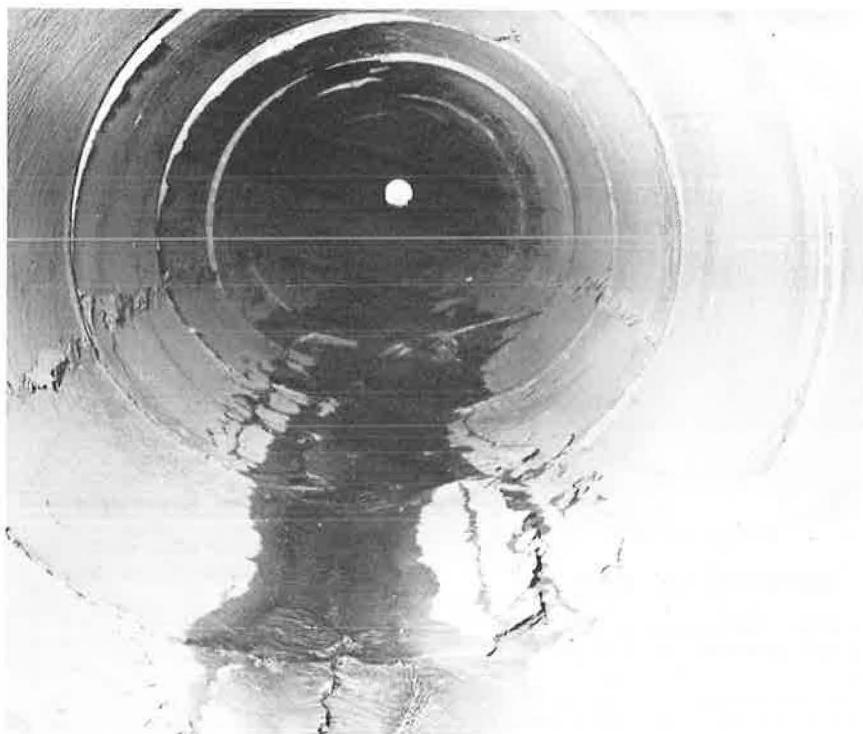
Figure 4. Failure in bottom of 54-in. culvert under a 53-ft fill; Station 1087+50, I-75-7(5)160, Grant County.

Many of the pipe found to be damaged in-place have been deformed considerably—otherwise the concrete shell would have remained intact (Figs. 4 and 5). Rejecting any thought toward jacking in-place pipe back to roundness, the problem at hand involves the degree of collapse to which remedial treatment might be deemed feasible. For instance, if the pipe is elongated horizontally and if the continuity of the shell is restored, the pipe could never be quite as strong as the original round pipe. If the interior of the pipe is also lined to provide an additional compression ring (preferably reinforced), it should be possible to strengthen the pipe to a degree equal to or greater than its original value (Fig. 6).

Soon after the ultimate load was reached, the concrete at the top and (or) bottom began to shear (Figs. 4, 5 and 20). There was a slight decrease in the load at this point

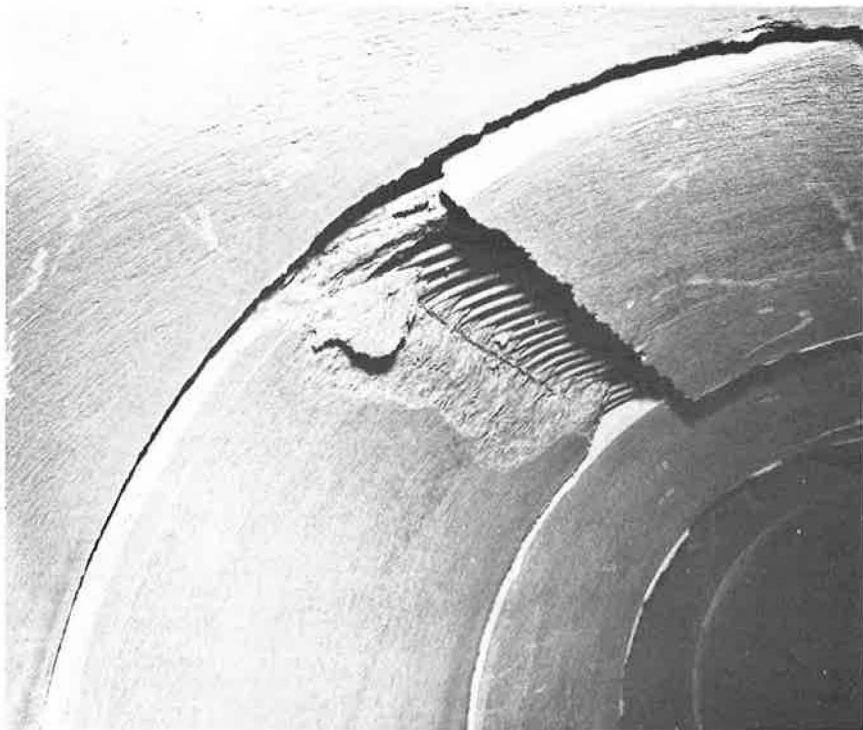
Figure 5. Failure in top of 54-in. culvert under a 53-ft fill; Station 1087+50, I-75-7(5)160, Grant County.

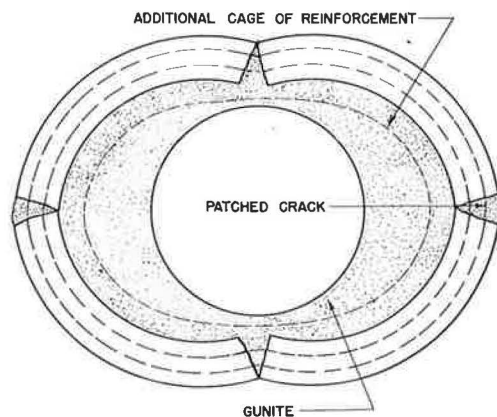
Figure 6. Repaired pipe with reinforced, gunite liner.

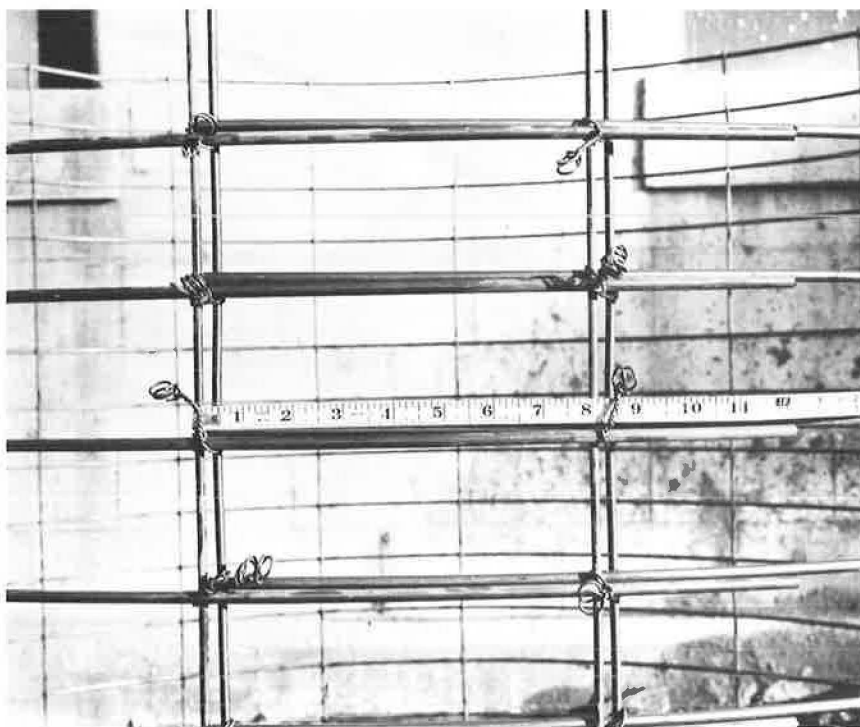
Figure 7. Joint of inner cages of reinforcement used in Series A and B.

1. The 0.01-in. crack strength and the ultimate strength are not significantly affected by the three methods used to fabricate joints in the reinforcing cages. Data indicate that there is very little difference in the overall performance of pipe prepared with: (a) lapped-and-tied joints (Fig. 7), (b) double-welded joints (Fig. 8), and (c) single-welded joints (Fig. 9).

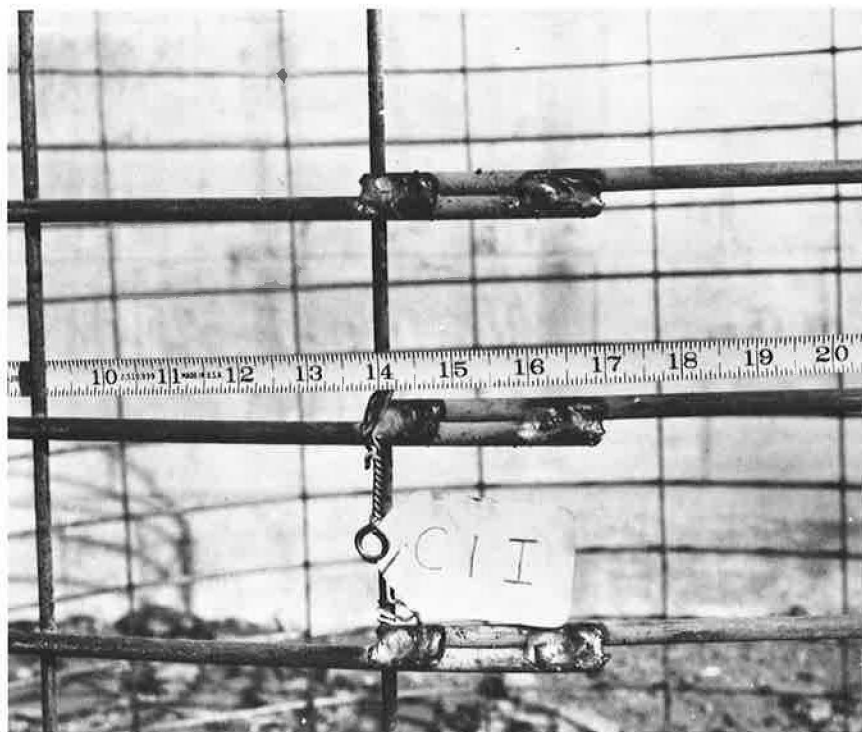
Figure 8. Joint of inner cages of reinforcement used in Series C, D and F.

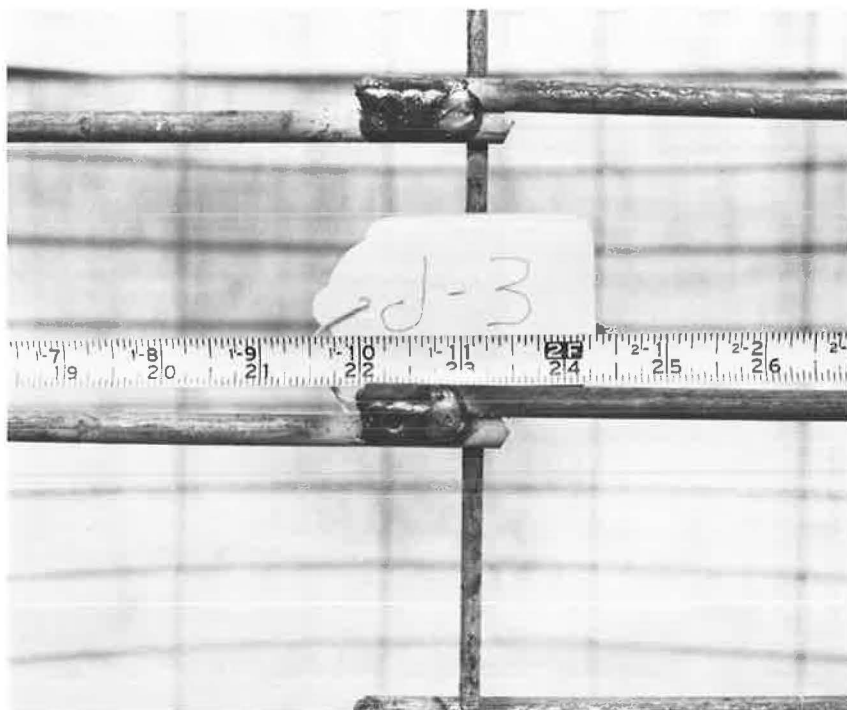
Figure 9. Joint of reinforced cages used in Series G, H and J.

Series G—Three sections, inner and outer cages lapped approximately $1\frac{1}{2}$ in. and fastened with one spot weld (Fig. 9), welds spaced 180 deg apart.

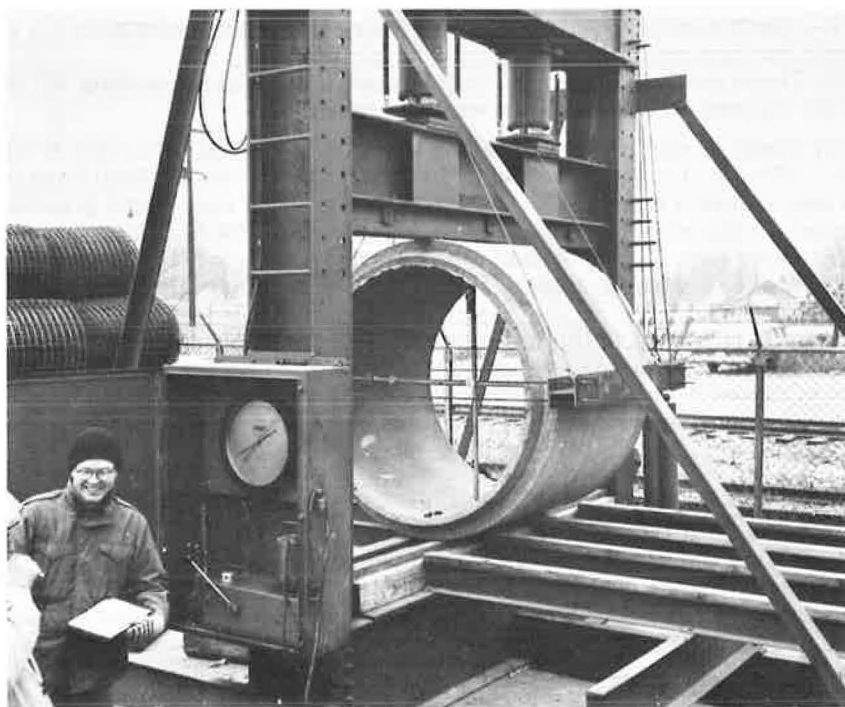
Figure 10 shows a yoke assembly which was used to restrain selected sections of pipe along their horizontal diameters during the three-edge bearing test. The four different sizes of tie rods used in this portion of the study were (a) uniform diameter of $\frac{3}{4}$ in.; (b) uniform diameter of $\frac{3}{8}$ in.; (c) a $\frac{3}{4}$ -in. rod with a reduced section, 8.0 in. long × 0.30 in. in diameter, at the middle; and (d) a $\frac{3}{4}$ -in. rod with a reduced section, 2.6 in. long × 0.30 in. in diameter, at the middle. Selected pipe were tested in three-

Figure 10. Yoke assembly for providing lateral restraint.

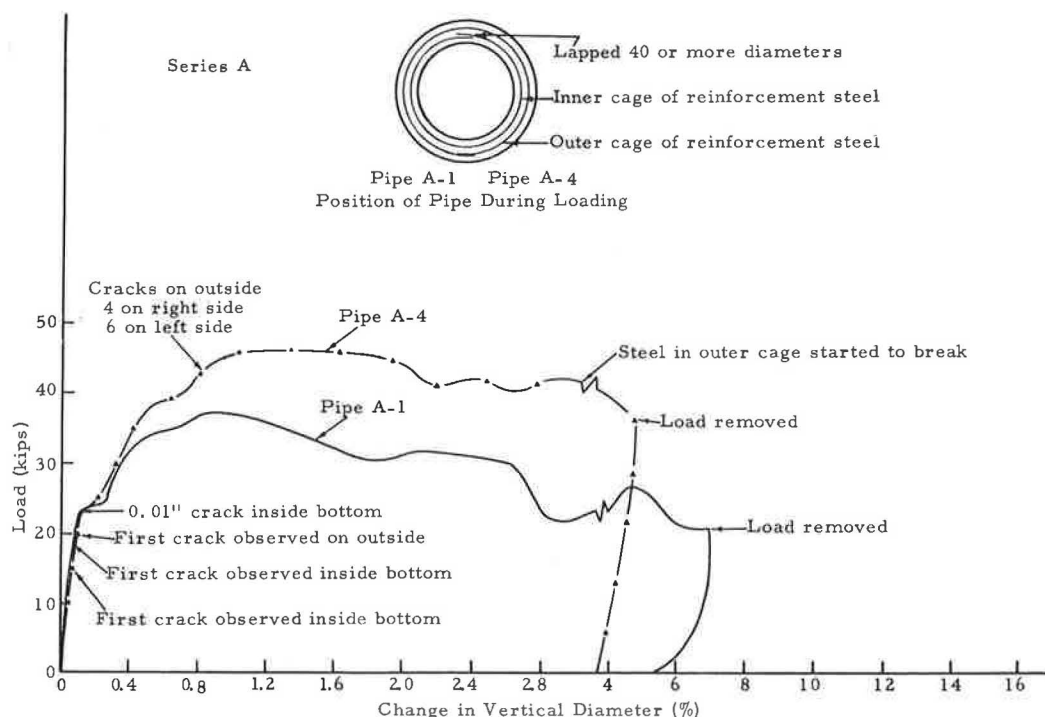
Figure 11. Load-deformation curves for Series A.

The load-deformation curves are essentially linear up to the occurrence of the 0.01-in. crack. There is a very slight tendency for the deformation to increase, with little attendant increase in load, when the first crack appears—at something less than 0.1 percent change in vertical diameter and a load of 13 to 18 kips. This tendency for the curve to flatten seems to be more pronounced after the 0.01-in. crack appeared—apparently, there was a slight redistribution of stress from concrete to steel. The 0.01-in. crack typically occurred at a strain of 0.1 to 0.2 percent and at a load of 18 to 25 kips. The slopes of the curves become flatter as the ultimate load (40 to 50 kips) is reached

at strains of 0.6 to 1.5 percent. The pipe in Series A and B (steel lapped 40 diameters and tied) appear to have reached the ultimate load at smaller deformations, 0.6 to 1.0 percent, and therefore gave steeper curves than pipe in which the steel was welded.

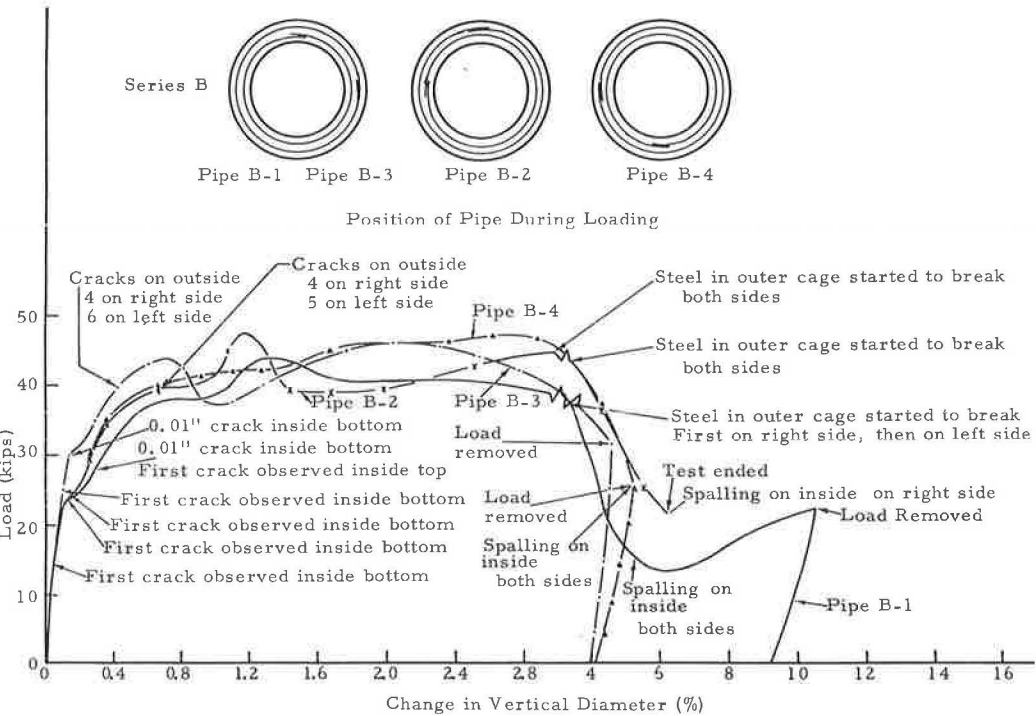
Figure 12. Load-deformation curves for Series B.

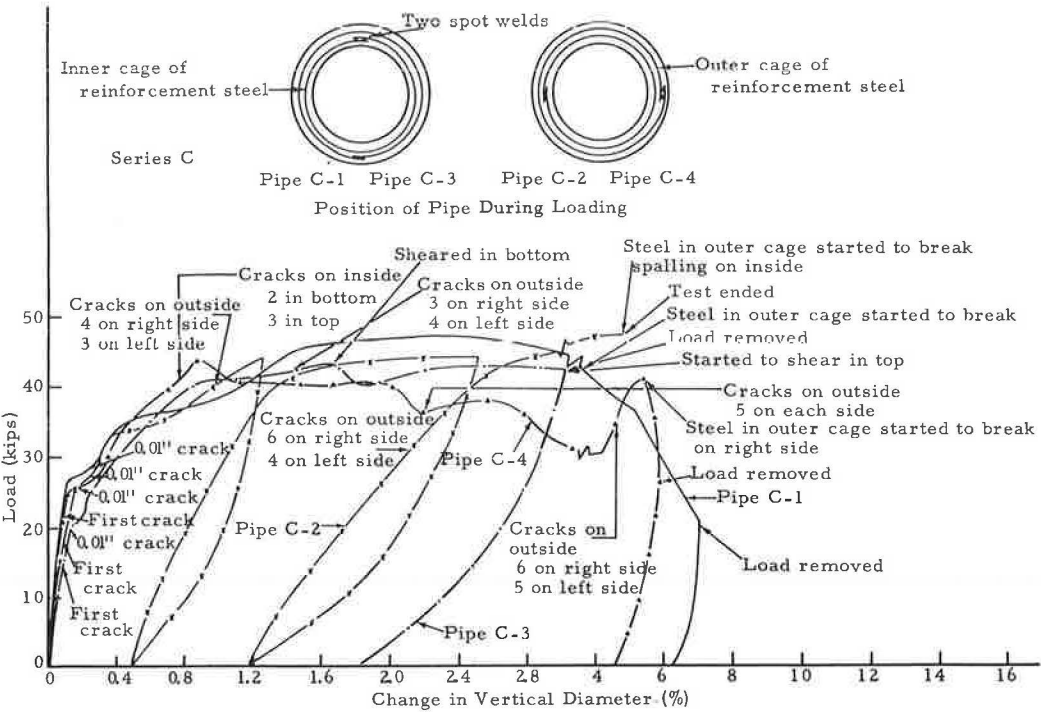
Figure 13. Load-deformation curves for Series C.

tests were given in Figures 13, 15 and 18—which indicate the extent of structural damage before repair was attempted. To effect the repair, a cage of reinforcement was placed in the damaged pipe and gunite was applied and permitted to cure. After repairs had been completed, the pipe were again loaded by the three-edge bearing method.

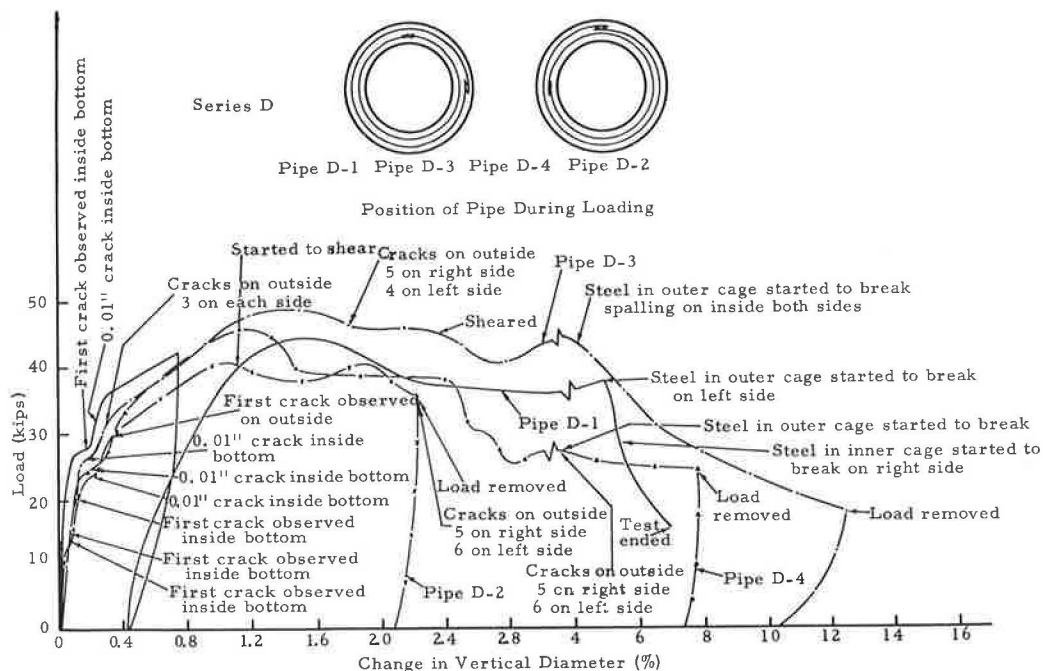
Figure 14. Load-deformation curves for Series D.

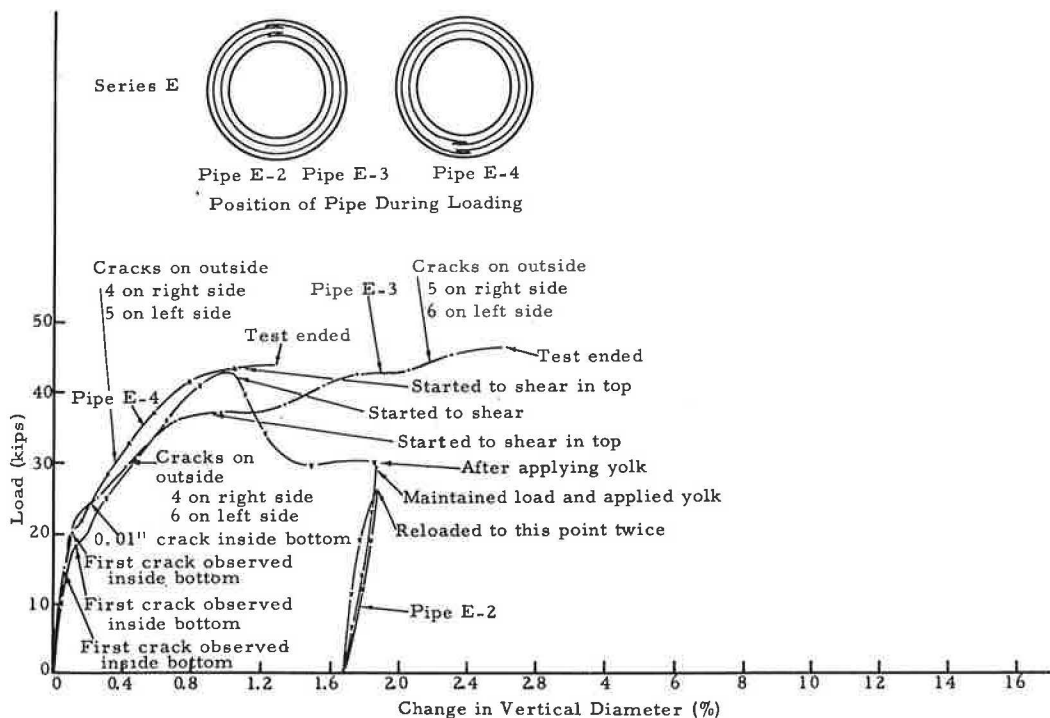
Figure 15. Load-deformation curves for Series E.

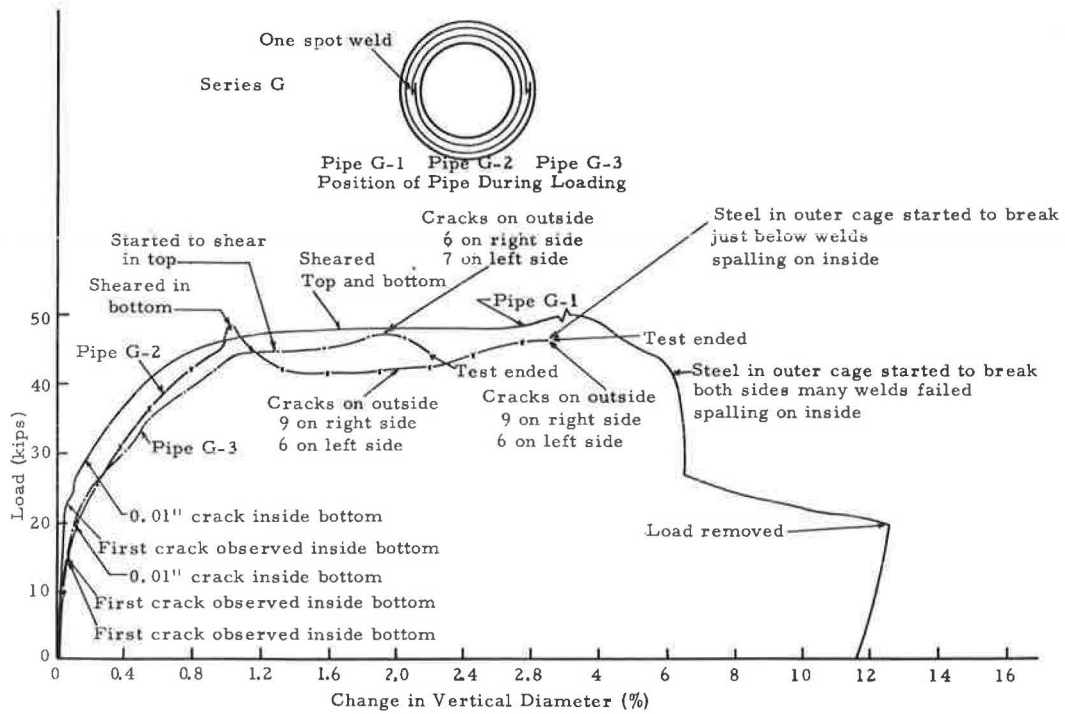
Figure 16. Load-deformation curves for Series G.

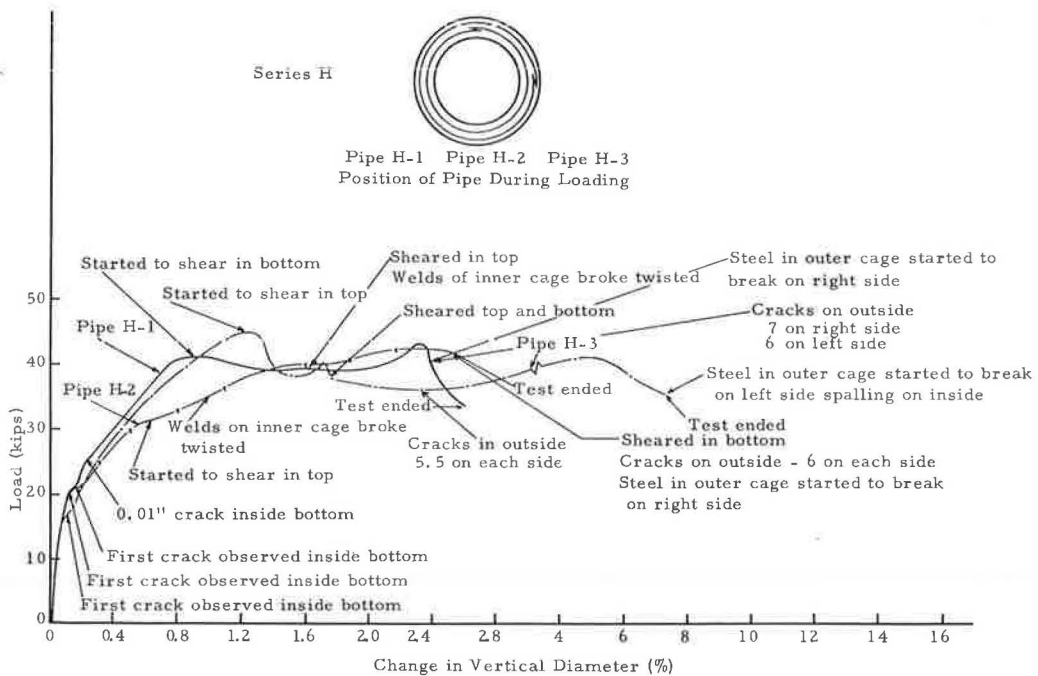
Figure 17. Load-deformation curves for Series H.

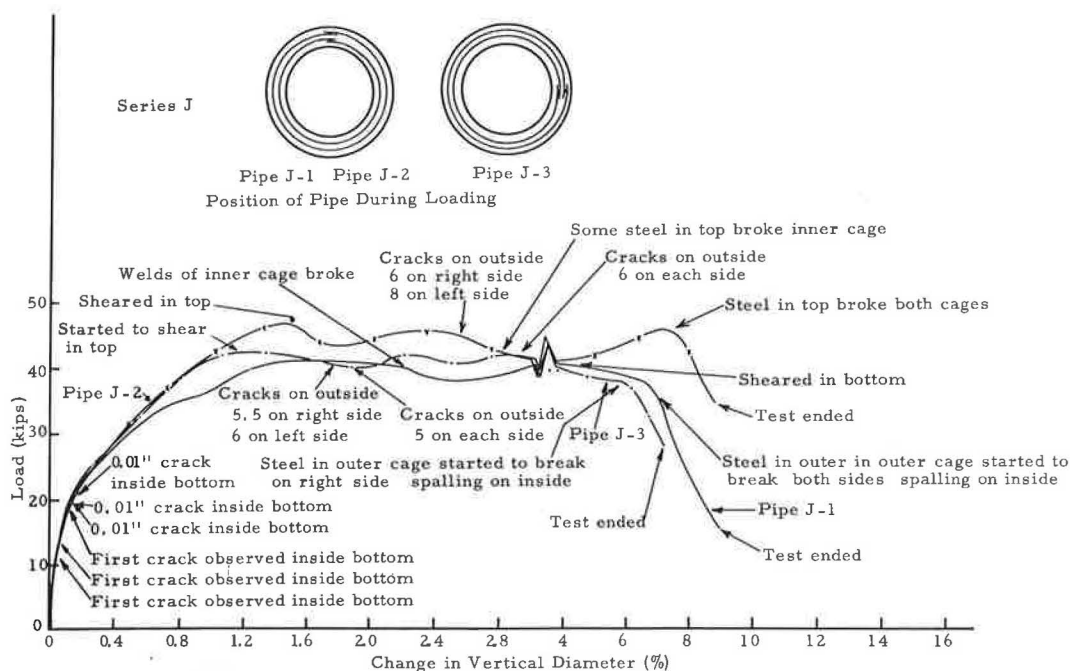
Figure 18. Load-deformation curves for Series J.

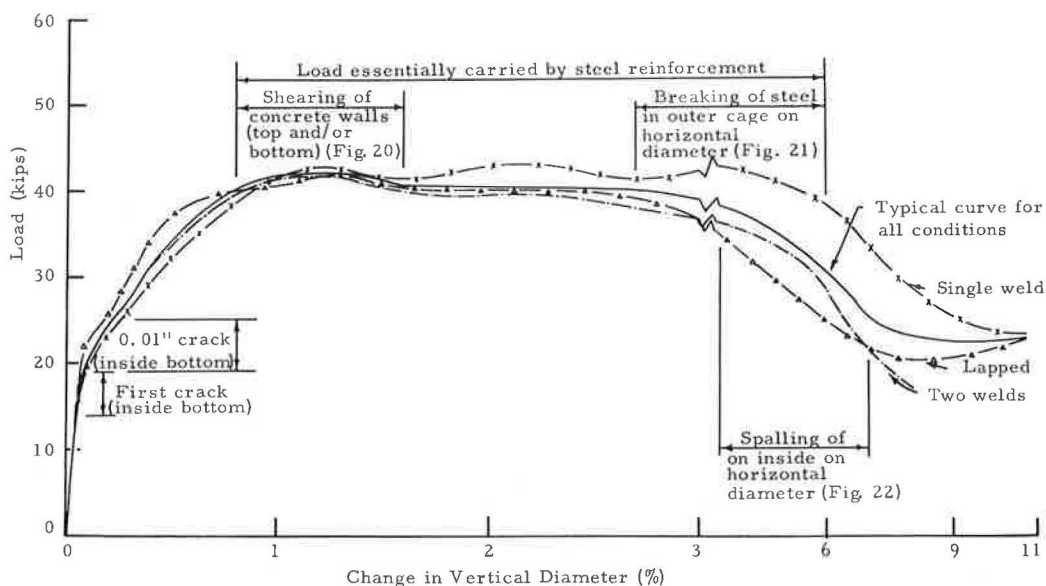
Figure 19. Typical load-deformation curves.

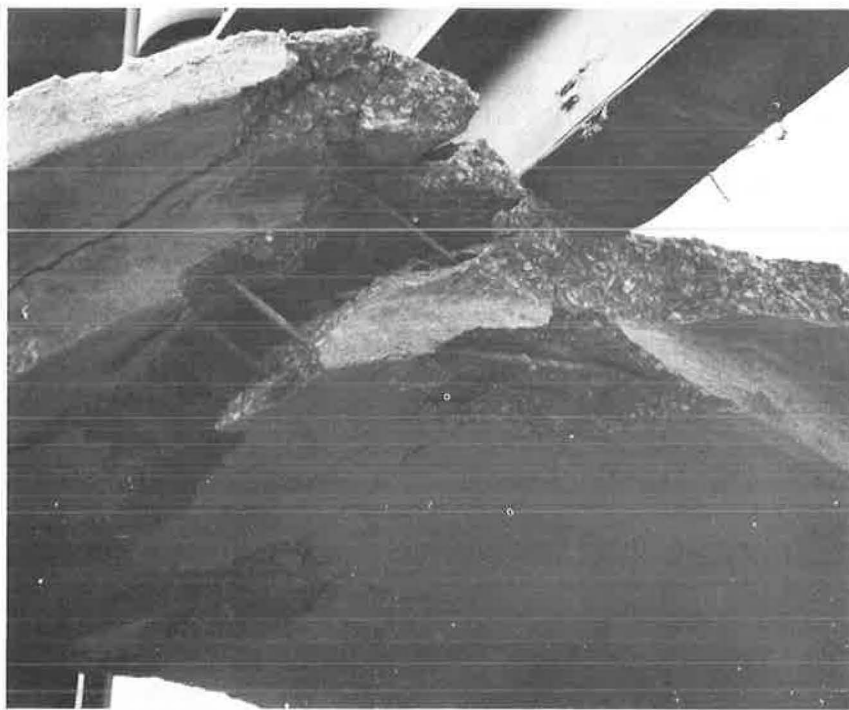
Figure 20. Shear-type failure in top of pipe.

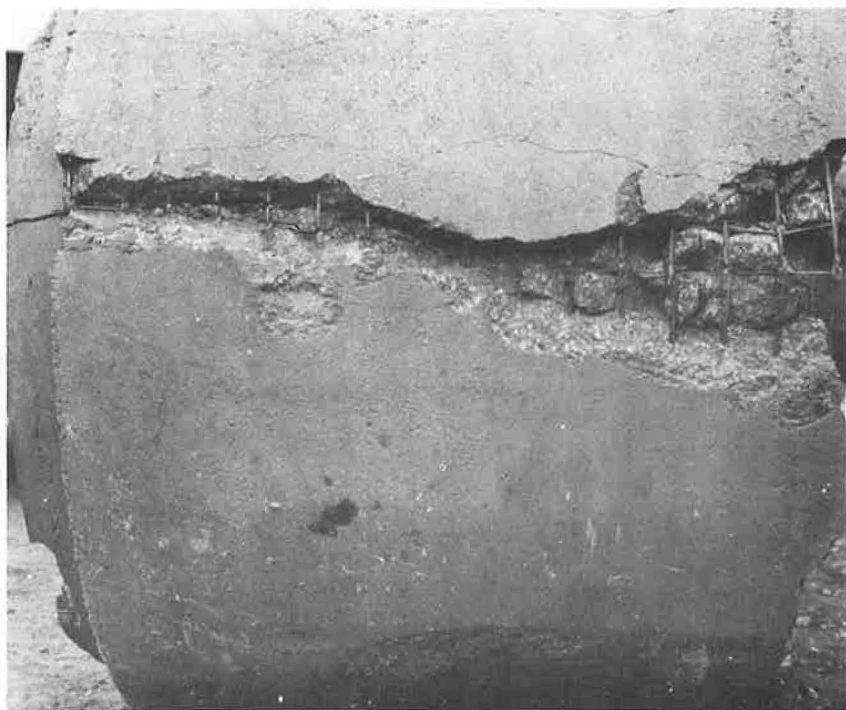
Figure 21. Broken steel in outer cage of reinforcement.

and thereafter the load remained rather constant to strains of 2.7 to 6 percent. At deformations of this magnitude the steel started to break in the outer cage about midway up the sidewalls (Fig. 21). Very soon after the steel began to fail, the load decreased rapidly as the stresses transferred to the inside portion of the wall and caused compressive failure of the concrete (Figs. 4 and 22). It may be noted from the load-deformation graphs that pipe not sufficiently loaded to break the steel recovered approximately 50 percent of the strain upon unloading, and that those in which the steel had been broken regained only about 15 percent of the strain.

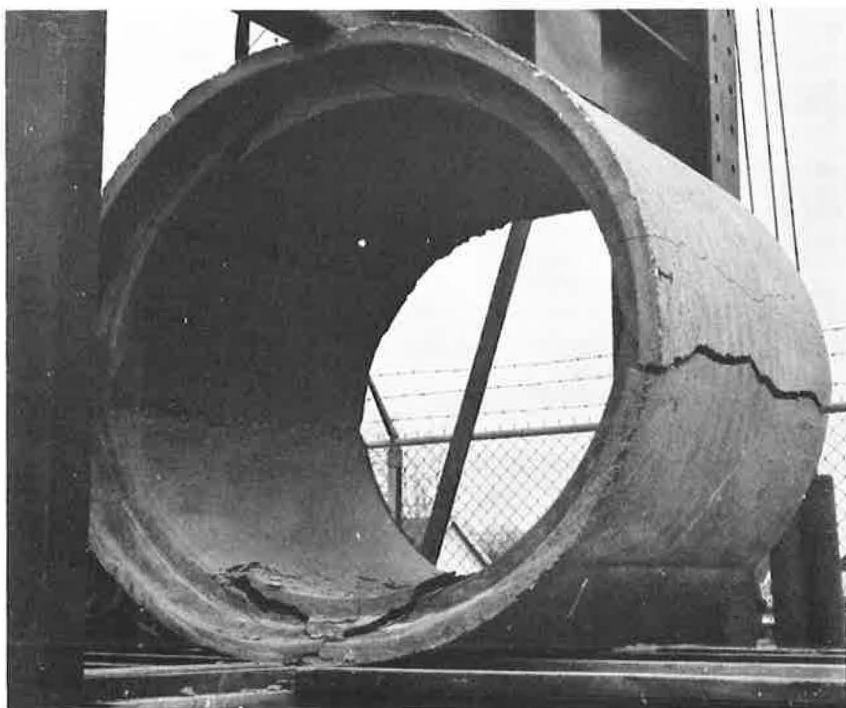
Figure 22. Compressive failure of inner portion of concrete wall.

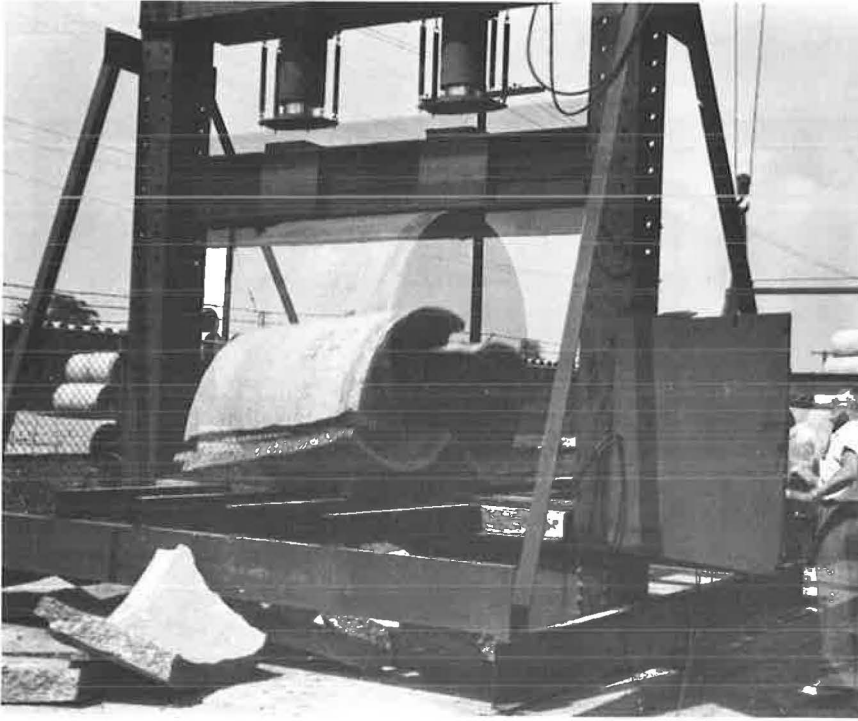
Figure 23. Non-reinforced concrete pipe under test.

Four pipe (Series F) fabricated with no reinforcing steel were broken in the three-edge bearing test (Fig. 23). The results of these tests are summarized in Table 2.

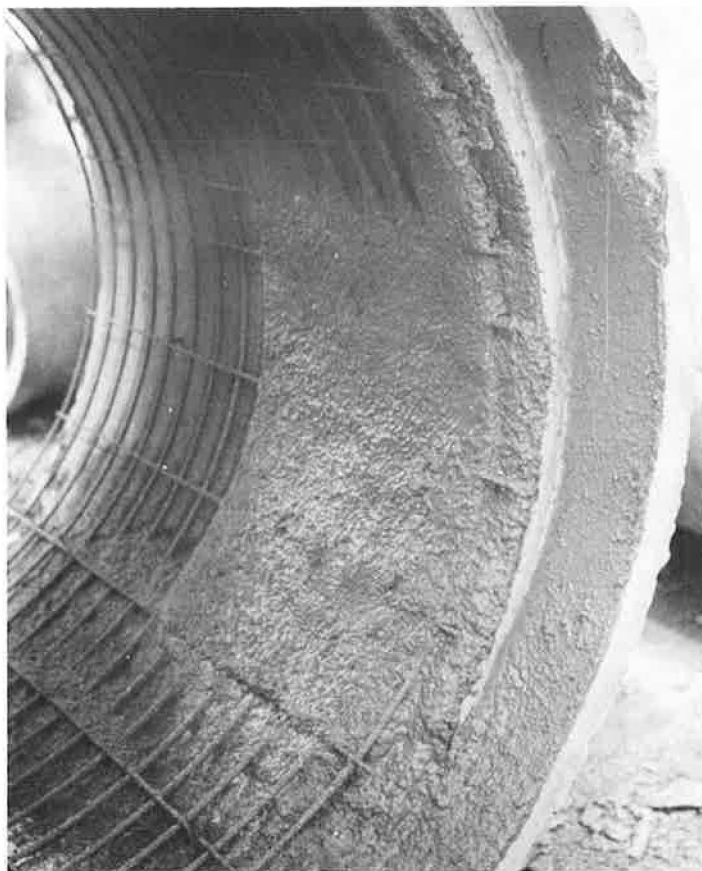
Figure 24. Close-up of gunite repair.

Repairs can be made either by threading a thin-walled steel pipe through the damaged pipe and pressure grouting the annular space with concrete, or by guniting a 2- to 3-in. lining on the inside of the damaged pipe, as shown in Figures 24, 25 and 29. This gunite lining should be reinforced, either by a wire mesh cage or a spirally wound continuous-bar cage. An economic study should be made to determine the proper choice between the liner pipe and the gunite methods of repair. Both are effective and will restore the pipeline to a serviceable condition.

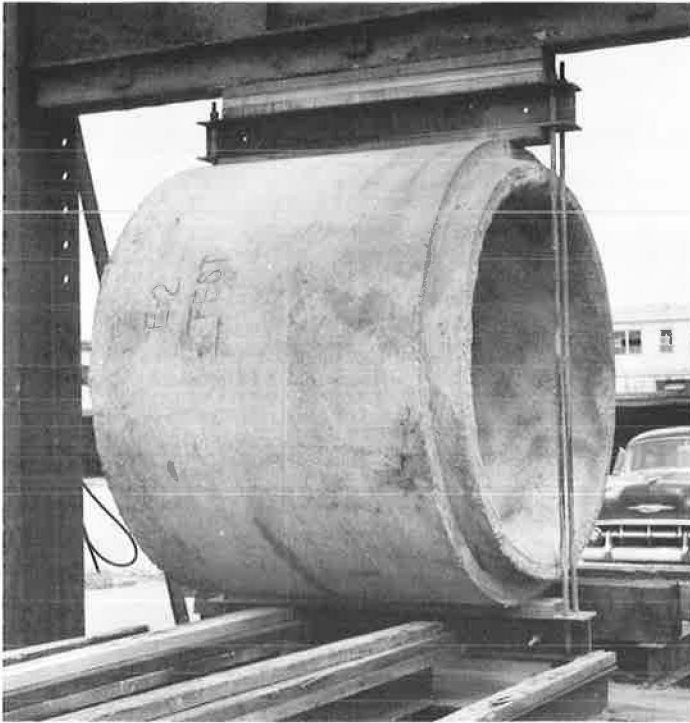
Figure 25. Repaired pipe E-2.

Special provision was made to prevent pipe E-2 from rebounding or recovering its circular shape after it had been loaded beyond its ultimate strength. At the conclusion of the initial loading test, the yoke assembly (Fig. 10) was placed on the pipe to hold it in its collapsed shape until it could be repaired and retested. Figure 25 shows pipe E-2 after it had been repaired and at the time of retesting.

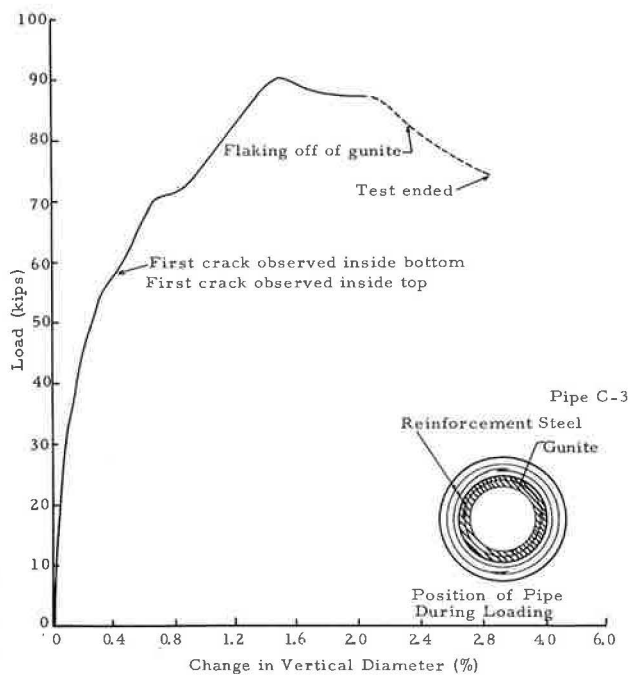
Figure 26. Load-deformation curve for repaired pipe C-3.

The load-deformation curves for the gunite-repaired pipe are shown in Figures 26 through 28. It is noted that this type of repair is more than adequate to restore structural integrity to the pipe. Table 3 summarizes some data obtained in this portion of the study. Figures 29 and 30 show a repaired pipe before and after the loading test.

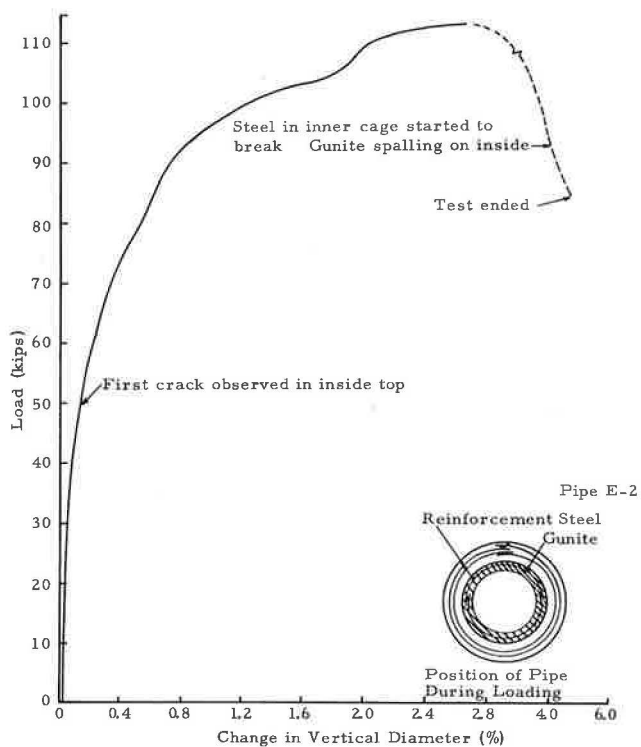
Figure 27. Load-deformation curve for repaired pipe E-2.

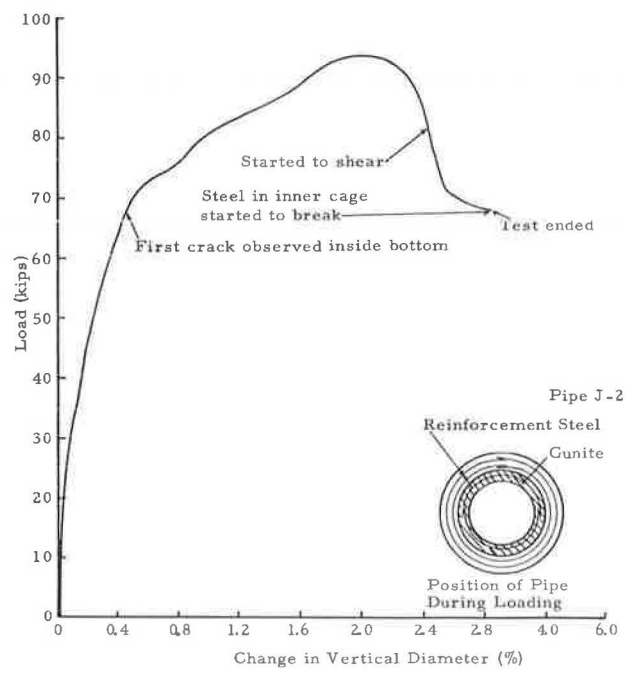
Figure 28. Load-deformation curve for repaired pipe J-2.

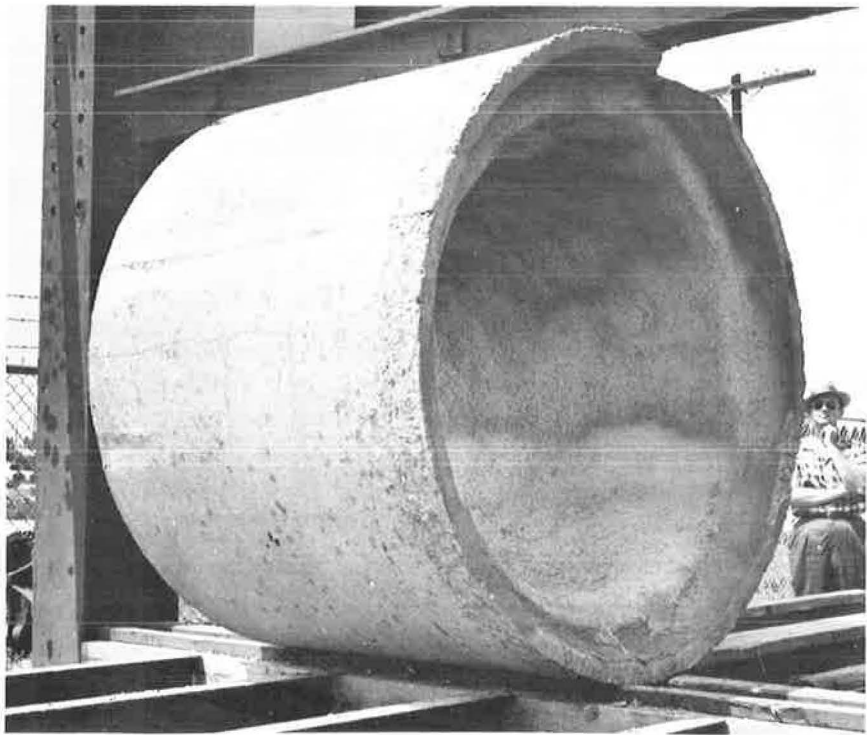
Figure 29. Repaired pipe before testing.

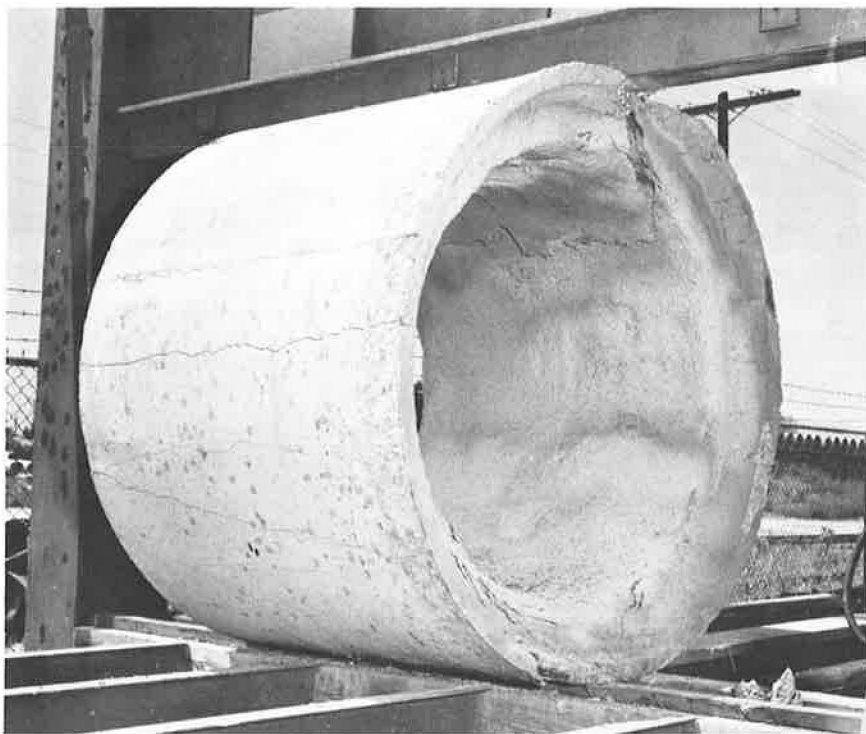
Figure 30. Repaired pipe after testing.

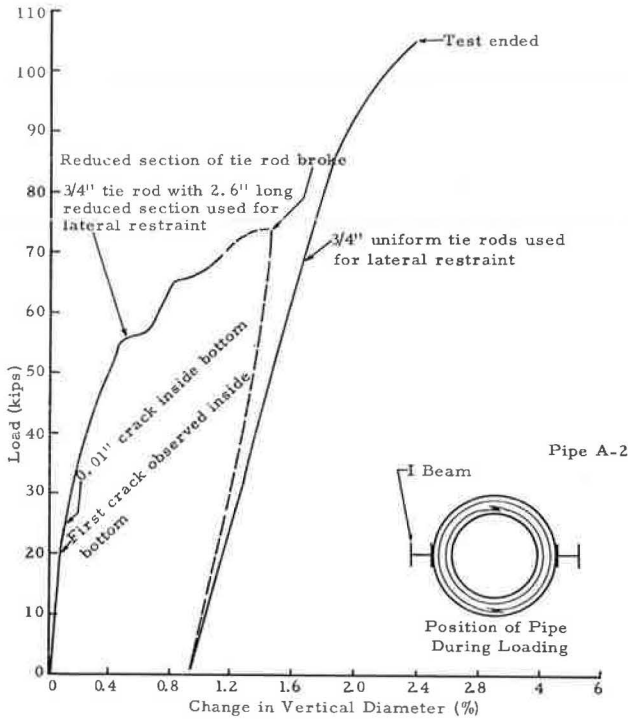
Figure 31. Test results for pipe A-2: (1) restrained by four 0.30-in. diameter, 2.6-in. long, reduced-section tie rods; loaded to failure of reduced section and then unloaded; and (2) restrained by four $\frac{3}{4}$ -in. uniform-diameter tie rods and loaded to ultimate. Both sets of tie rods elongated (yielded); elongation was concentrated in reduced section in first test condition; uniform rods elongated uniformly throughout their full length.

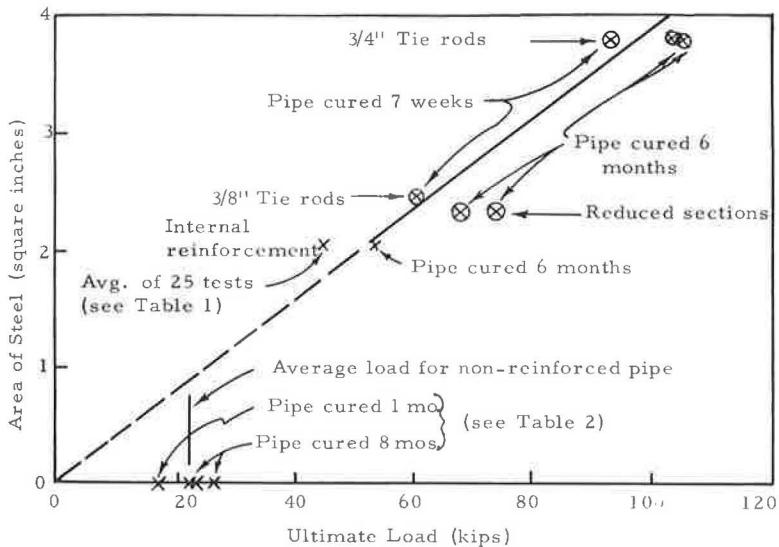
Figure 34. Relationship between ultimate load and total area of steel (internal reinforcement plus external tie rods).

The ultimate load data summarized in Table 4, as well as those contained in Tables 1 and 2, are presented in graphical form in Figure 34. The sums of the areas of steel in the internal reinforcement and in yoke-assembly tie rods have been plotted as a function of the ultimate loads obtained in the bearing tests. A similarity is noted here in the linear relationships apparent in these data and in those presented by the American Concrete Pipe Association (5); that is, the additional area of steel contained in the yoke-assembly tie rods increases the load-carrying capacity of the pipe in much the same manner as if this steel had been included in the internal reinforcement. Also, the ulti-

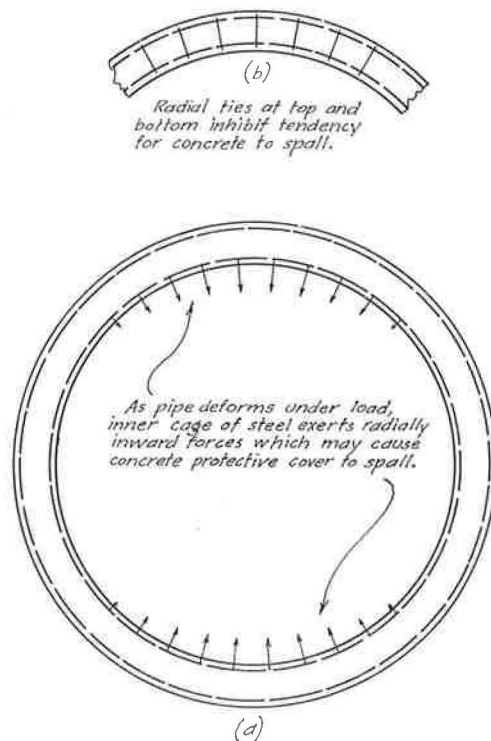
Figure 35.

This spalling action can be prevented or greatly inhibited by incorporating radial ties in the pipe wall at the top and bottom during manufacture as shown in Figure 35b. The function of these ties is to hold the inner cage of steel in position and prevent its displacement toward the center of the pipe, thus eliminating the tendency for radial stress damage to the concrete cover.

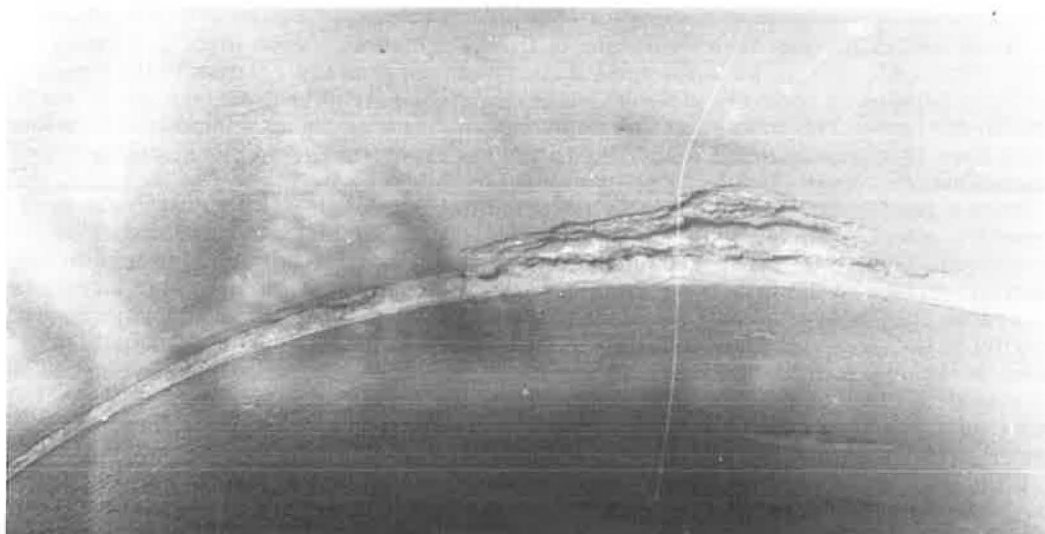
Figure 36. Incipient spalling stage II damage. End view of circumferential crack in protective cover over reinforcement.

A preliminary or incipient phase of spalling is the development of rupture of the protective cover of concrete along a circumferential surface at the inner cage of reinforcement. This rupture surface may not be visible from the inside of the pipe, but can be identified by tapping lightly on the pipe wall with a ball peen hammer. Areas thus affected will yield a hollow sound under the hammer. A circumferential rupture surface at the end of a pipe is shown in Figure 36.

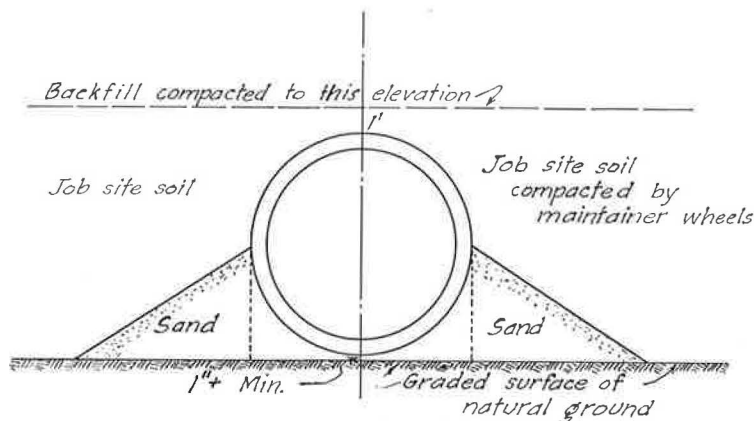
Figure 37. Pipe bedding.

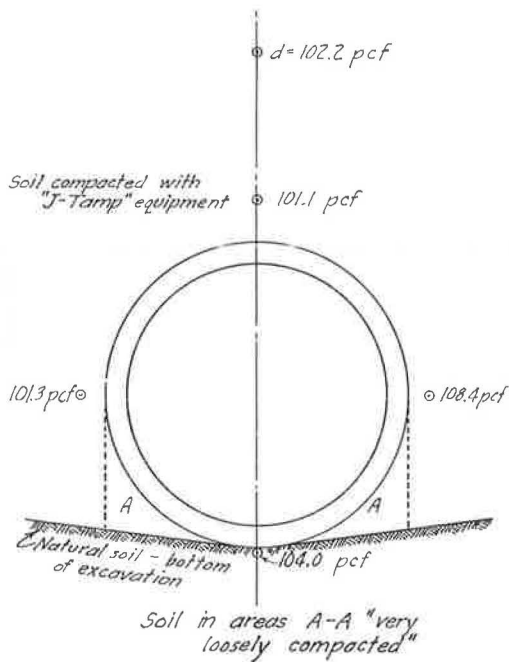
Figure 38. Pipe bedding.

The pipes were installed on this compact material at the bottom of the excavation, which was not shaped to fit the contour of the pipe. Backfill was placed under the haunches and alongside the pipe. The soil at the sides was compacted in layers by means of mechanical equipment which had a tamping face about 12- x 18-in. in area. Tamping was carried out in a vertical direction only, with no special effort made to compact soil in the triangular areas below the springlines.
