Some Effects of Fabrication Practices on Strength Characteristics of Reinforced Concrete Culvert Pipe

ROBERT C. DEEN and J. H. HAVENS

Respectively, Assistant Director of Research and Director of Research,
Kentucky Department of Highways, Lexington

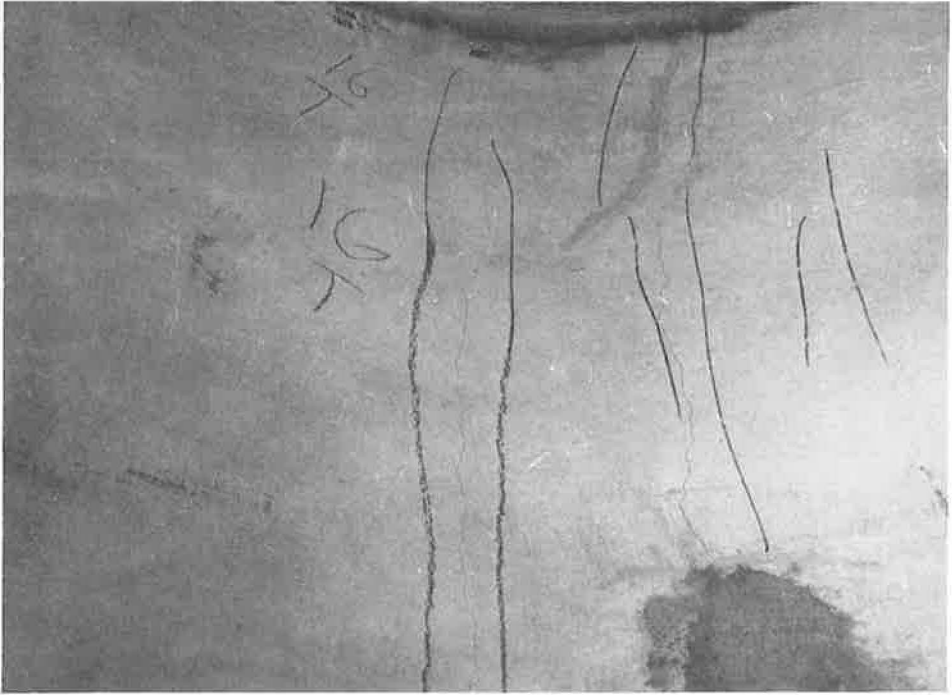
Figure 39. Stage I cracks in crown of pipe— $\frac{1}{100}$ -in. crack center; hairline crack, right; very fine hairline crack, left.

It is feasible and usually economical to repair damaged reinforced concrete pipe in situ without removal and replacement. Pipes which are cracked longitudinally to the extent described in stage I, cannot be said to have failed in any reasonable sense of the word. As a rule, such cracks indicate nothing more than that the reinforcement steel is being stressed at a level somewhere near that for which it was designed and which it is capable of carrying. Unless the cracks are wide enough to permit corrosion of the steel, they are not at all damaging to the pipe. Longitudinal cracks typical of stage I structural effect are shown in Figures 39 and 40.

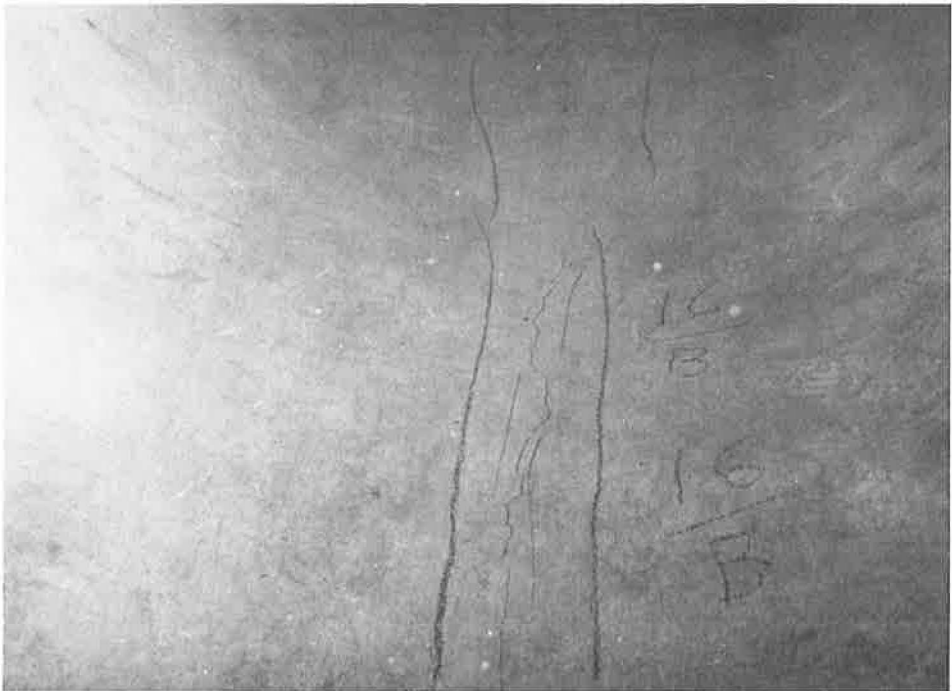
Figure 40. Stage I crack in pipe invert—approximately $\frac{1}{16}$ in. wide.

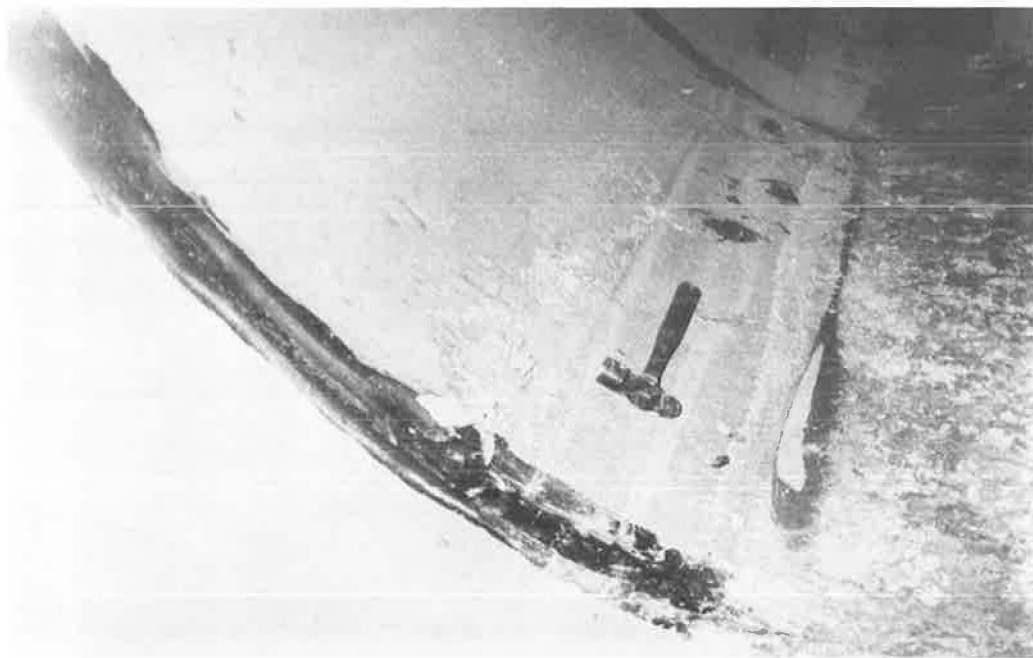
Figure 41. Spalled concrete, stage II damage to left of hammer, ice in pipe invert at right.

Damage described under stage II (that is, spalling of the protective cover over the steel at the top or bottom) has the appearance of a very severe condition (Figs. 41 and 42). One engineer described it by saying, "It looks like the foundation is coming up through the bottom of the pipe." Actually it is not as severe as it appears to be and can be repaired with complete safety and confidence. When this type of damage occurs, the pipe has deformed enough to develop a substantial amount of passive resistance pressure of the soil at the sides. It has, in effect, become a "semi-rigid" pipe and a state of equilibrium develops in which the vertical load is carried by the residual inherent strength in the pipe plus the passive resistance pressure against the sides. This state of equilibrium develops in early phases of pipe damage and can be verified by measuring the vertical and horizontal diameters of the pipes and marking the points

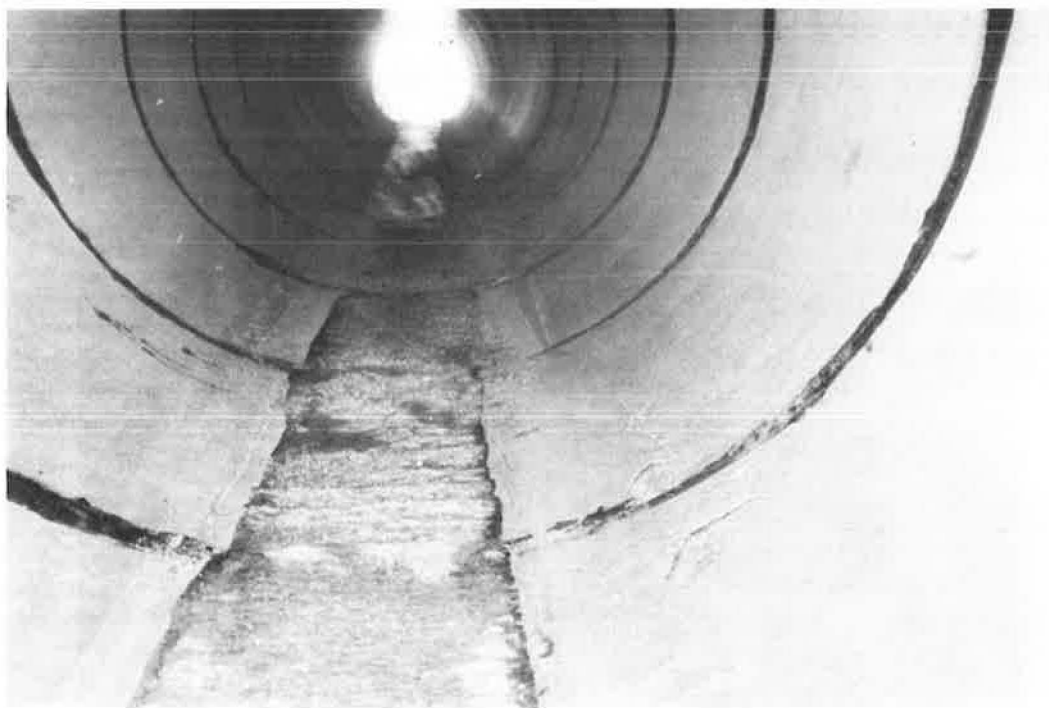
Figure 42. Spalled concrete, stage II damage.

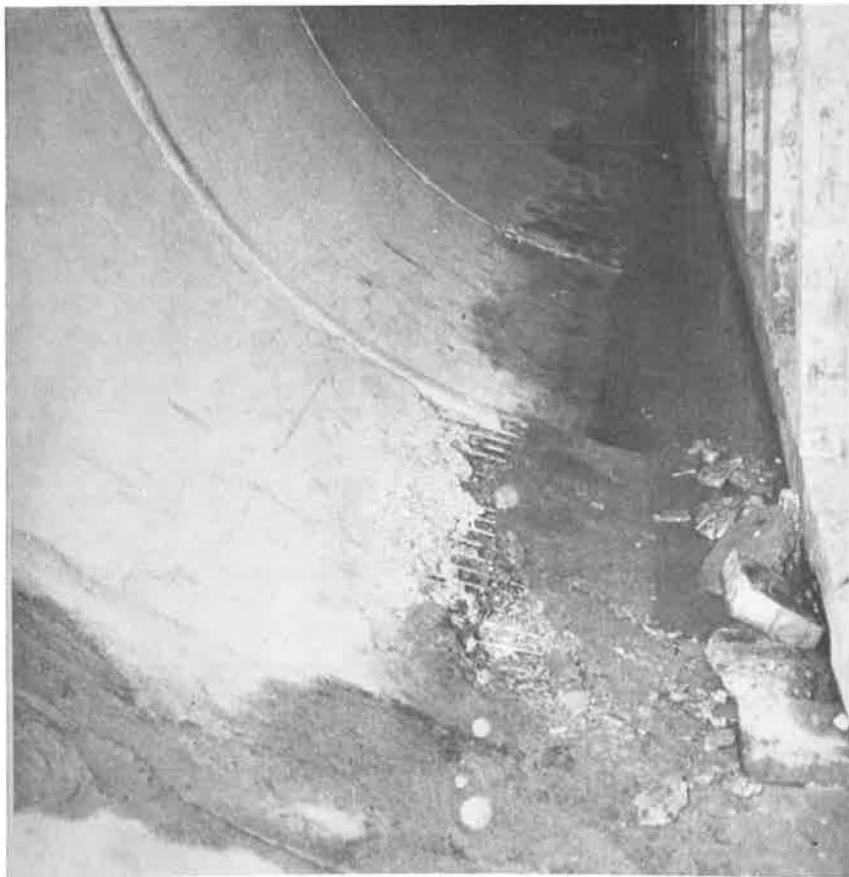
Figure 43. Advanced stage II damage to 108-in. pipe. When damage was first discovered, engineer ordered timber struts installed. Later these were removed and a system of diameter measurements established, which indicated that the pipe had reached state of equilibrium. Beddings were improved by grouting, then pipe walls were repaired with concrete. Pipeline has served satisfactorily for 14 years (at this writing).

In severe cases of stage II damage (Fig. 43), when it is known that the density of soil beneath the lower haunches is deficient, the pipe can be strengthened by pressure grouting the soil in this region. Holes may be drilled in the pipe wall between the spring line and the lower quarter point and grout forced into the soil (Fig. 44). This improves the bedding situation and increases the lateral pressure and the pipe is greatly strengthened. An 84-in. pipe grouted in this manner and then removed to observe the results is shown in Figure 45. After the grouting operation was completed, gunite repairs of the inside of the pipe were carried out.

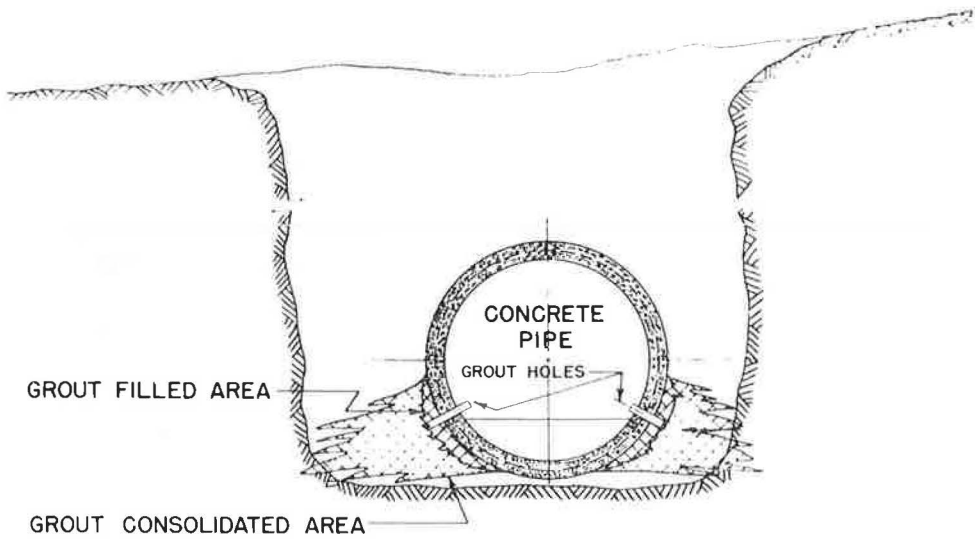
Figure 44. Method of improving pipe bedding by grouting.

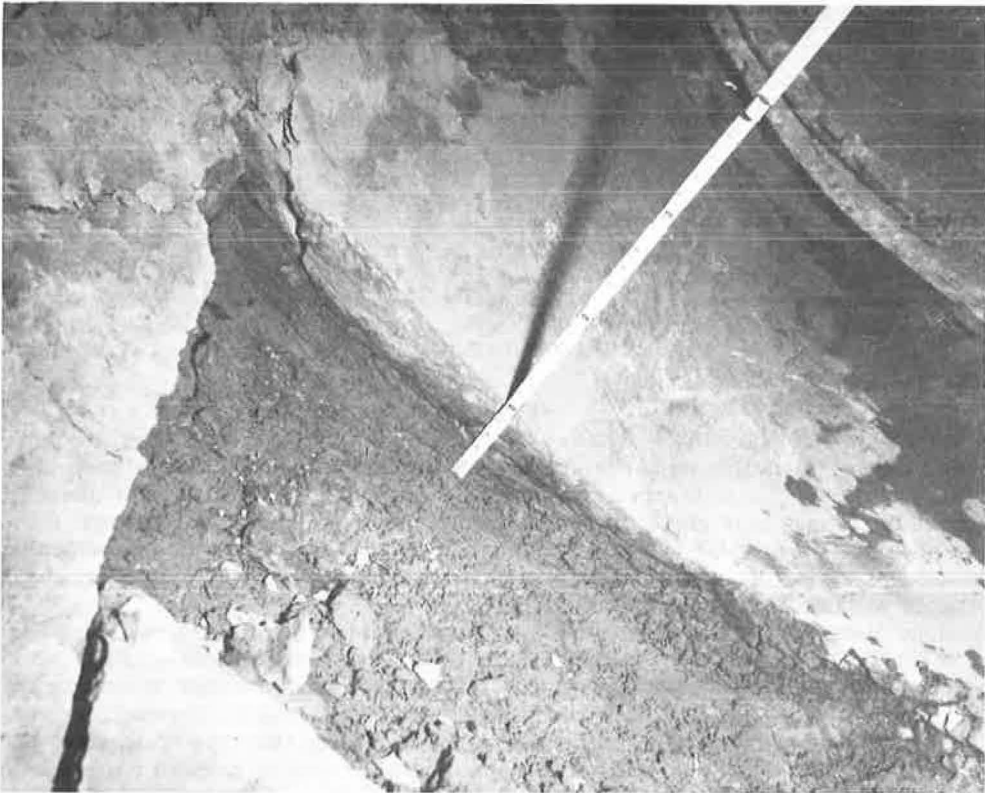
Figure 45. Stage II damaged 84-in. pipe removed for inspection of grout injected through holes drilled approximately at lower quarter points. After bedding was improved, pipes were repaired on the inside with gunite concrete. Pipeline has served satisfactorily for 9 yr (at this writing) and repairs appear to be permanent.

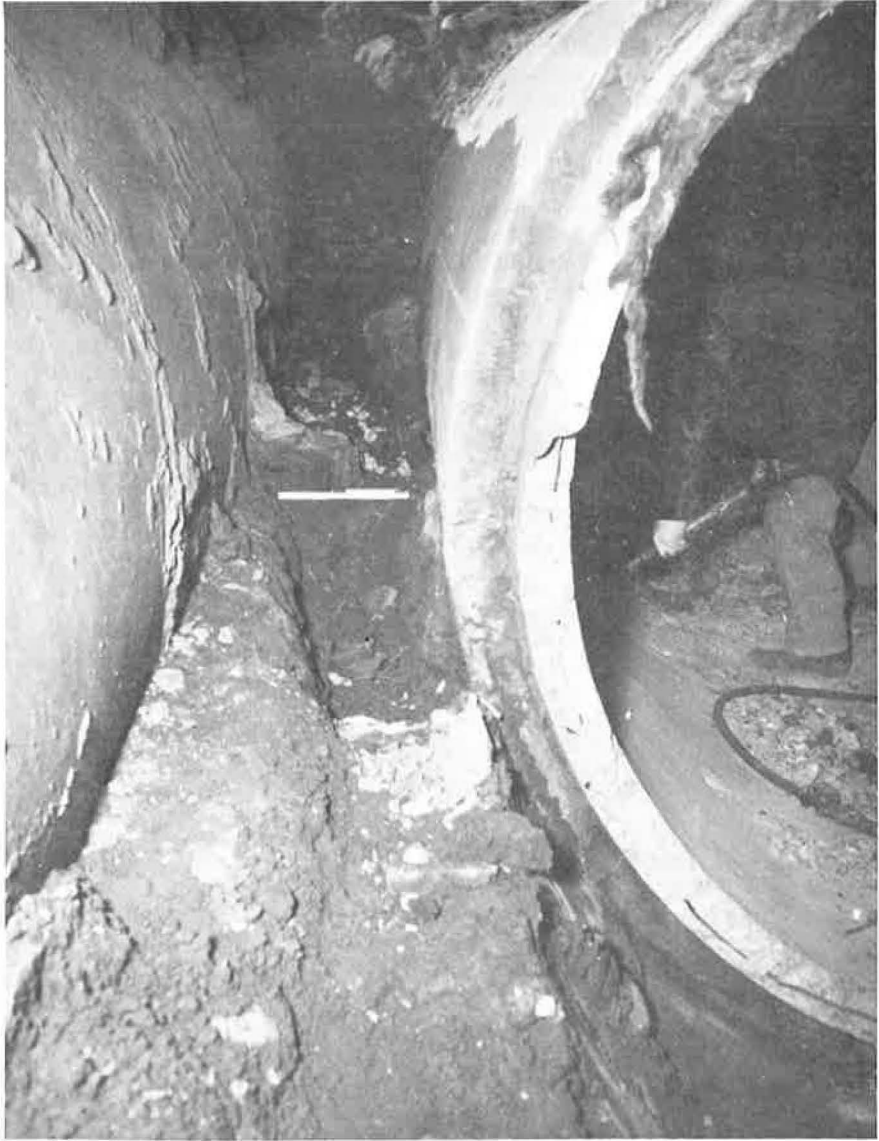
Figure 46. Parallel 84-in. pipelines only 1 ft apart. Impossible to do an adequate job of compacting soil under haunches with pipes so close together.
