# Construction of a Continuously-Reinforced Concrete Pavement in South Dakota

ROBERT A. CRAWFORD and DONALD W. ANDERSON  
Assistant Physical Research Engineers, South Dakota  
Department of Highways, Pierre

•THIS REPORT is primarily concerned with the environment, design, construction, and testing program of two continuously-reinforced concrete test sections constructed in South Dakota in 1963.

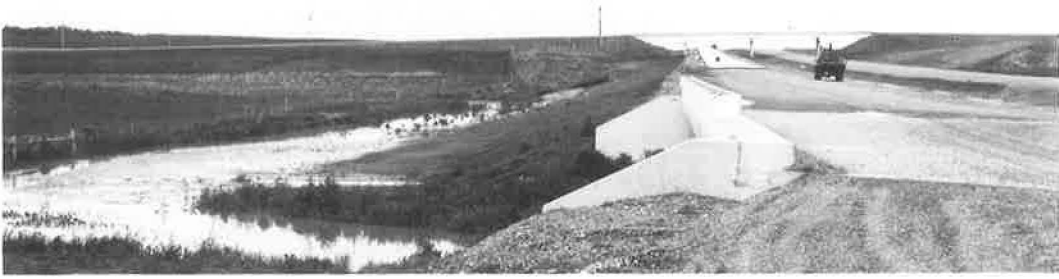
Figure 3. Water standing in poorly drained channel between sections.

Drainage is generally good throughout the test section areas. Natural slopes vary from 1 to 7 percent with the general drainage toward the south. A poorly drained channel crosses the project between the two continuously-reinforced sections and would possibly affect them in periods of above normal precipitation. Figure 3 shows undrained water standing in this channel approximately 24 hr after rain occurred during construction. The east end of Section 2 which had been completed at the time of the rain is visible.

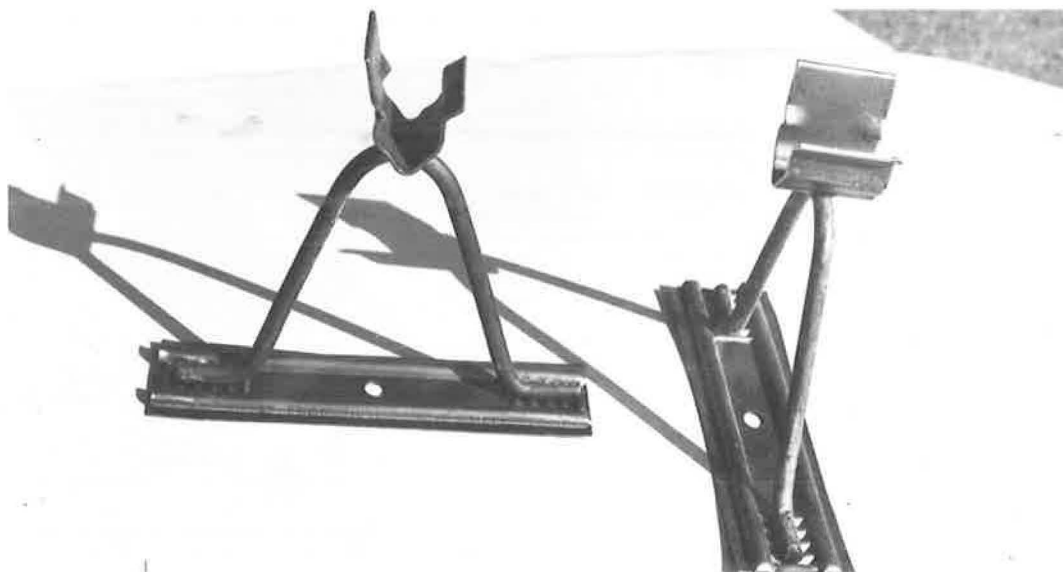
Figure 4. Support chairs for reinforcing steel.

Because of severe climatic conditions, it was decided to use over 0.6 percent longitudinal steel. This requirement was met with No. 5 deformed bars spaced on 6-in. centers. This provided longitudinal steel at the rate of 0.646 percent of the cross-sectional area of the slab. A further safety factor was the use of A-432 billet steel with a minimum yield point of 60,000 psi (Table 1). Specifications required the steel in 40-ft lengths as it was felt that this was the maximum length which could be easily handled. Transverse steel was also No. 5 deformed bars of the same billet steel spaced on 44-in. centers, 23 ft 10 in. long for a 24-ft pavement width. All longitudinal and transverse steel intersections were tied. Support chair placement under the intersection of every sixth longitudinal bar with every transverse bar provided one support chair ever 1.222 sq yd.

Specifications required that the chairs (Fig. 4) be approved by the State engineers because it was important that the steel be maintained in its proper position during concrete placement.

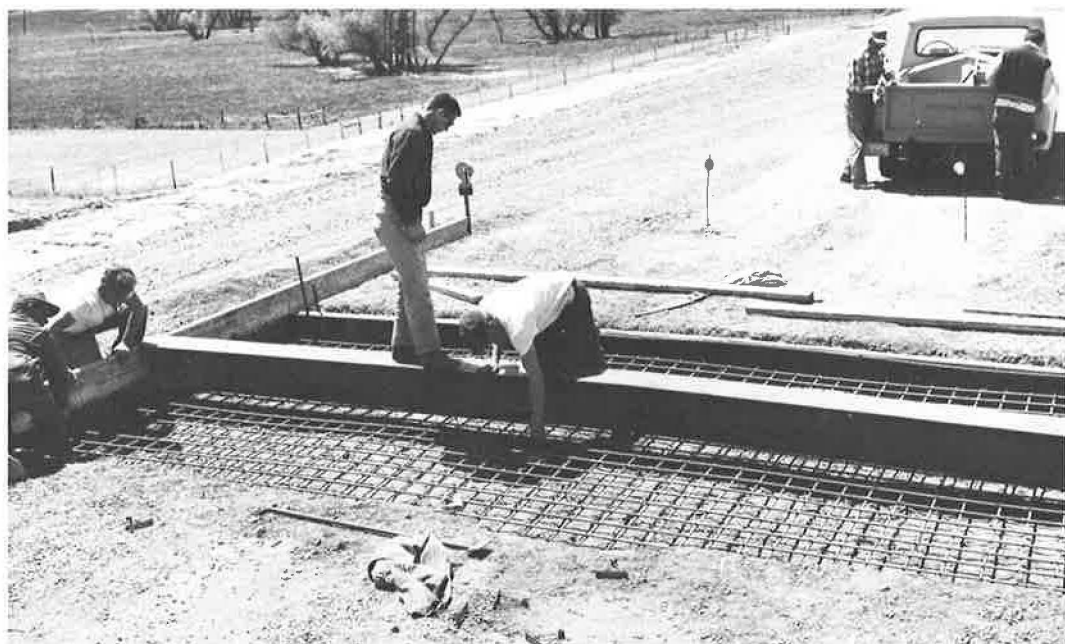
Figure 7. Wide-flange end joint prior to pouring sleeper slab.

In order to maintain the wide-flange beam at the proper elevation in the sleeper slab, the contractor tack-welded the ends of the beam to paving forms that had previously been placed to grade (Fig. 7). The reinforcing steel was then placed under the beam, tied, set on chairs, and the concrete poured.

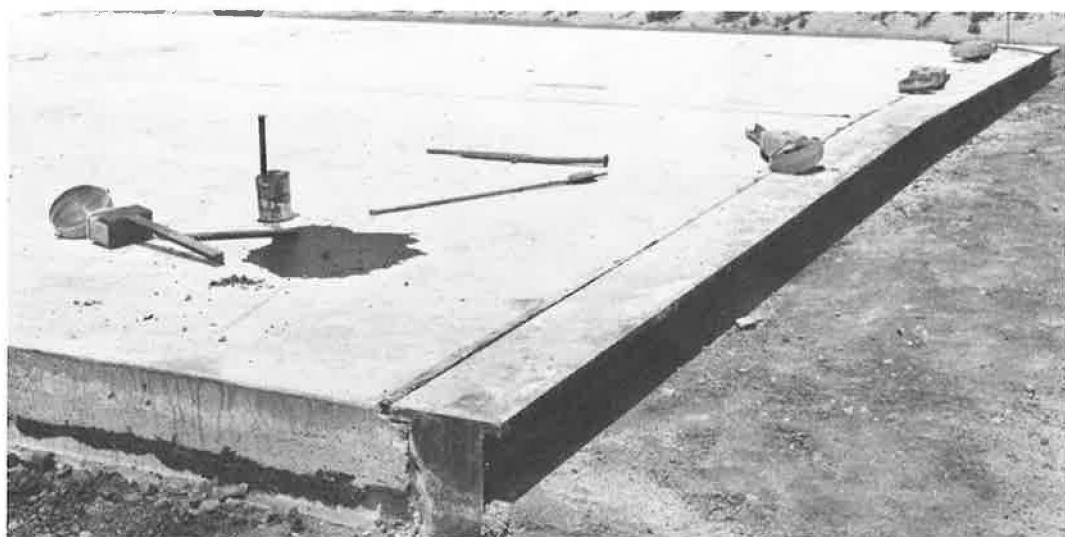
Figure 8. Continuously-reinforced concrete in place against wide-flange beam.

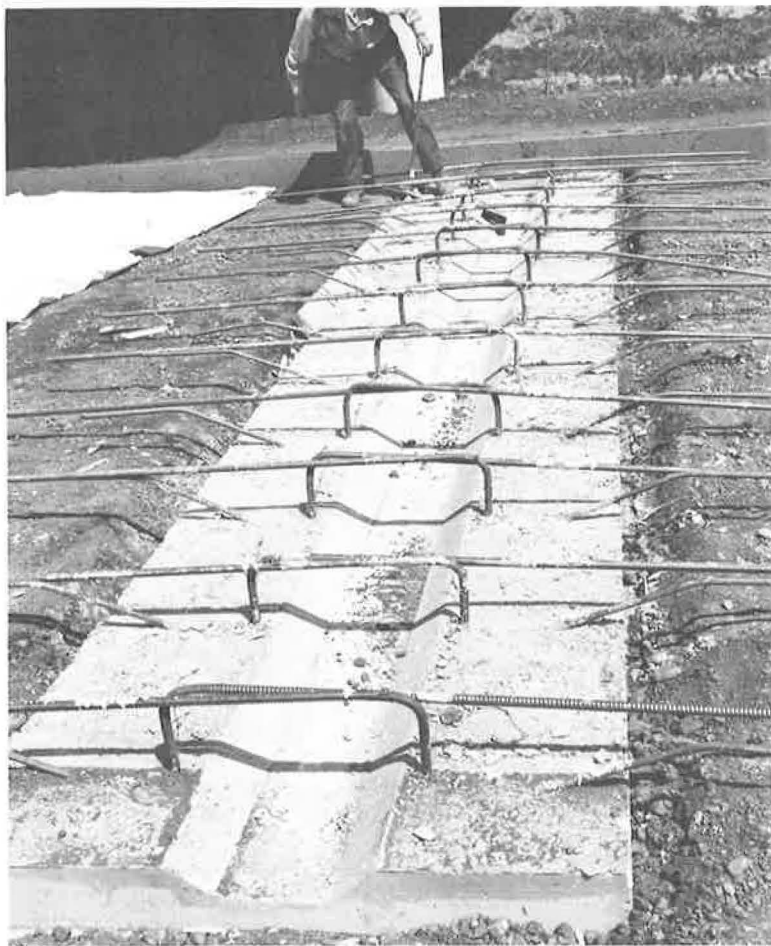
Figure 10. Completed end-anchor lug.

Three end-anchor lugs were placed at each end of Section 2. The reinforced end anchors, 5 ft deep and 2 ft thick, were cast separately to the full width of the pavement. A keyway was formed into the top of each lug to aid in transmitting pavement stresses

to the anchorlug. A completed end-anchor lug is shown in Figure 10. The pavement thickness was increased to 10 in. in the region of the end anchor lugs. Figure 11 shows design details of the end anchors.

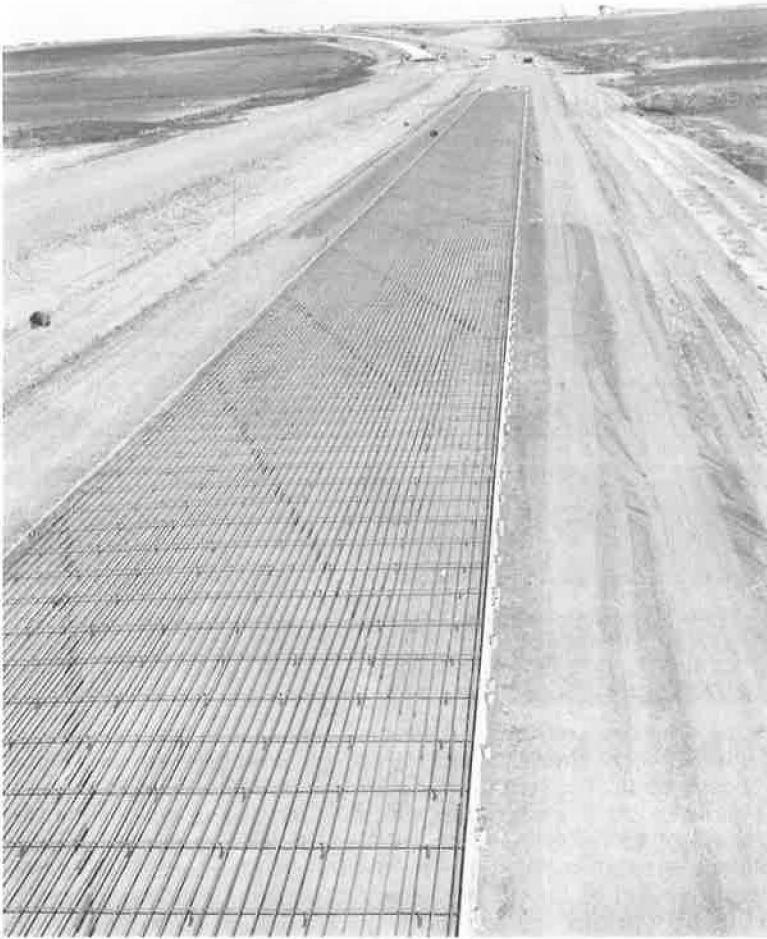
Figure 14. Reinforcing steel in place.

Fine-grading was completed and the forms were set in place before any steel was placed. The forms were then marked and the transverse steel was laid in position on the grade. Every sixth longitudinal bar was laid on top, and both the overlaps of this longitudinal steel and its intersections with the transverse steel were tied. Chairs were then placed under the transverse steel to lift it to its proper elevation. Figure 13 shows this operational sequence. The first eight longitudinal bars were spaced using steel rods welded on an old scratcher. The remaining bars were then carried into place and tied, spacing them from the original eight bars. As previously mentioned, all transverse and longitudinal steel intersections were tied, and all overlaps were tied twice. Figure 14 shows the steel in place before pouring concrete in Section 1.
