New York State Experience with Concrete Pavement Joint Sealers

MALCOLM D. GRAHAM, WILLIAM C. BURNETT, J. G. FREDERICK HISS, JR., and JOHN R. LAMBERT

Respectively, Director, Associate Civil Engineer, Senior Civil Engineer, and Assistant Civil Engineer, Bureau of Physical Research, New York State Department of Public Works

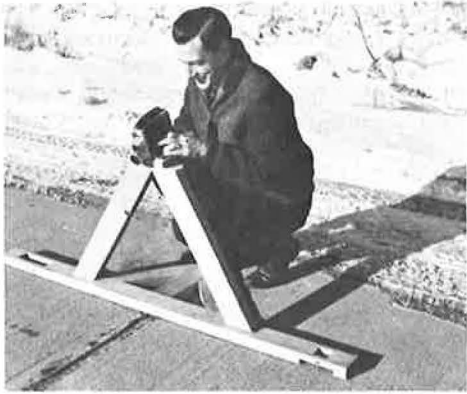
Figure 2. Time-lapse movie camera.

Time-lapse movies of the pavement joints are being used to evaluate the performance of the sealers. For this purpose, a 16-mm magazine-loading movie camera is mounted on a wooden jig. The jig is positioned in the same location for each exposure by aligning two sets of guide wires directly above a pair of brass pins set in the concrete (Fig. 2). A film magazine for each joint to be photographed is exposed for 2 seconds every other week. The film when projected will show an accelerated movie of the life of the sealer.
