# Field Verification of Ring Compression Conduit Design

J. DEMMIN, Armco-Thyssen, Dinslaken, Germany

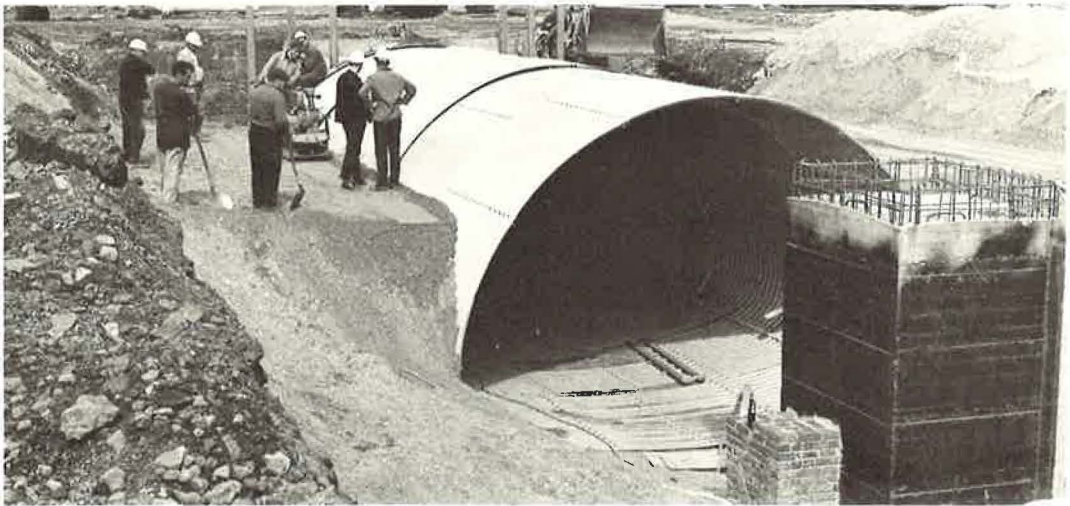
Figure 2. Placement and compaction of backfill.

Backfill material was placed in lifts of 8 in. , with each layer tamped separately (Fig. 2). Gravel was used as backfilling material and surface vibrators were employed for compaction. Tamping operations were continuously checked by drop-penetration testing. A laboratory Proctor test showed a soil density of 107 percent of single Proctor density (see Appendix).

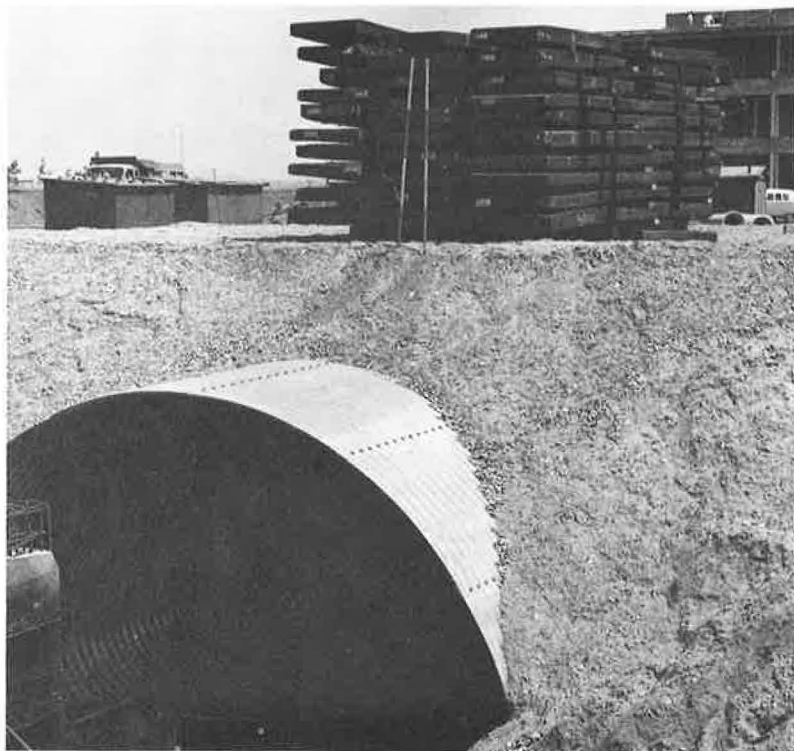
Figure 8. Live-load test, test structure with 151.32-ton axial load.

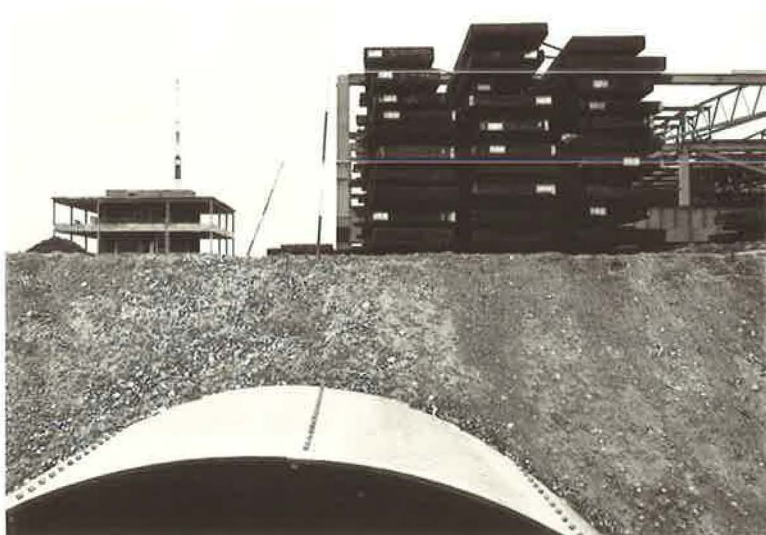
Figure 12. Test structure under load of 151.32 tons applied in 6.89-ft off-center position.

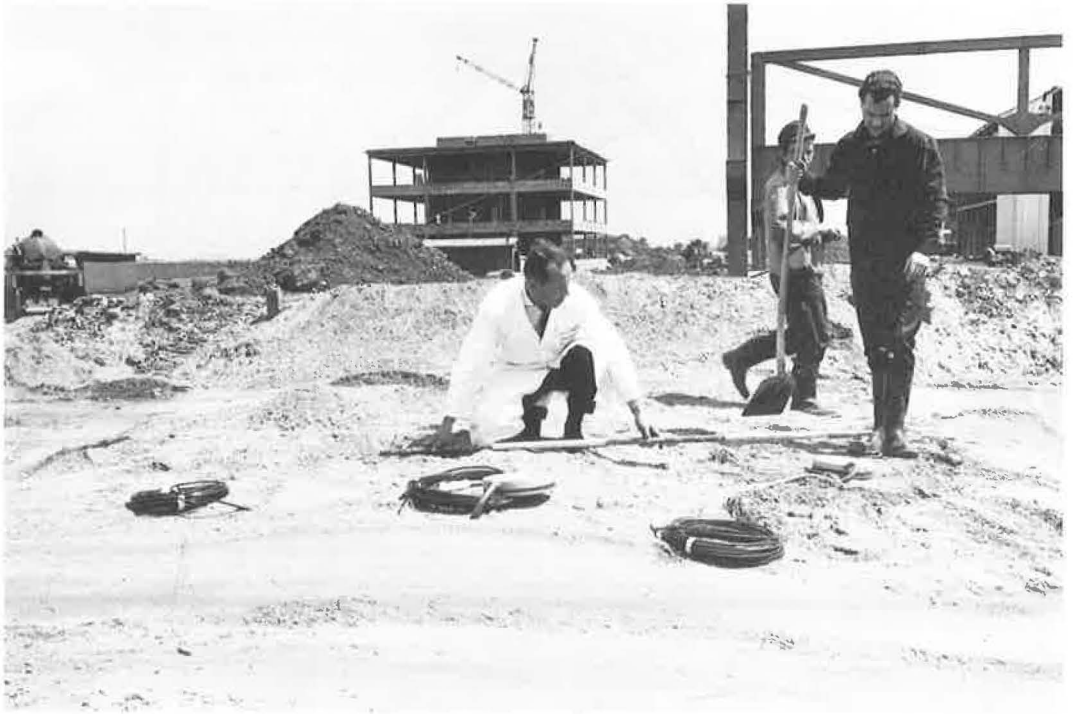
Figure 22. Installing Heierli pressure cells.

On June 28, 1963 preparations began for the loading-to-failure test. The slabs were removed and the pipe arch uncovered to the crest. The unloading caused a slight vertical rise of the crest of 3.47 in. The upper layers were removed for the purpose of conducting the crushing test with undisturbed and unpreloaded soil in the area of largest soil pressures, i. e., directly underneath the applied load. Before the new material was placed, three Heierli pressure cells were installed in backfill in a horizontal place above the pipe arch (Fig. 22). The center cell was placed 4 in. above the crest underneath the center of the loaded area, and the other two were installed at distances of

6.56 ft left and right of the crest. Measurements are made by pressure gage strips incorporated in pressure cells. For the crushing test, the backfill was extended at the shoulders as a further precaution against subgrade failure. This required the addition of another ring section at the open end of the structure. After the cover height of 5.15 ft for the crushing test was reached, loading was started on July 2, 1963. For higher

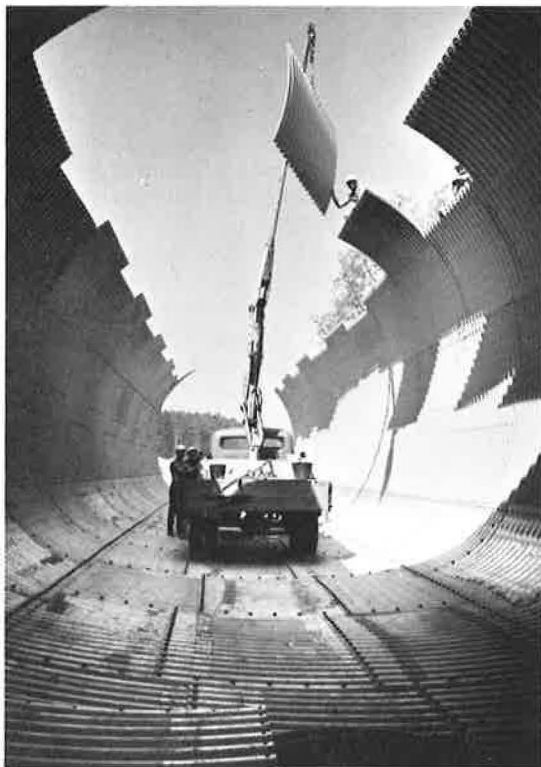
Figure 44. Special profile S 32 during construction.
