Some Tests of Studded Tires in Illinois

JOHN E. BURKE and LLOYD J. McKENZIE

Respectively, Engineer of Research and Development and Principal Researcher, Illinois Division of Highways

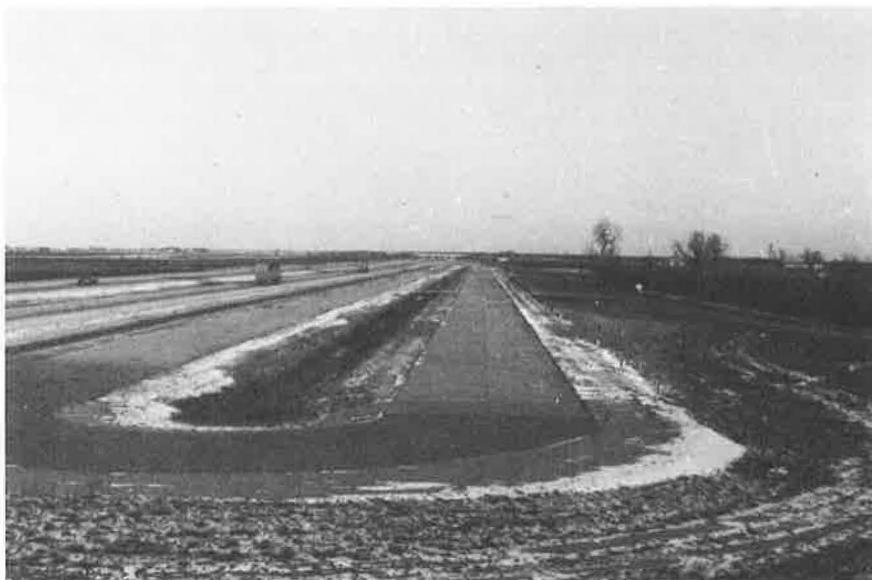
Figure 1. Loop 1 of AASHO Road Test, where studded tire test was conducted.

Initially, seven test sections were marked with paint on the pavement surfaces of the east half of loop 1, the one remaining loop of the AASHO Road Test facility (Fig. 1). Of these, three were on a portland cement concrete surface and four were on a bituminous-concrete surface. One section on each type of pavement was designated for start tests, one for stop tests, and one for constant speed (25-mph) driving. The fourth section on the bituminous-concrete surface was located on the turnaround at the east end of the loop, and was used for observing the effect of the studded tires while turning. Starts and stops were both the normal (with no spinning or sliding of the wheels) and the emergency type (with wheels spinning to start and sliding to stop). Normal start and stop tests preceded the emergency start tests and stop tests on a given test section.

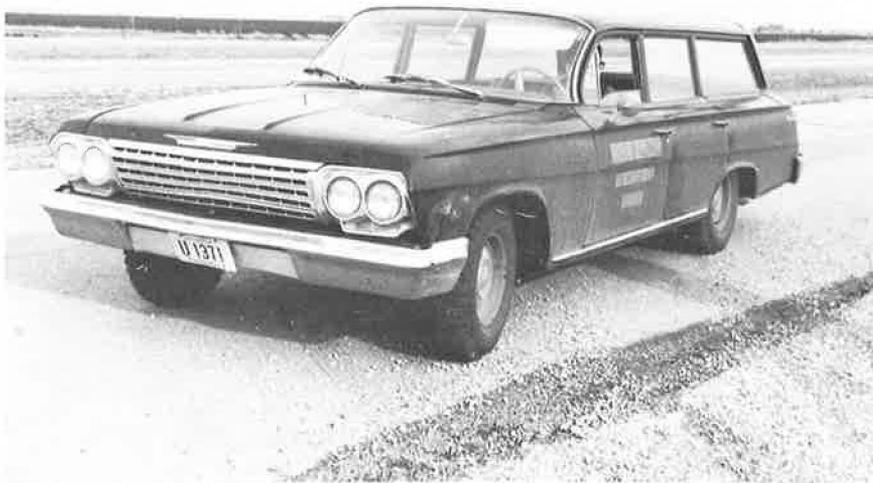
Figure 4. Chevrolet station wagon with studded tires on all four wheels.

Two Allstate and four Goodyear studded snow tires, together with several standard tires, were used in the tests. The two Allstate tires had 52 tungsten carbide studs per tire equally spaced around the circumference in four rows, two rows along each edge of the tread. Studs were set approximately flush with the tread surface, ranging from slightly below the surface to about $\frac{1}{32}$ in. above it. These two tires were mounted on the rear wheels of a 1961 Plymouth sedan. The Goodyear studded tires contained from 103 to 108 tungsten carbide studs per tire, also arranged in two rows along each edge of the tread. The studs on these tires protruded on the average about $\frac{3}{32}$ in. above the surface of the tread. The Goodyear tires were mounted on all four wheels of a 1962 Chevrolet station wagon (Fig. 4).

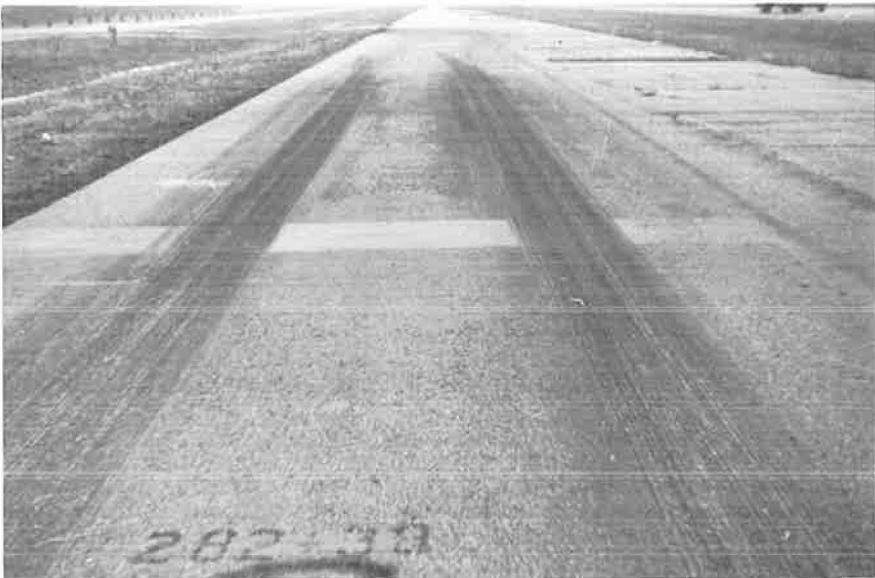
Figure 9. Bituminous-concrete surface after application of 175 normal stops followed by 25 emergency stops.

On the stopping test section of the bituminous-concrete pavement the paint mark was completely obliterated in the wheelpaths and abrasion of the surface was evident after 175 normal stops followed by 25 emergency stops (Fig. 9).

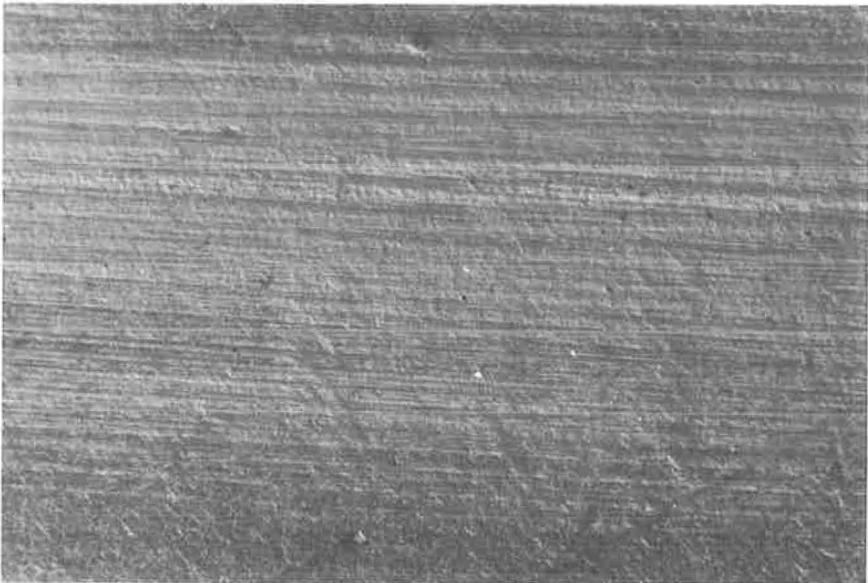
Figure 18. Special test no. 1; pavement surface after completion of tests.

Dry Portland Cement Concrete Surface, Studded Tires.—Abrasion of the pavement in this special test (Figs. 17 and 18) appeared similar to that resulting from the original starting and stopping tests.
