HIGHWAY RESEARCH RECORD

Number 173

Maintenance
and
Equipment

HIGHWAY RESEARCH BOARD

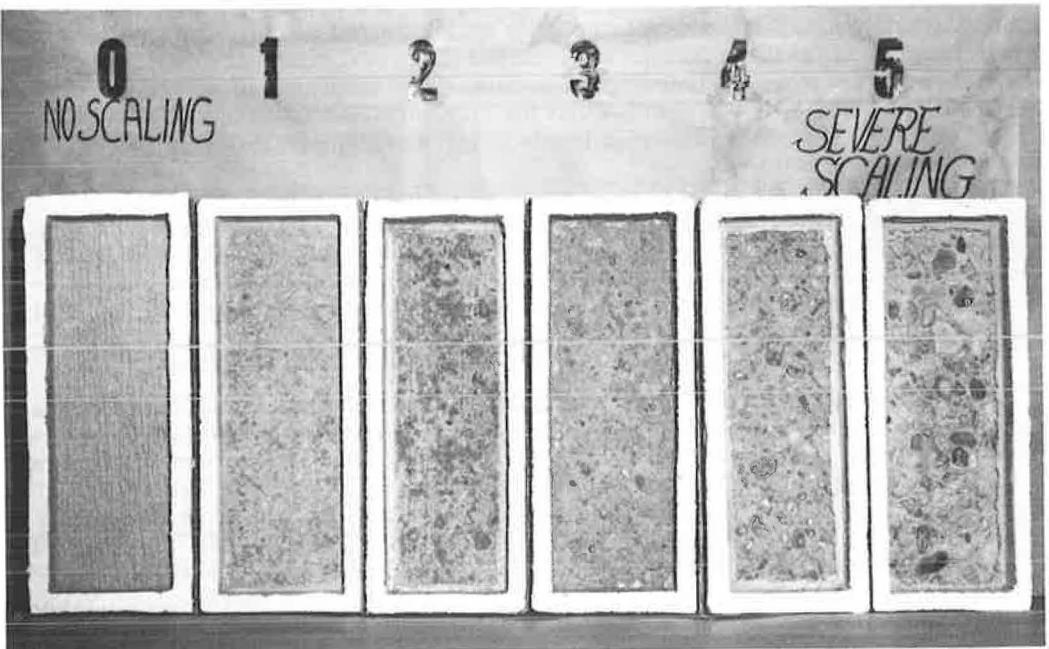
Figure 1. Rating of concrete slabs.

In the tables, RCS stands for regular (tar-based) concrete sealer. Clear stands for clear (resin-based) concrete sealer. Linseed stands for a 50-50 blend of boiled linseed oil and mineral spirits. The linseed oil was selected after consultation with experts and was included as a reference standard. Black stands for a black sealer of an entirely different type from RCS. The second black sealer was included, as previously explained, to reduce any possible tendency for bias which might have occurred with only one black sealer. Surface condition ratings are based on a scale of 0 to 5, as previously mentioned (Appendix D, Fig. 1).

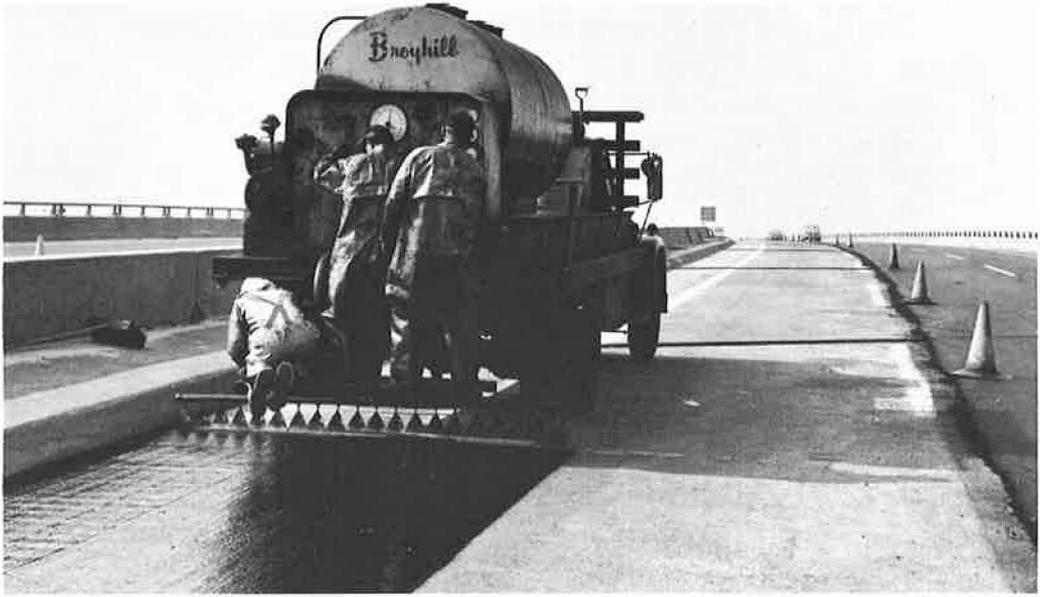
Figure 1. Combination mixer and sprayer of epoxy membrane.

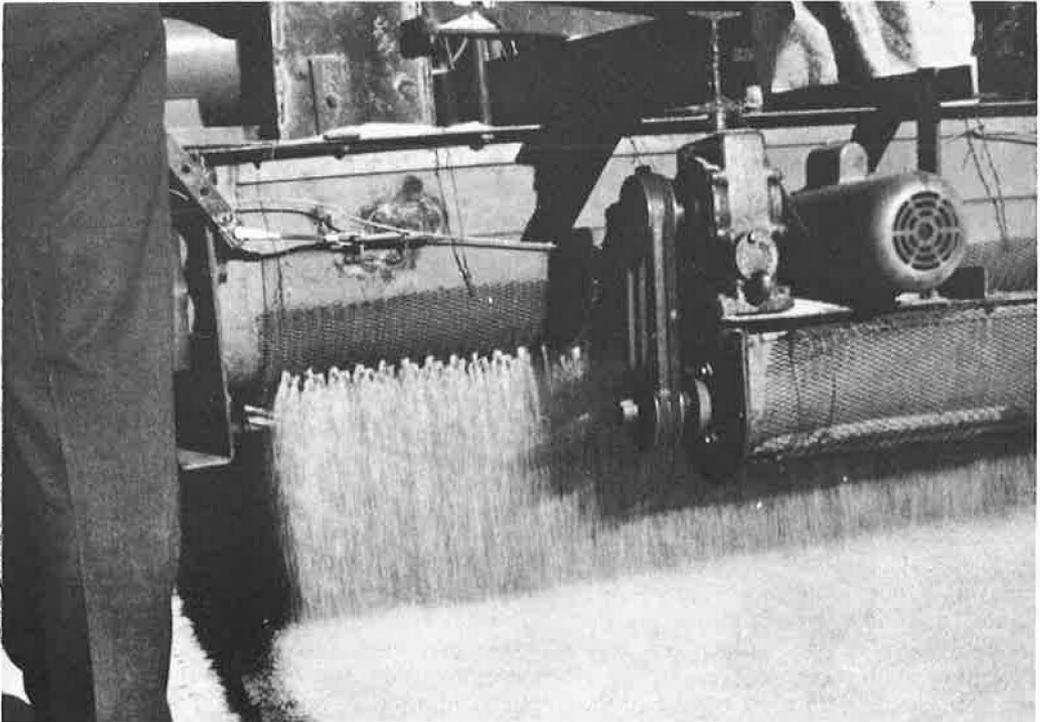
Figure 2. Distributor truck conveyor system.

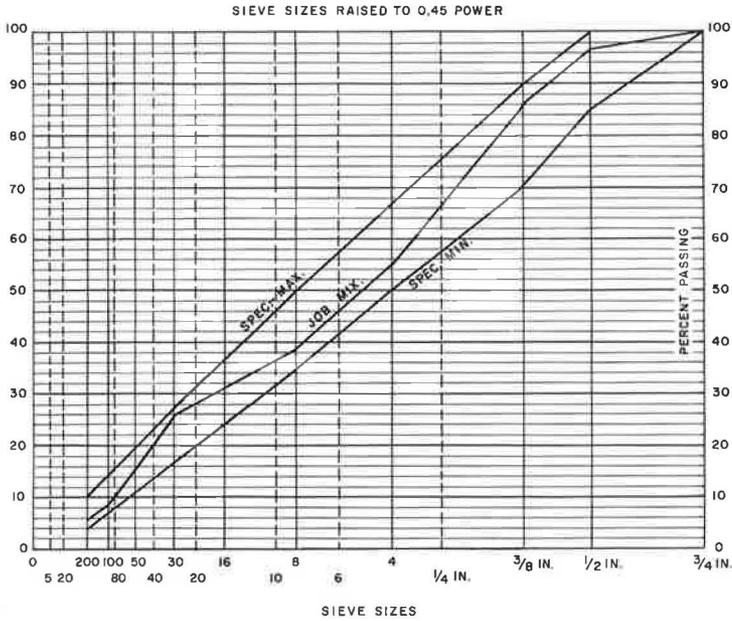
Figure 3. Aggregate gradation chart.

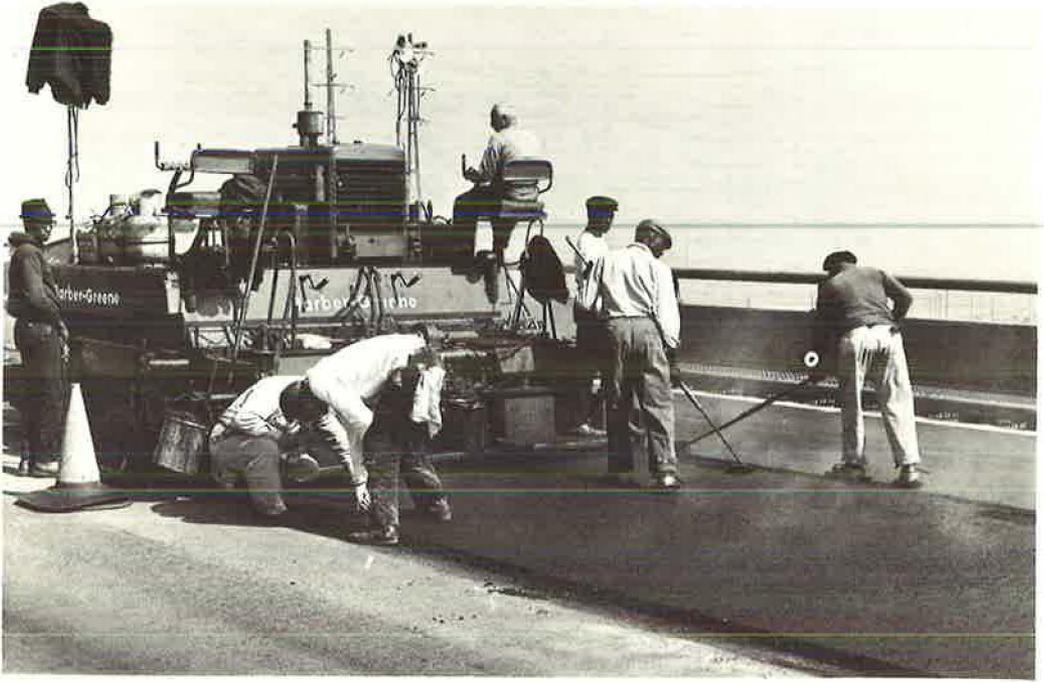
Figure 4. Neoprene-modified, asbestos-additive pavement construction.

The methods of construction for the neoprene-modified, asbestos-additive pavement are the same as those used for any asphalt overlay (Fig. 4) with the exception that the mix is somewhat sensitive to rolling temperature. If the mixture is rolled when too hot, a mud wave may develop in front of the roller (Fig. 5). Also, hand-raking should be avoided because this disrupts the careful blending to achieve maximum density. Such an asphalt mix is, of course, expensive. Latex additives add from \$0.50 to about \$2.50 to the cost of a ton of asphaltic concrete, depending on the type and quantity involved, and the asbestos adds another \$1.50. So such a mixture adds about \$4.00 per ton to the cost of a conventional asphalt surface course mix. But bridge deck surfacing is usually extremely expensive anyway because of the low production rate that can be realized per day on a short span bridge. On one major turnpike, working under severely restricted conditions, the cost for the total job generally runs to about \$20.00 per ton, or about \$1.62 per sq yd, which, as noted previously, is about half the cost of the membrane we are trying to protect (see Table 1).

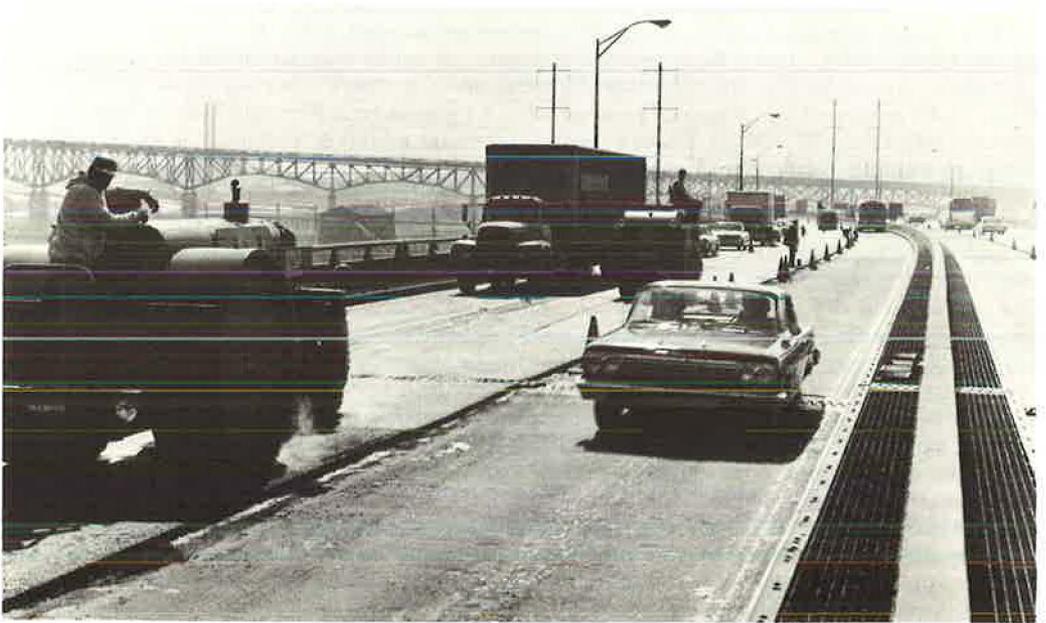
Figure 5. Rolling operation.

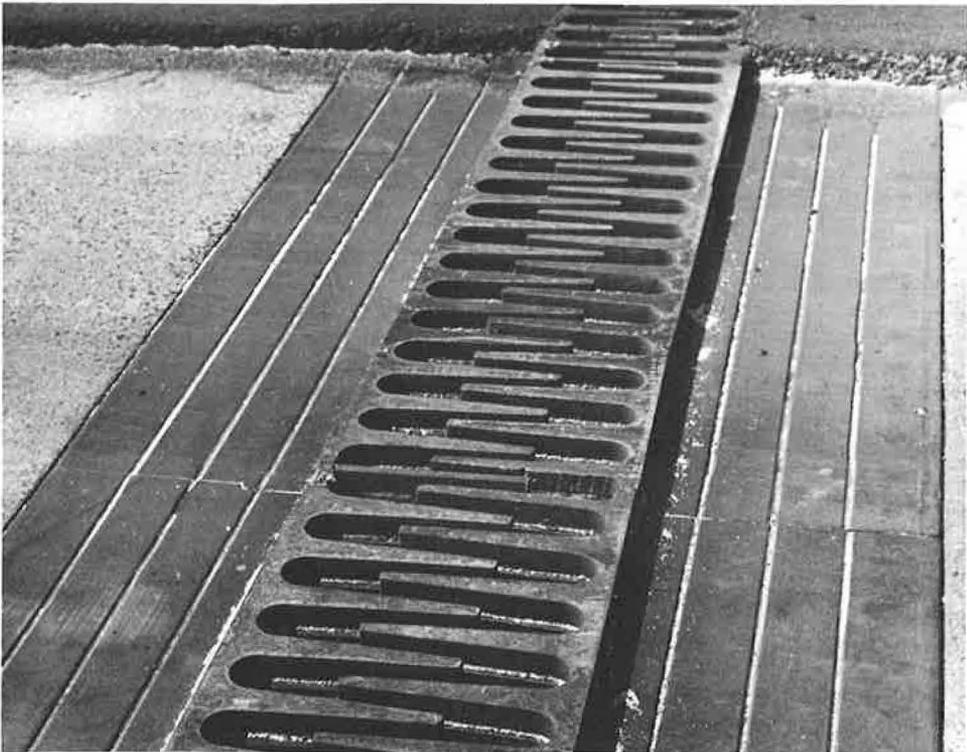
Figure 6. Large finger dam built up $1\frac{1}{4}$ in.

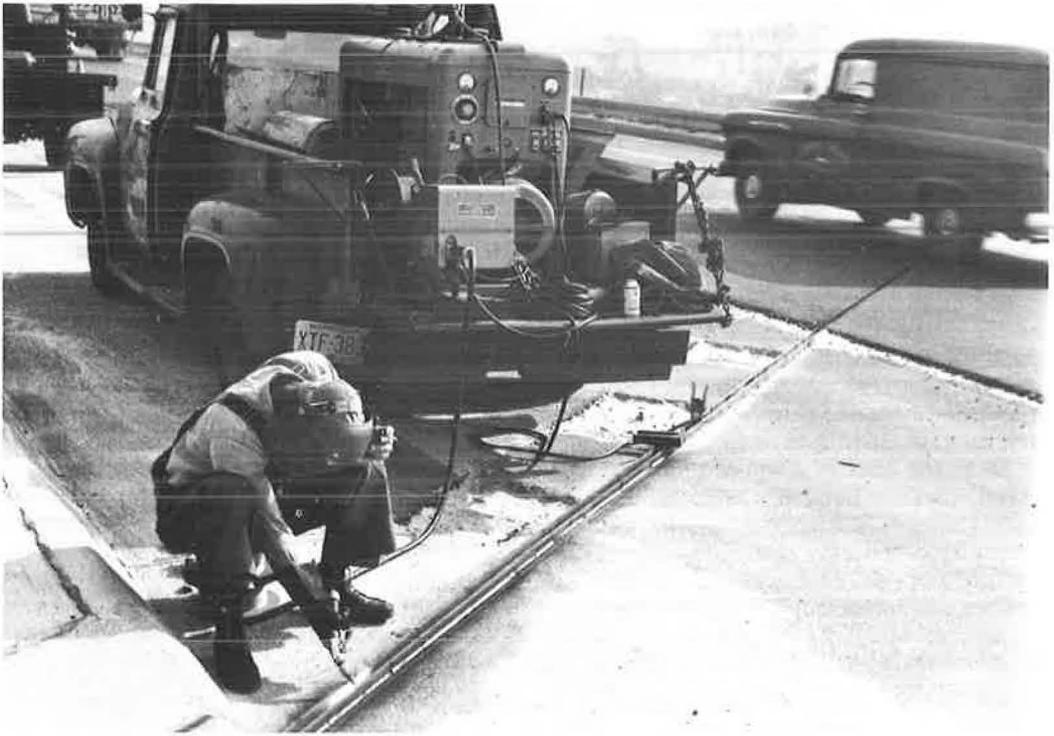
Figure 7. Welding of bar stock to top of old dam.

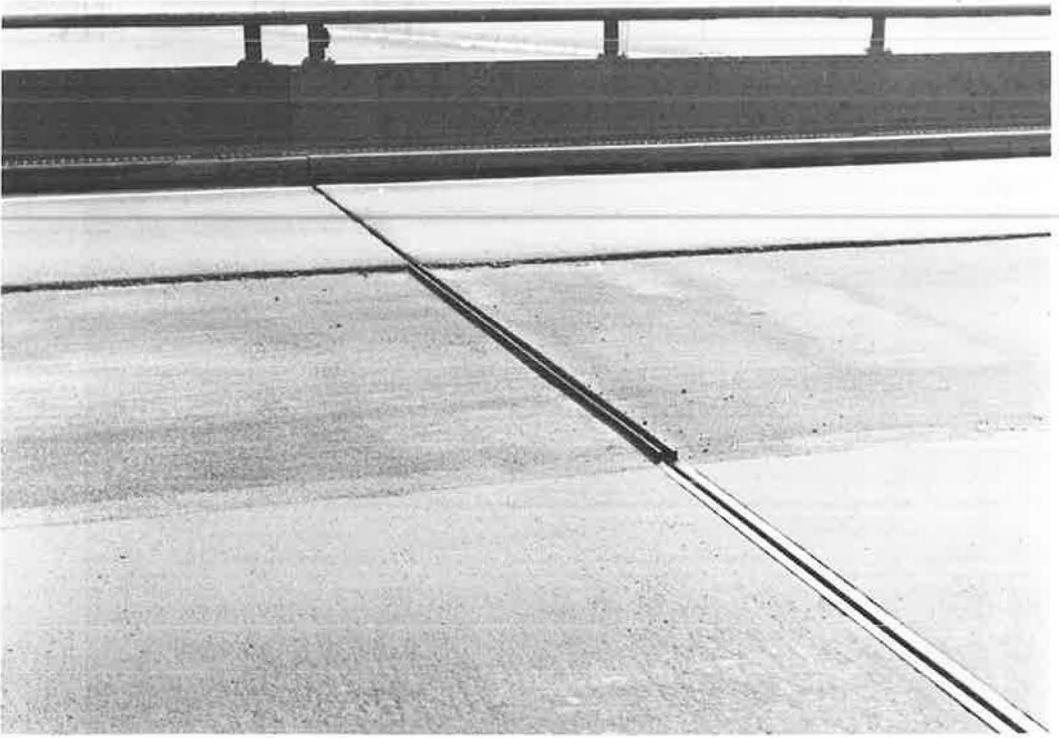
Figure 10. Mat of neoprene-modified asphalt-concrete with asbestos added to protect membrane.

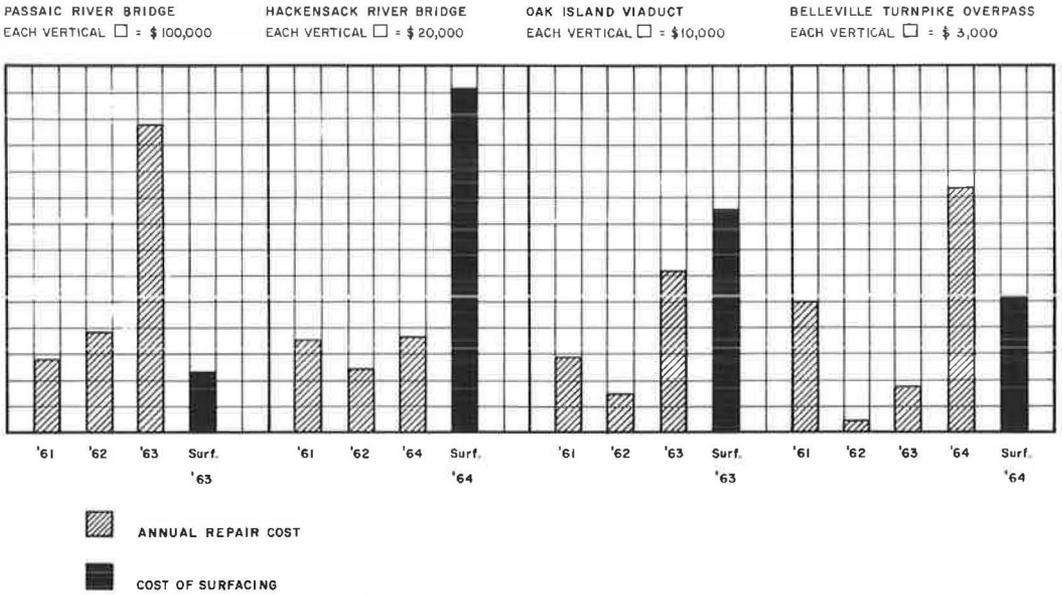
Figure 11. Cost of protective treatment.

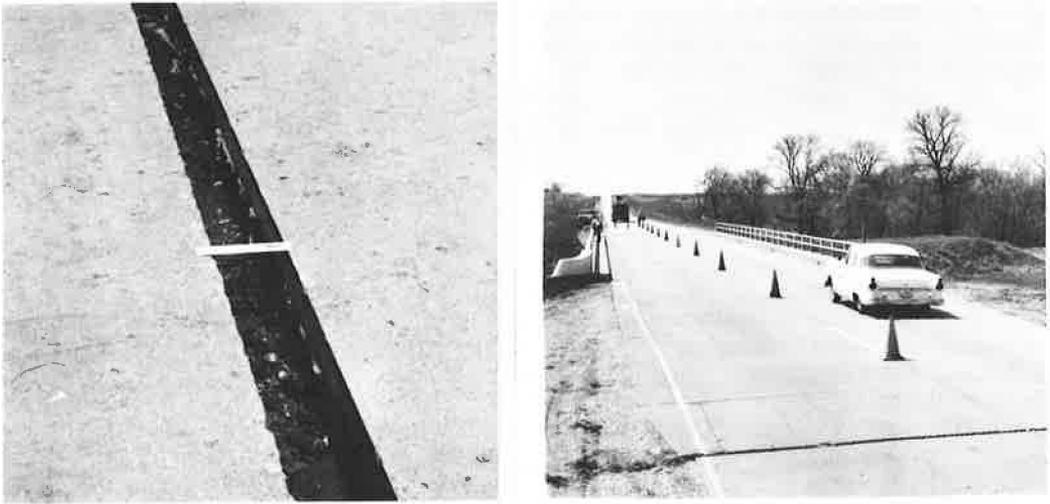
Figure 1. Prepared relief joint.

the pavement and a nominal 4 in. wide (Fig. 1). Joints over 5 in. wide may be objectionable to traffic.

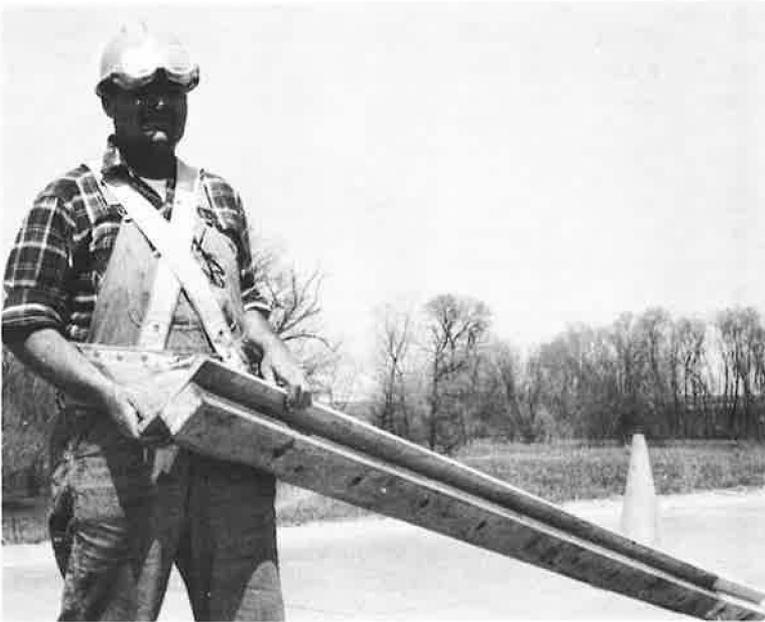
Figure 2. One-inch vent holes through form on 1-ft centers to allow entrapped air or excess foam to escape.

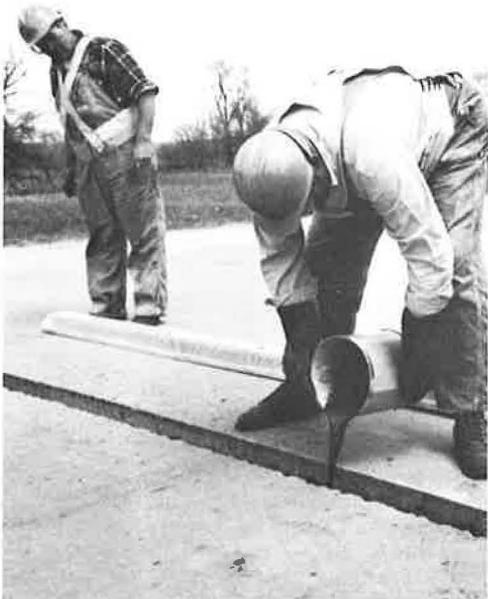
Figure 5. Pouring mixed material into prepared joint.

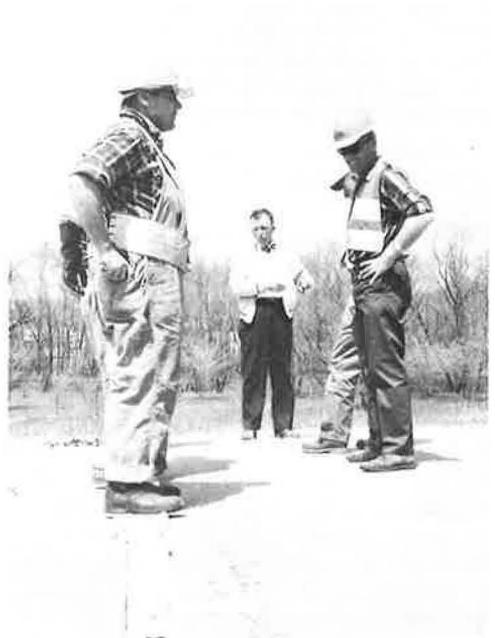
Figure 6. Man holding form down until foam has completed its rise.

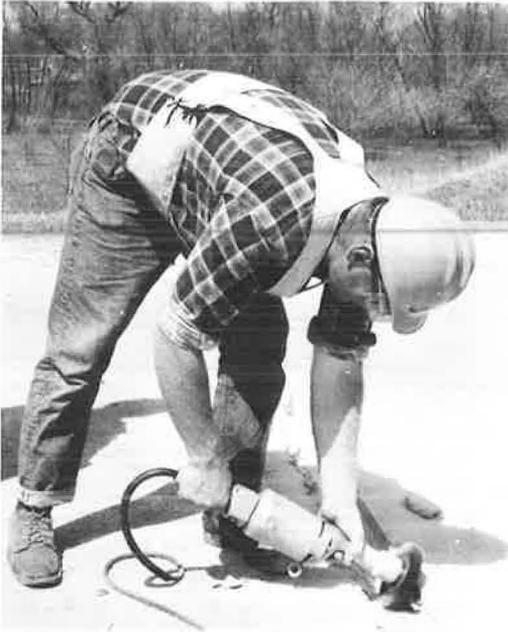
Figure 7. Cleaning excess rigid foam from sides of joint.

along the form or above the controlled height must be removed before placing the flexible foam (Fig. 7).

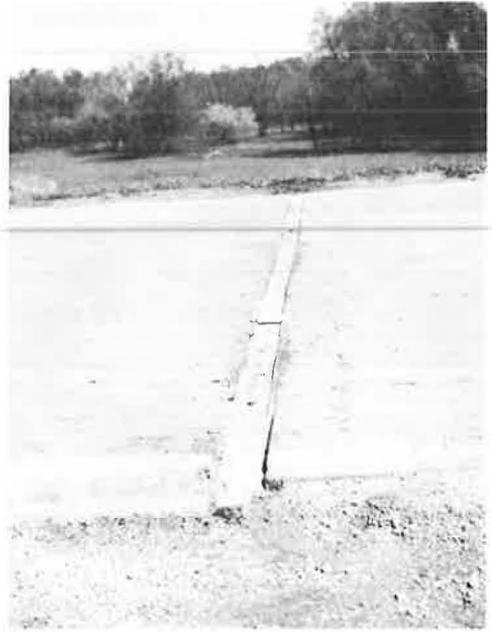
Figure 8. Completed joint.

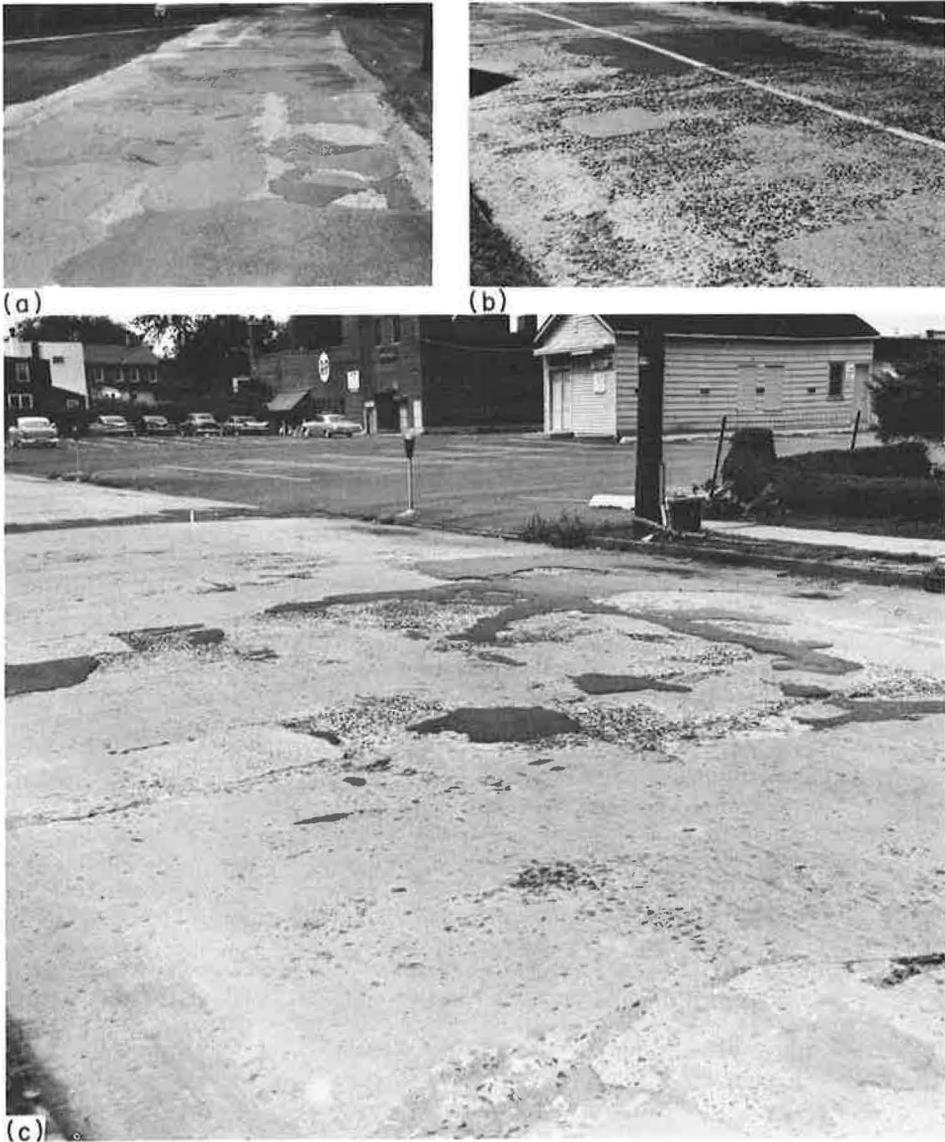
Figure 1. Condition of pavement before surfacing: (a) asphalt, (b) and (c) portland cement concrete.

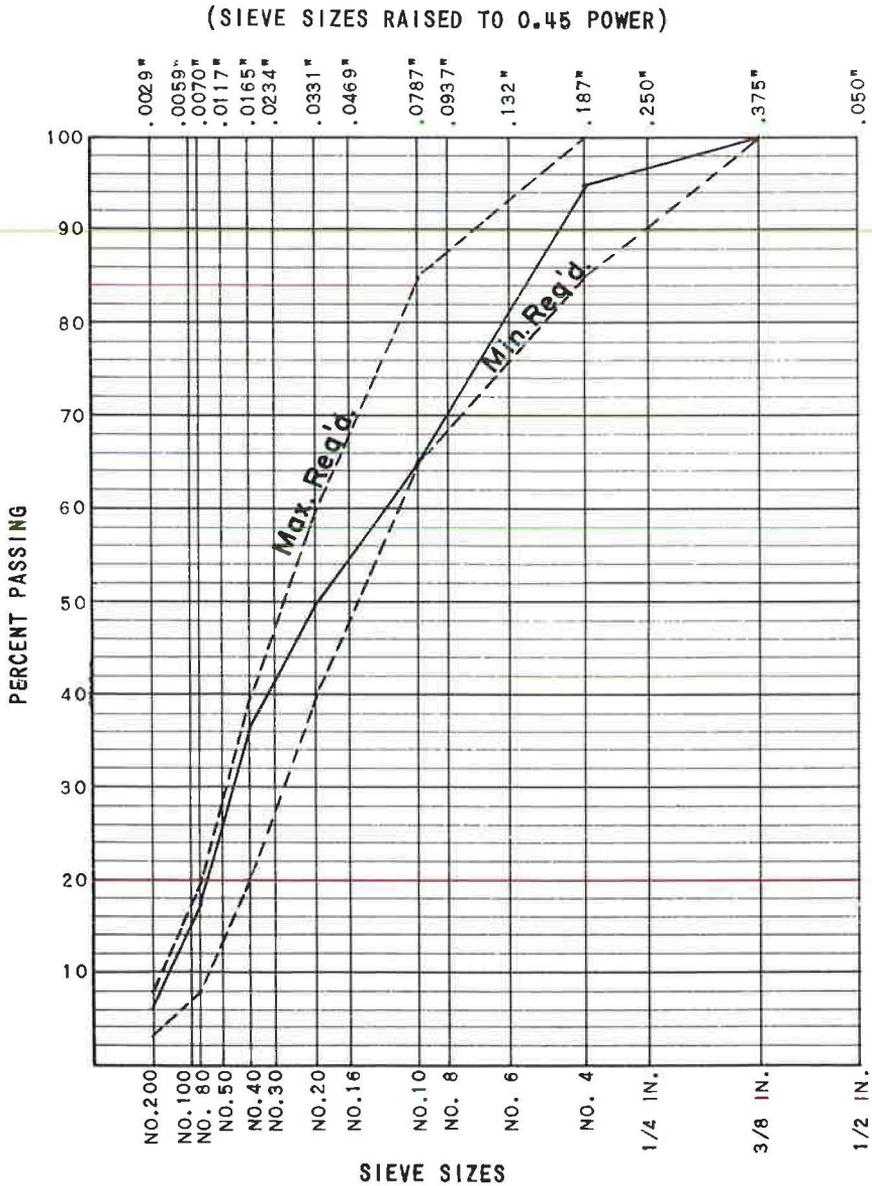
MATERIALS:	TYPE
1 27% Stone	Trap Rock
2 66% Stone Sand (Trap Rock)	
3	(Washed Sand)
4 7% A.C.	MC 5 Pen. 136

Figure 2. Gradation chart—Perfect Dix Seal, average of samples taken.

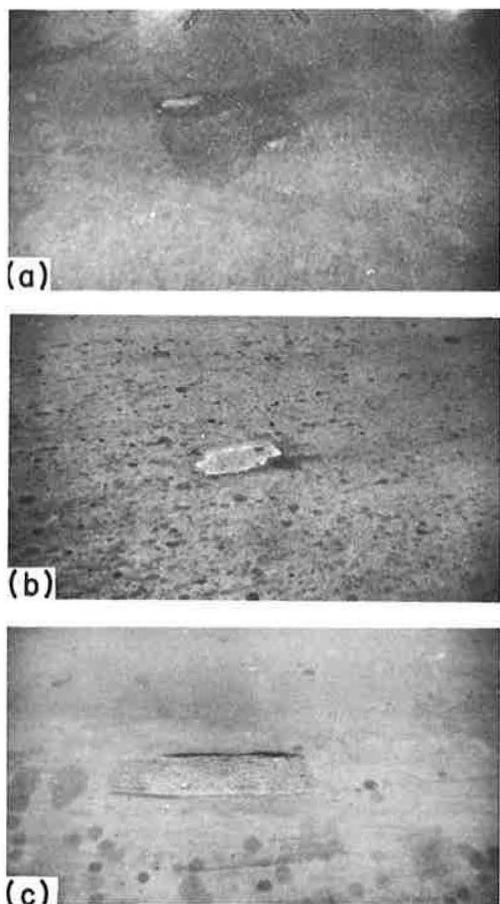
Figure 3. Perfect Dix Seal mix: (a) pushing or shoving, (b) and (c) cutting caused by rapid acceleration.

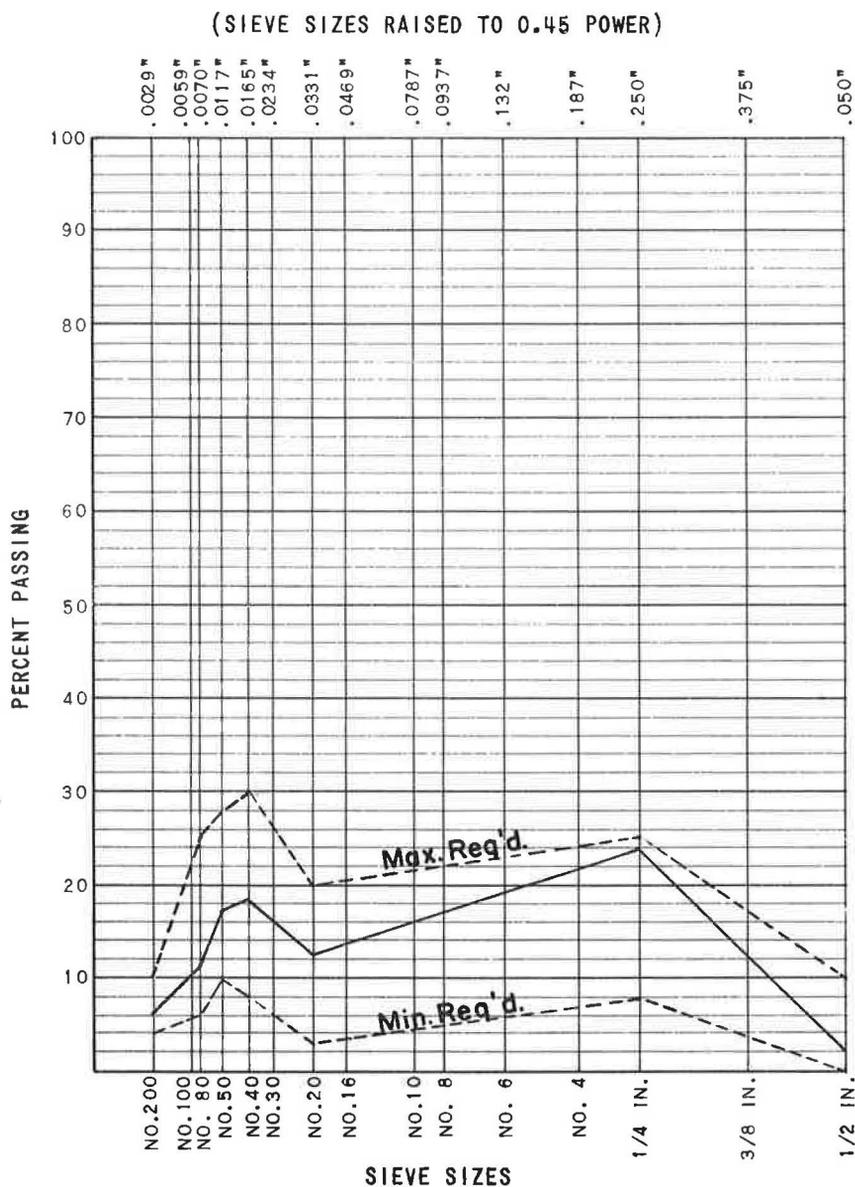
Figure 4. Gradation chart—SP-1, average of samples taken.

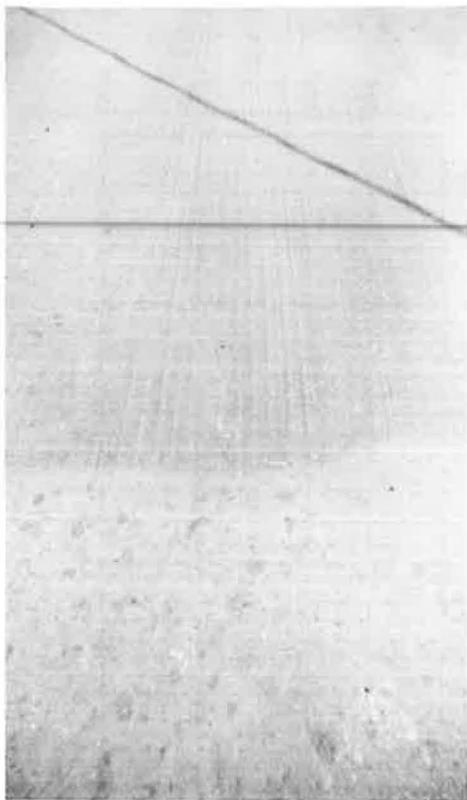
Figure 5. Pavement surfaced with SP-1 mix, showing tire marks.

asphalt pavement. When the air temperature went above 90 F, the surface became soft and left tire marks (Fig. 5). Tire impressions occurred only at two different locations on asphalt pavement, and both were under heavy traffic conditions. This could have been caused by an excess of asphalt on the original pavement. It is recommended that a lower penetration asphalt be used in the SP-1 mix when it is to be applied to asphalt pavement. To surface 23, 115 sq yd of pavement 750 tons were used. The yield was 64.4 lb/sq yd at a unit cost of \$0.338 per sq yd.

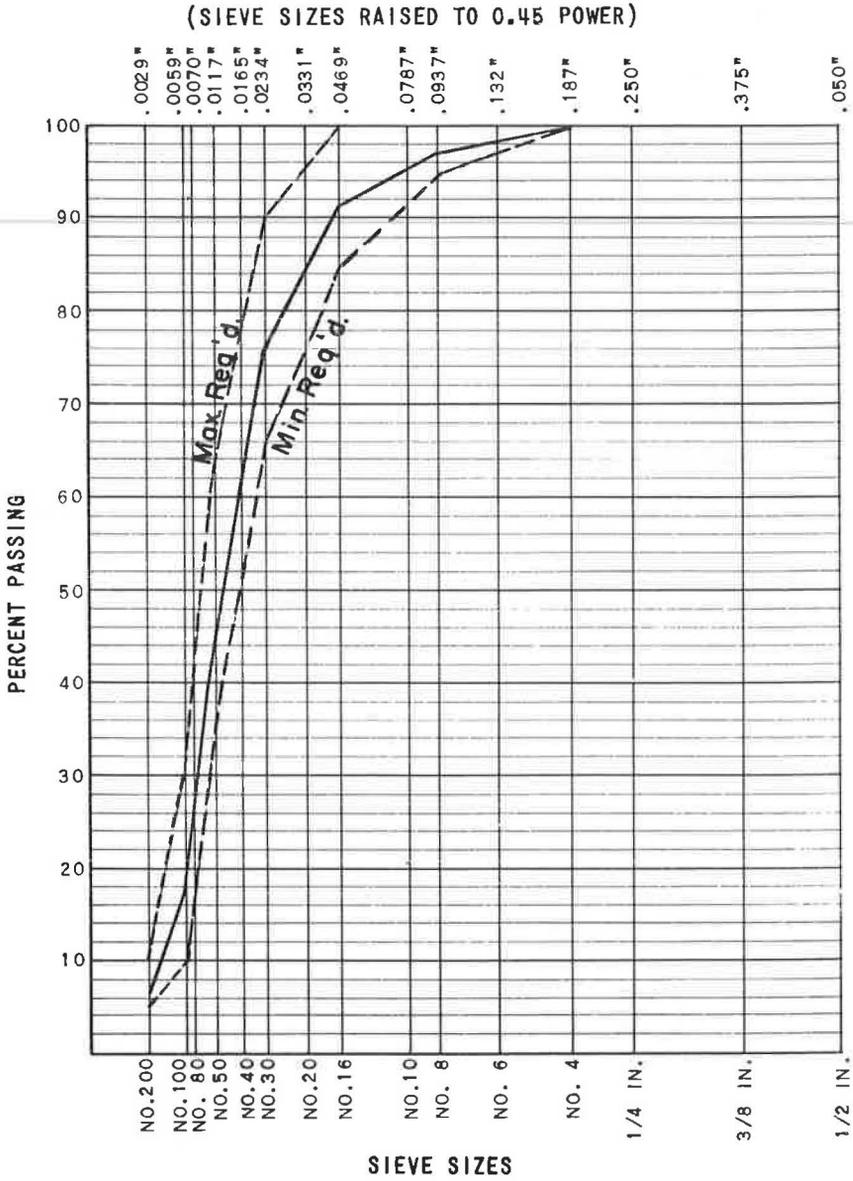
MATERIALS:	TYPE
1 87 % Sand	Washed Sand
2 4 % Filler	Limestone Dust
3 8.55 % A.C.	O.A. (85-100 Pen.) Pen. 97
4 0.9 % Rubber	R- 504

Figure 6. Gradation chart—Hot-laid rubberized sand asphalt, average of samples taken.

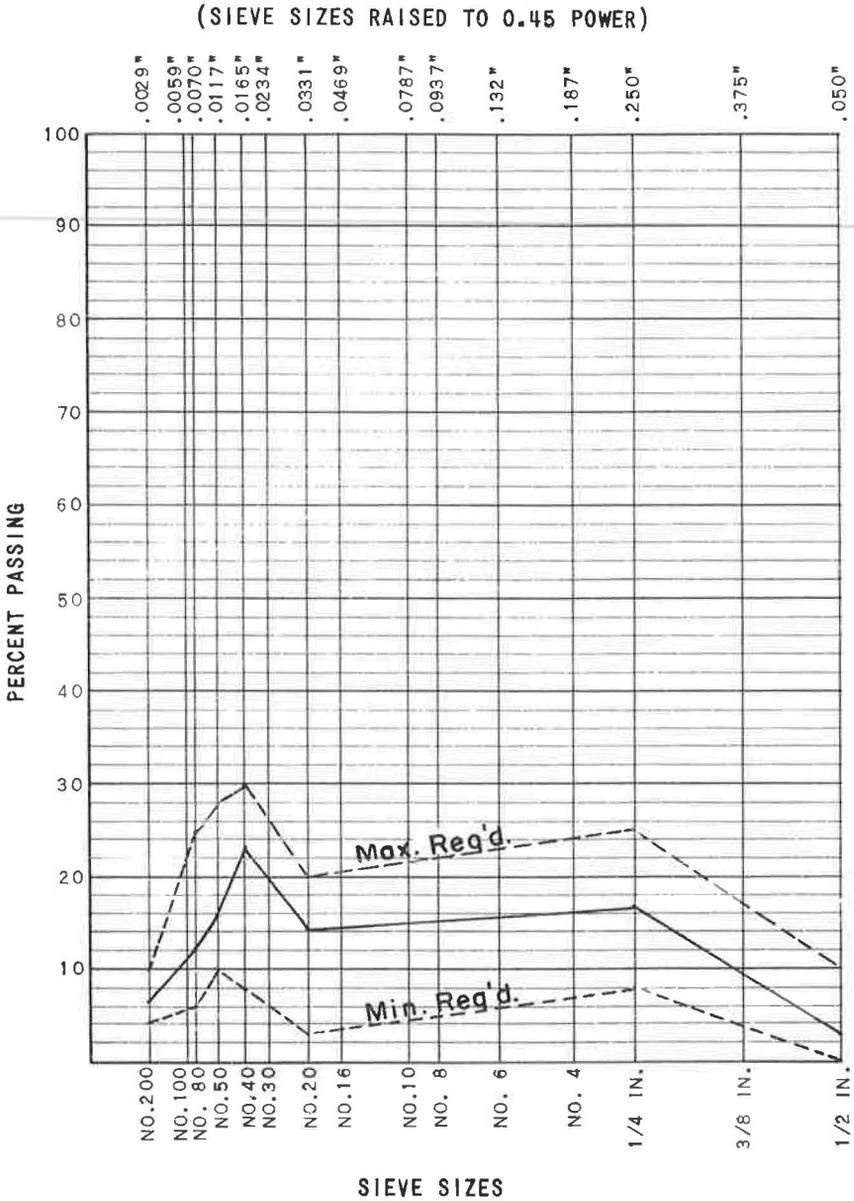
MATERIALS:		TYPE
1	22 % Stone	Trap Rock
2	63.5 % Sand	Bituminous Sand
3	5 % Filler	Limstone Dust
4	9.5 % A.C.	R.S.3 K Pen. 178

Figure 8. Gradation chart—Asphalt emulsion hot mix, average of samples taken.

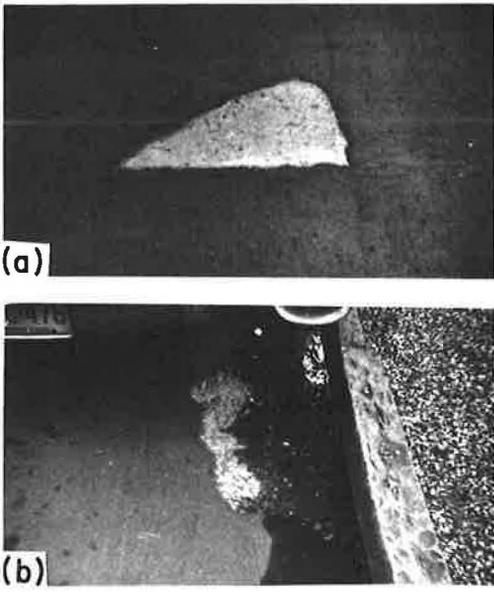
Figure 9. Faults on concrete pavement surfaced with emulsion hot mix: (a) in the crown at a transverse joint where reflection cracking occurred; and (b) on gutter line, caused by improper sweeping.

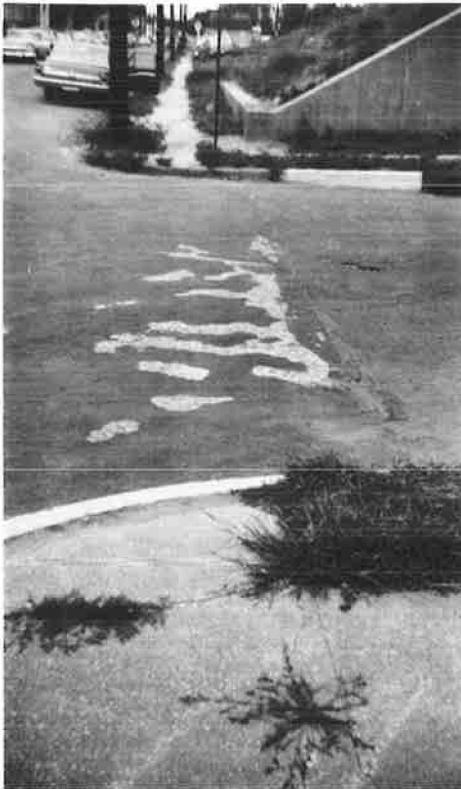
Figure 11. Maryland Smooth Seal surface showing an example of worn spots which occurred at four intersections.

This mix was laid when the temperature of the concrete pavement was approximately 40 F. The mix cooled rapidly and did not provide the fine texture and smooth joints which can be achieved when the pavement is warmer. The tack coat used was asphalt emulsion grade RS-1, uniformly applied; it appeared to be very effective. Because the ambient temperature was about 40 to 45 F, the mix tore behind the paving machine, making it necessary to hand broadcast behind the paver, accompanied by raking and luting. The 3-wheel and tandem roller were right behind the paving machine; the mix compacted well but cooled rapidly. The rough-textured areas were smoothed out by traffic action. The temperature of the mix was about 310 F on the job, and it was handled through the paving machine satisfactorily, except for the tearing caused by the cold pavement temperature.

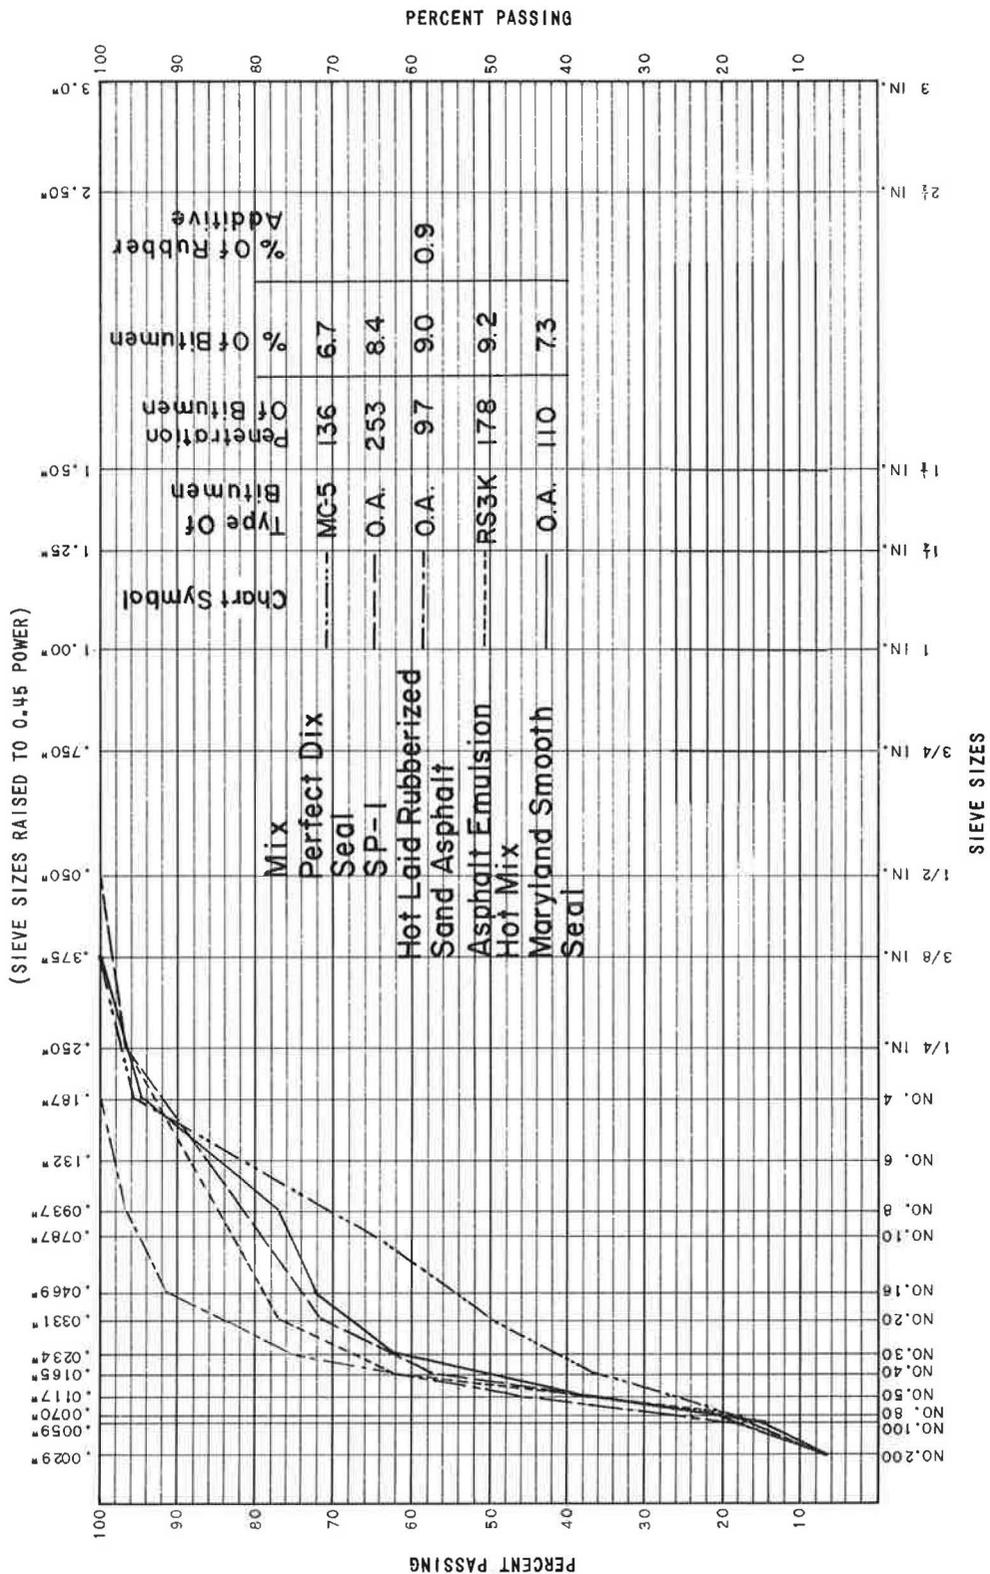
Figure 12. Comparison of gradations and bitumen.

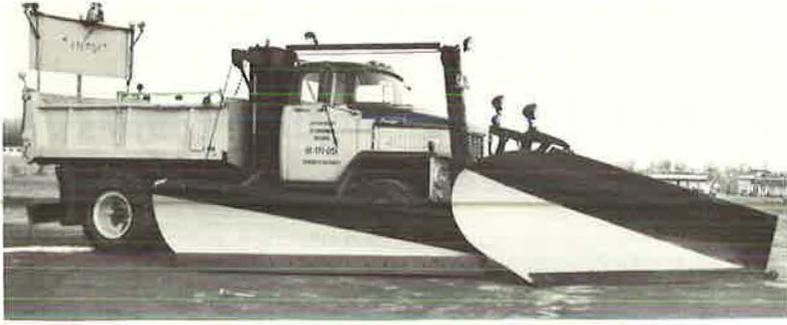
Figure 1. One-way plow.

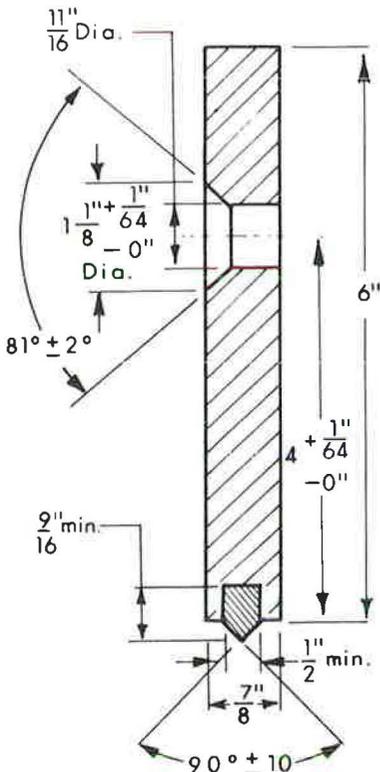
Figure 2. Original blade design.

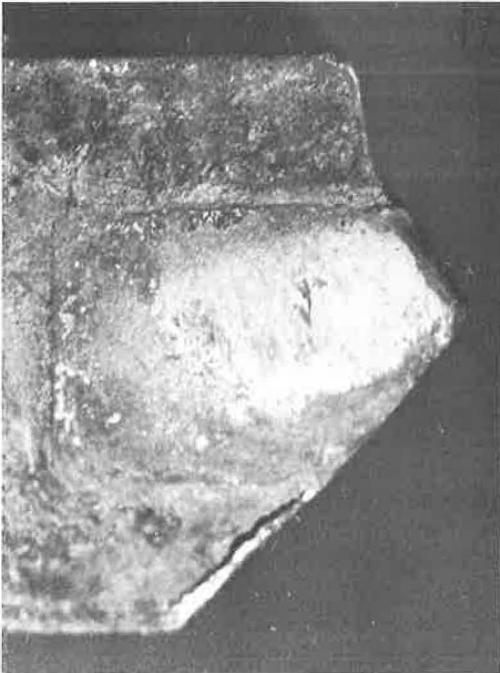
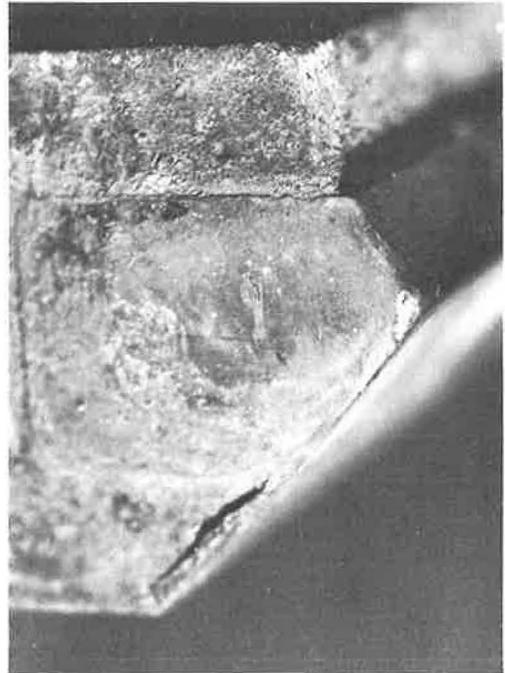
Figure 4. Original blade after three winters' use.

The two plows were operated in tandem throughout the winter season and each plow was alternately used in the lead position so that both blades were exposed to leading and trailing positions and covered equal mileages. During this test over the full plowing season, the plow fitted with the conventional steel blade used a total of 8 blades, whereas it was not necessary to replace the experimental blade, which suffered only a minor amount of wear. The wear that occurred was fairly uniform across the length of the blade, practically nil at the leading edge, and only $\frac{1}{32}$ in. at the trailing edge. Figure 4 shows this blade after 3 winters' use.

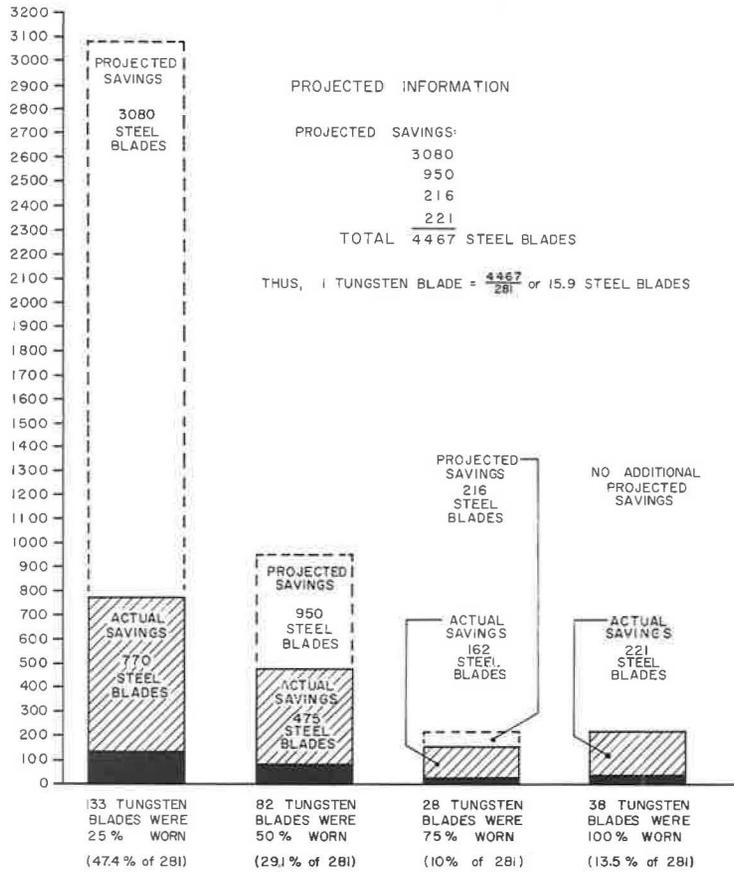
Figure 5. Actual savings in steel blades and projected savings (116-in. blade).

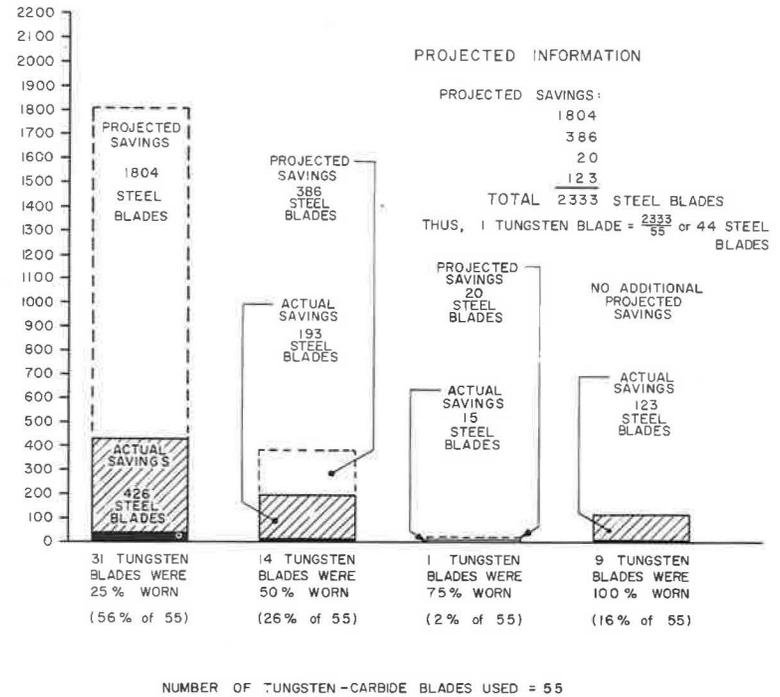
Figure 6. Actual savings in steel blades and projected savings (132-in. blade).

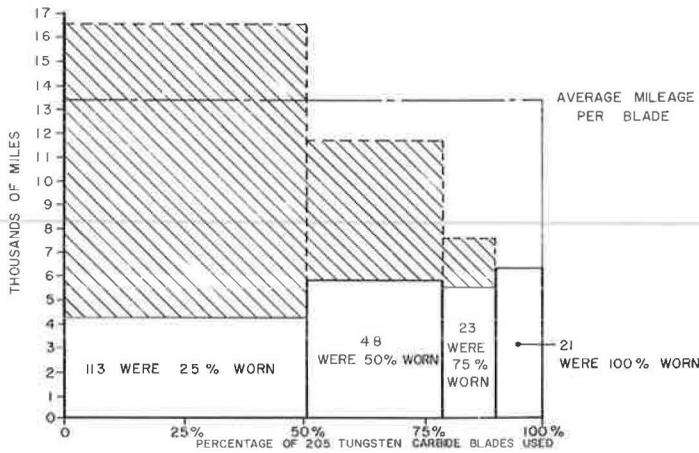
Figure 7. Actual mileage for 1965-1966 season and projected mileages for 116-in. tungsten carbide blades.

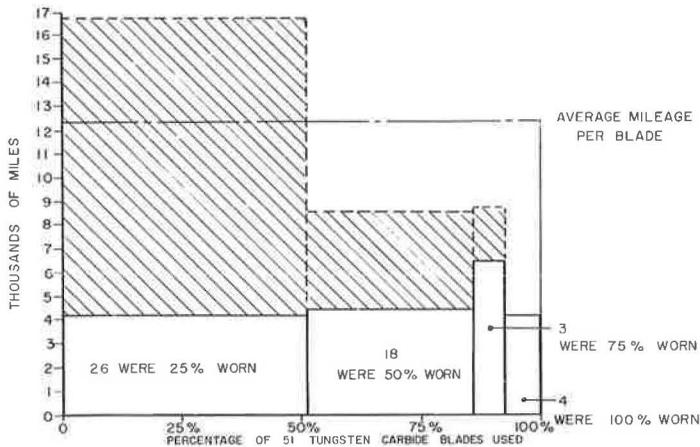
Figure 8. Actual mileage for 1965-1966 season and projected mileages for 132-in. tungsten carbide blades.

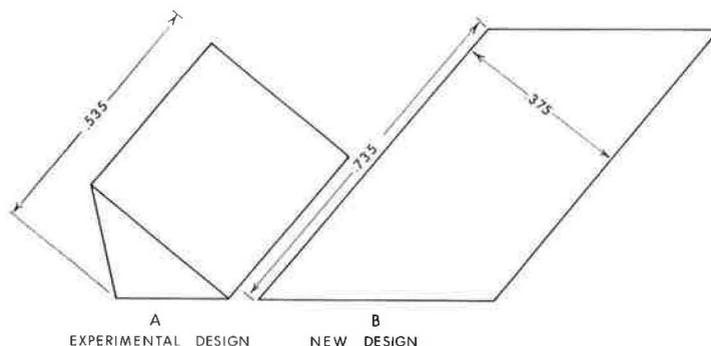
Figure 9. Original and new blade design.

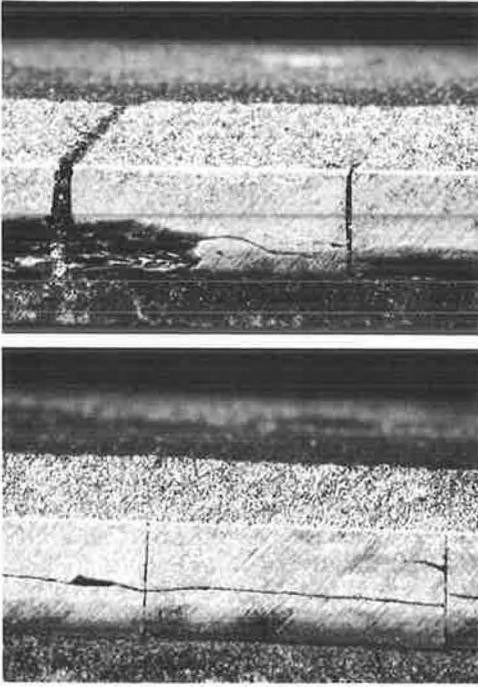
Figure 10. Blade shattering along the longitudinal plane.

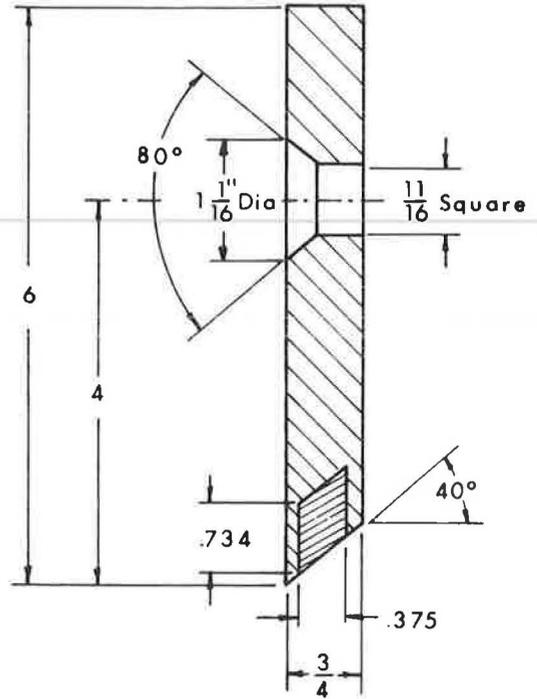
Figure 11. New design of blade.
