HIGHWAY RESEARCH RECORD

Number 173

Maintenance
and
Equipment

HIGHWAY RESEARCH BOARD

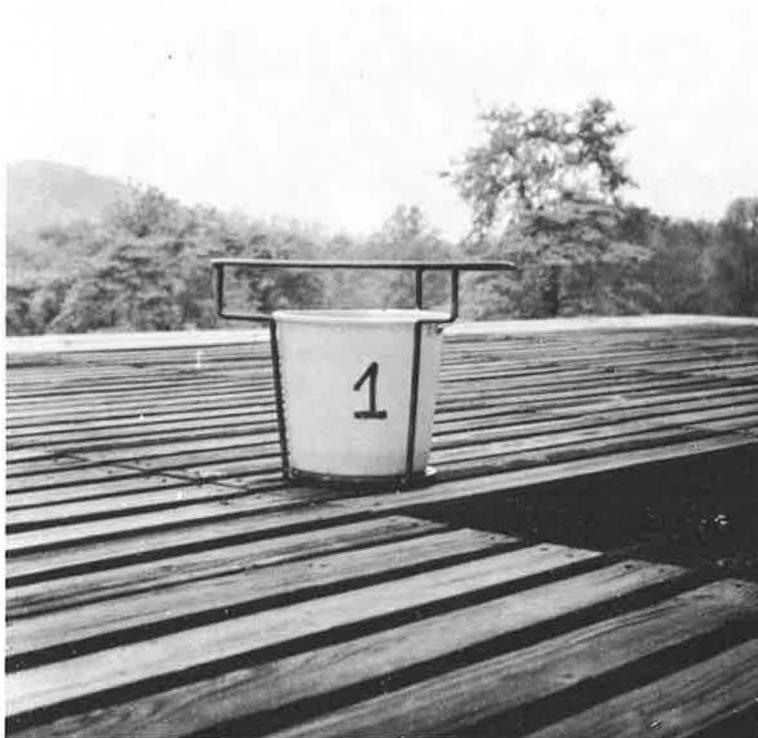
Figure 1. Typical dustfall bucket.

month. Figure 1 shows one of these dustfall buckets; it is nothing more than an ordinary plastic waste basket. Figure 2 shows typical dustfall data taken across a line traversing the quarry property and indicates how rapidly the heavier settleable dusts deposit themselves. In the case illustrated, over 90 percent was dropped within a half mile of the source.

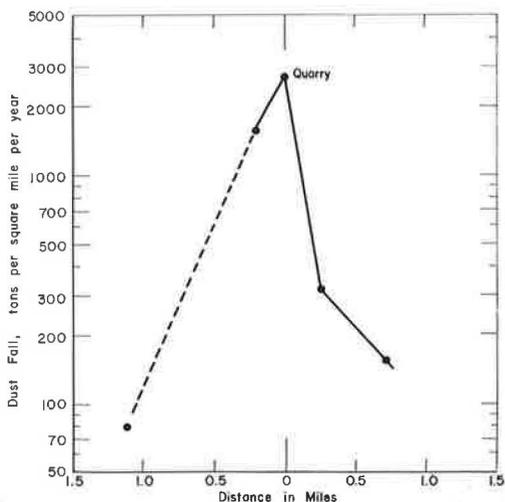
Figure 2. Northwest-southeast dustfall profile across study area.

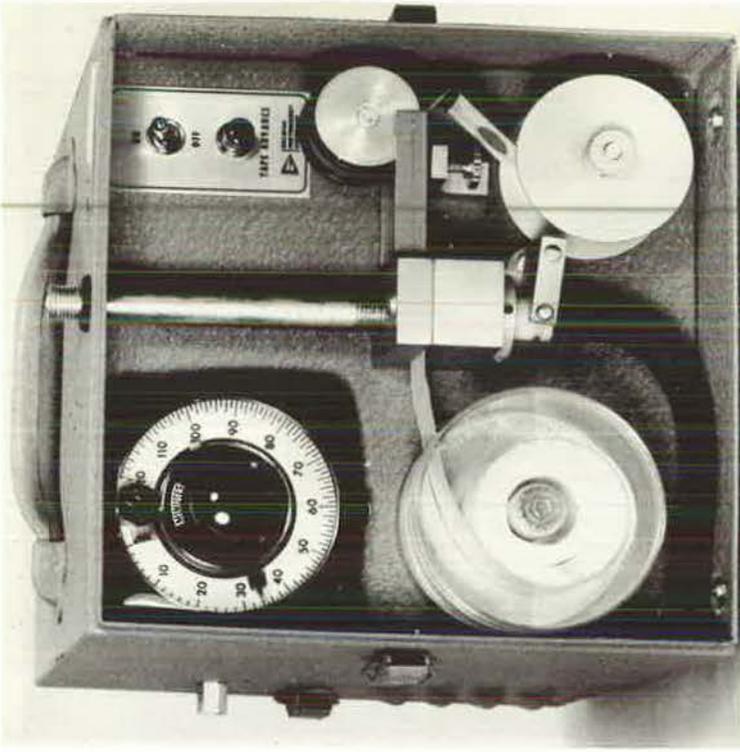
Figure 4. Automatic tape sampler.

The tape sampler (Fig. 4) is essentially a small vacuum pump which draws air through a filter paper tape. The tape effectively removes the suspended dust from the

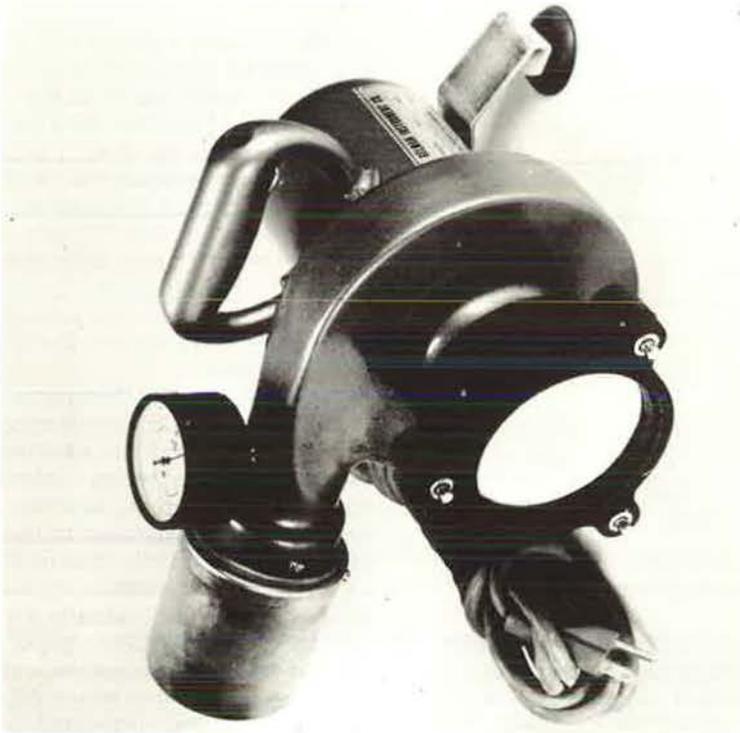
Figure 3. High-volume sampler.

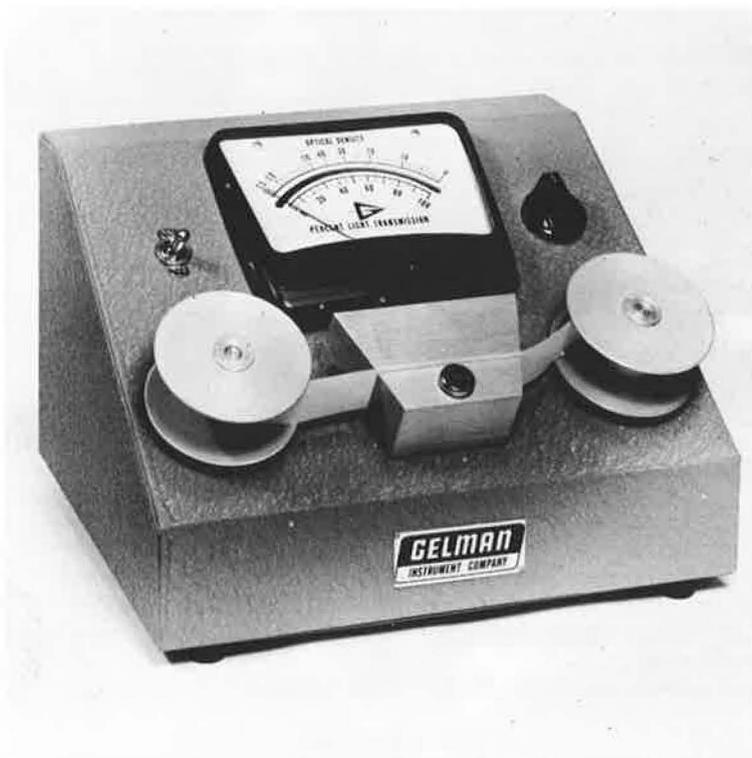
Figure 5. Papertape analyzing unit (densitometer).
