# Cofferdams for the Town Creek Piers of the Silas N. Pearman Bridge Over the Cooper River, Charleston, South Carolina

ROBERT J. CARLE, Sales Engineer, Bethlehem Steel Corporation,  
Bethlehem, Pennsylvania

This paper discusses the cofferdam design for Pier T-2 of the Town Creek spans of the Silas N. Pearman Bridge at Charleston, S. C. The discussion covers the adverse soil conditions at the site as well as the design assumptions and procedure. A large portion of the paper is devoted to the installation procedure in which the contractor employed various expedients to reduce the cost of cofferdam construction. These reduced costs were reflected in the bid price which was below the engineer's estimate.

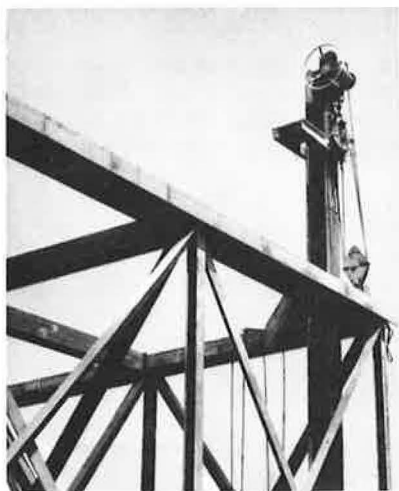
Figure 9. Hand winch on spud pile.

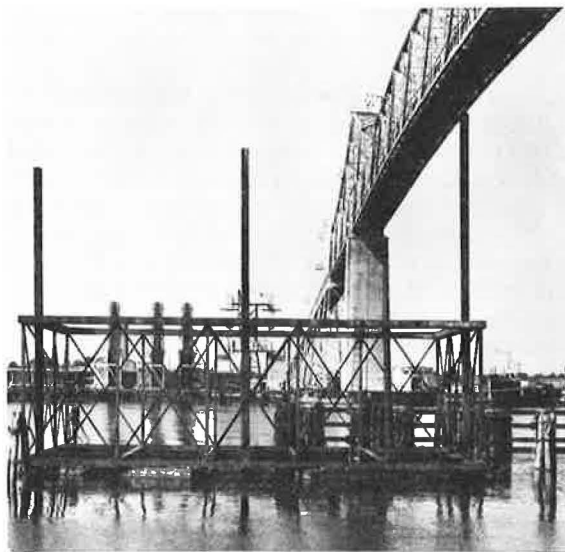
Figure 10. Bracing on pontoons (photo taken at Pier T-3).

periphery. When the spuds were dropped through the prefabricated slots along the wale (see Fig. 8), they penetrated the soil under their own weight to elevation -60, which was just 2 ft above the proposed sheet piling tip elevation. The six piles, each 120 ft in length, were then driven into the Cooper marl to elevation -87. The two tiers of bracing were hung from hand winches located at the top of the spud piles. Figure 9 shows the winch installation. The winch lines were taut at high tide so that, as the tide went out, the pontoon barge was floated out from under the bracing cage. Figure 10 shows the pontoon-mounted bracing.
