HIGHWAY RESEARCH RECORD

Number 262

Pipes
and
Culverts

REBUILT WOLF CREEK CULVERT BEHAVIOR	
Alfred C. Scheer and Gerald A. Willett, Jr.	1
Discussion: M. G. Spangler.	10
PERFORMANCE OF A REINFORCED CONCRETE PIPE CULVERT UNDER ROCK EMBANKMENT	
Robert C. Deen	14
Discussion: M. G. Spangler.	27
CULVERT DESIGN IN SOME EUROPEAN COUNTRIES	
Gabor M. Karadi and Raymond J. Krizek	29
THE MECHANISMS OF ABRASION OF ALUMINUM ALLOY CULVERT, RELATED FIELD EXPERIENCES, AND A METHOD TO PREDICT CULVERT PERFORMANCE	
Almont H. Koepf.	44
CORROSION EVALUATION OF ALUMINUM CULVERT BASED ON FIELD PERFORMANCE	
T. A. Lowe, R. H. Vaterlaus, R. I. Lindberg and L. R. Lawrence	56

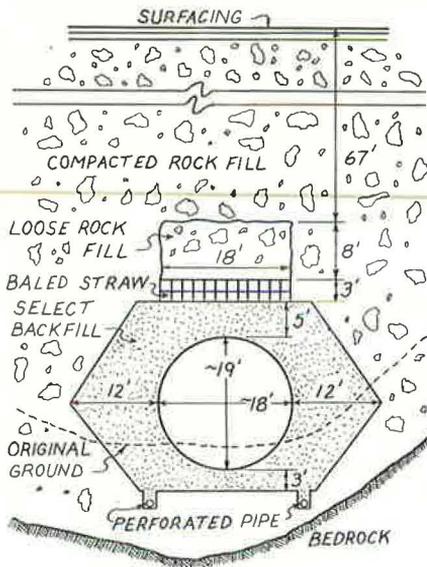
Figure 1. Typical cross section of rebuilt culvert.

There have been relatively few opportunities to observe empirical values of this ratio, but on the basis of limited information, the writer has used and recommended values in the range of -0.3 to -0.5. Although the geometry of the reconstructed Wolf Creek culvert imperfect ditch does not comply exactly with the situation for which the load theory was developed, the basic principle of creating favorable differential settlements between the central prism of soil and the adjacent side prisms is the same, and it is of interest to calculate a load by the theory and compare the result with the present authors' measured loads. The main difference between the actual and the theoretical case is the existence of a 5-ft layer of highly compacted granular soil between the top of the pipe and the bottom of the imperfect ditch where the layers of straw bales were placed, as shown in Figure 1 of the paper.

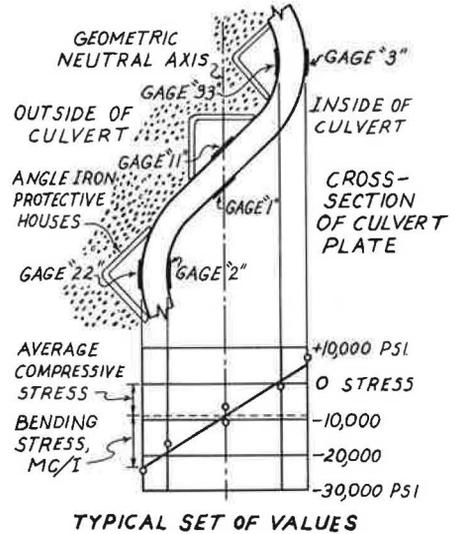
Figure 2. Position of SR-4 strain gages to measure circumferential strain in the corrugated plates.

The six plates, containing a total of 36 gages, were identified as plates A, B, C, D, E, and F. The strain gages located on the inside of the culvert, using plate A as an example, were numbered A1, A2, and A3, while those on the outside were A11, A22, and A33. Figure 3 shows the locations of the plates on which strain gages were attached. They were placed in the side walls of the culvert, at mid-height. The rings were numbered from 1 through 70 from downstream to upstream end, as they were in the original culvert, for identification purposes. Ring number 39 is under the centerline of the Interstate roadway. Notice from Figure 3 that plates A and B were installed in adjacent rings, in approximately diametrically opposed positions, as were plates C and D.

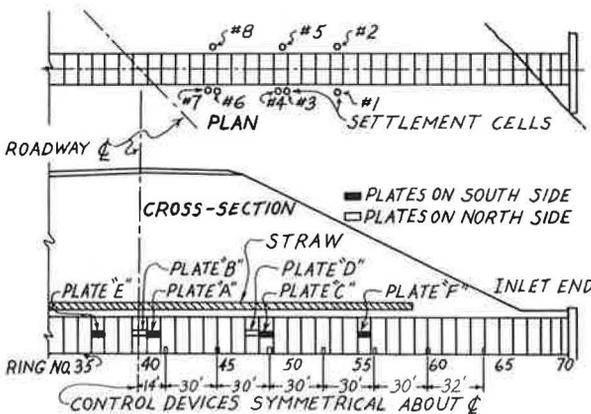
Figure 3. Location of SR-4 strain gages, settlement cells, and control devices.

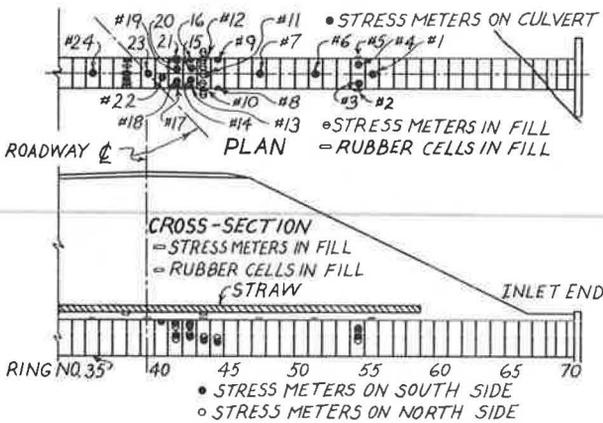
Figure 4. Location of Carlson stress meters and rubber pressure cells.

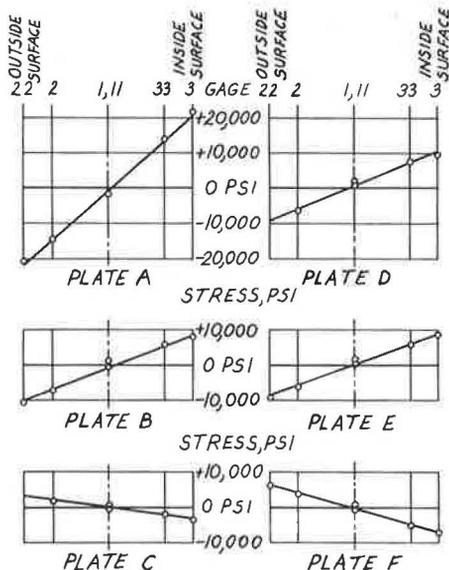
Figure 5. Erection stress in the six instrumented plates.

The placement and compaction of the backfill at the sides of the culvert caused a compressive bending stress in the outside fibers and tensile bending stress in the inside fibers of the sidewalls. For plates A, B, D, and E, these bending stresses were directly additive to erection stresses and therefore produced relatively large compressive stresses in the outside fibers. The strain gages showed a steady increase in direct wall compression but little additional change in bending as the embankment was

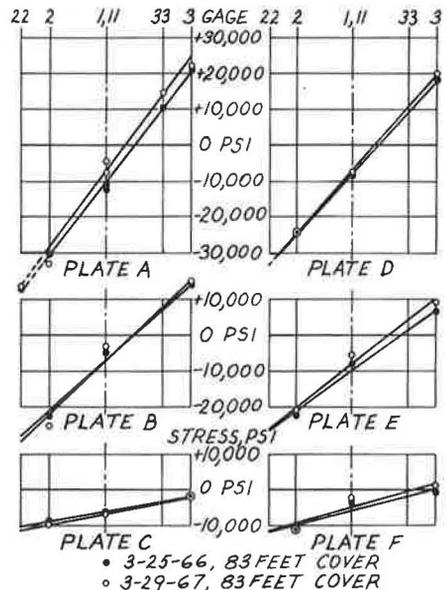
Figure 6. Combined stresses on March 25, 1966, and March 29, 1967.

constructed to its full depth. Thereafter the changes were relatively small, as indicated by Figure 6, which shows the stresses approximately 3 months and 15 months following completion of the embankment. By the end of the first winter, many of the gages on the outside walls had deteriorated and no longer furnished usable readings. The performance of the gages on the inside walls did not deteriorate until the summer of 1967.

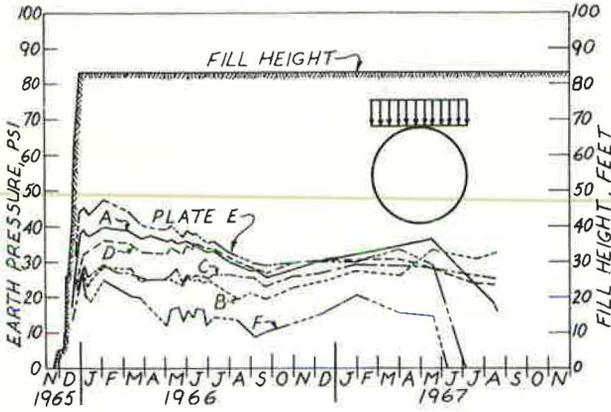
Figure 7. Equivalent uniform vertical earth pressures on culvert, deduced from SR-4 strain gages.

compressive stress by the wall sectional area per unit of culvert length and dividing by one-half the culvert width. The pressure was highest shortly after completion of the embankment and it eventually stabilized at a value near 30 psi, which is less than half of the nominal pressure of 72 psi that could be expected from an 83-ft depth of overburden weighing 125 pcf.

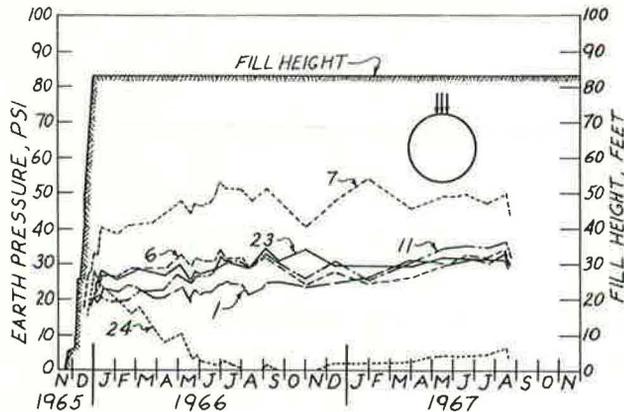
Figure 8. Earth pressure vs time—stress meters No. 1, 6, 7, 11, 23, and 24.

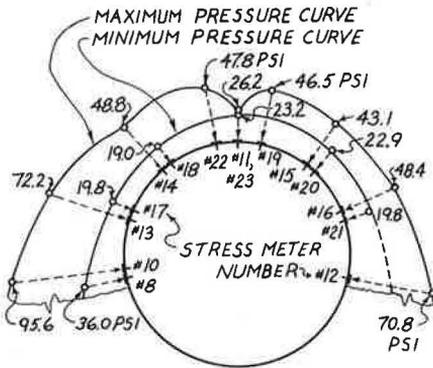
Figure 9. Earth pressures acting on the culvert walls on January 4, 1966.

In Figure 9, the minimum and maximum pressure curves are curves that were drawn to mark the boundaries of the zone within which all 15 of the observed pressures fell on January 4, 1966. No special sig-

nificance is attributed to the fact that all 15 of the plotted points happen to lie on one or the other of the two boundary curves.

Significantly, the lateral load on the culvert exceeds the vertical. The stress meter results in Figure 9, the bending stress pattern in the sidewalls, and the slight increase in vertical diameter observed during the final year of the study, are all indicative of dominant lateral pressure.

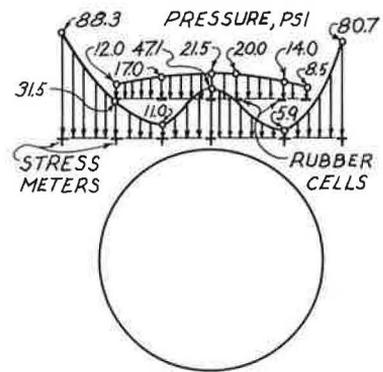
Figure 10. Earth pressures on January 4, 1966, determined from the stress meters and rubber pressure cells located in the fill.

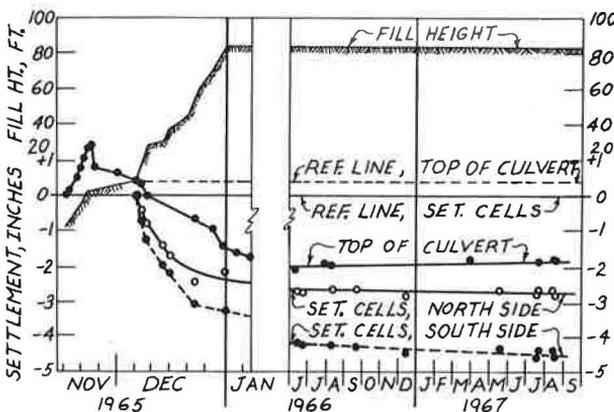
Figure 11. Settlement of the settlement cells and top of culvert.

Figure 11 shows the average settlement of the culvert crown, near the center of the culvert, and the average settlement of the north-side and south-side settlement cells in the same vicinity. Notice that the top of the culvert settled about 2.3 in. while the north-side cells settled 2.7 in. and the south-side cells settled 4.5 in. The lesser amount of settlement experienced by the north-side settlement cells is perhaps related to the fact that the depth to bedrock is somewhat less on the north side of the culvert than on the south side. However, the top of the culvert settled less than any of the settlement cells, which shows that the prism of soil "sandwiched" between the straw and the culvert is subjected to a "positive projection" condition, with the adjacent prisms exerting downward frictional drag stresses on each of the two side faces.

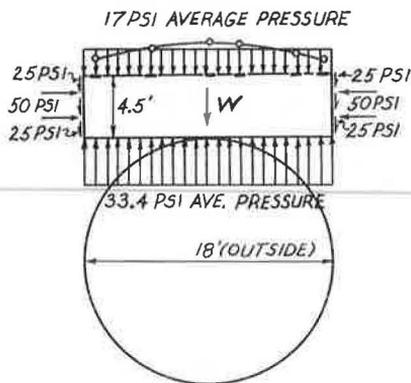
Figure 12. Pressure at top of culvert estimated from rubber pressure cells.

Figure 12 shows a free-body diagram of the $4\frac{1}{2}$ -ft thick central block below the straw with the 17-psi average pressure (from the rubber cells) acting on its top face. The normal pressure on the sides is estimated from Figure 9 as 50 psi and the

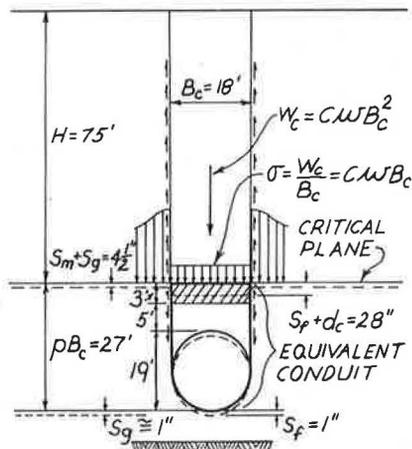
Figure 13. Application of Marston's theory to the Wolf Creek culvert.

For all practical purposes this is equivalent to a complete ditch condition, so the diagram for ditch conduits may be used to calculate the pressure on the straw. The curve for minimum pressure, in Figure 24-3 of Spangler's text (4), would come the closest to representing the correct condition for the cohesionless rock fill of the Wolf Creek culvert embankment. Then $H/B_c = 75/18 = 4.2$, which yields a value of $C = 2.1$ from the ditch conduit diagram. Estimating the embankment unit weight, w , as 125 pcf, we may then estimate the pressure on the straw, according to Marston's theory, as

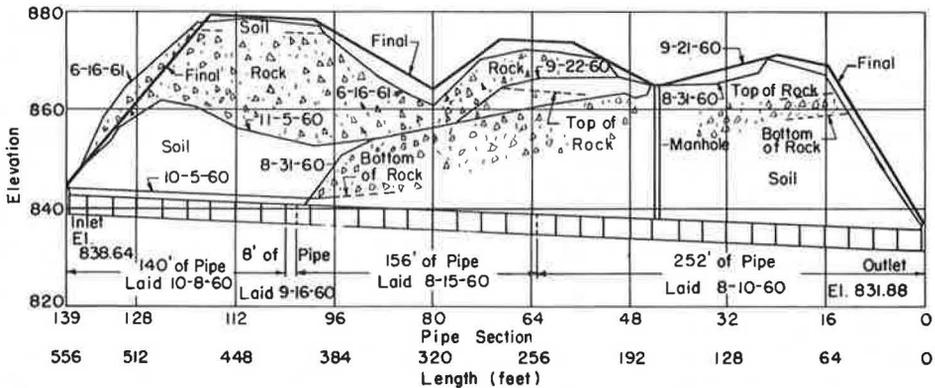
Figure 1. Fill profiles.

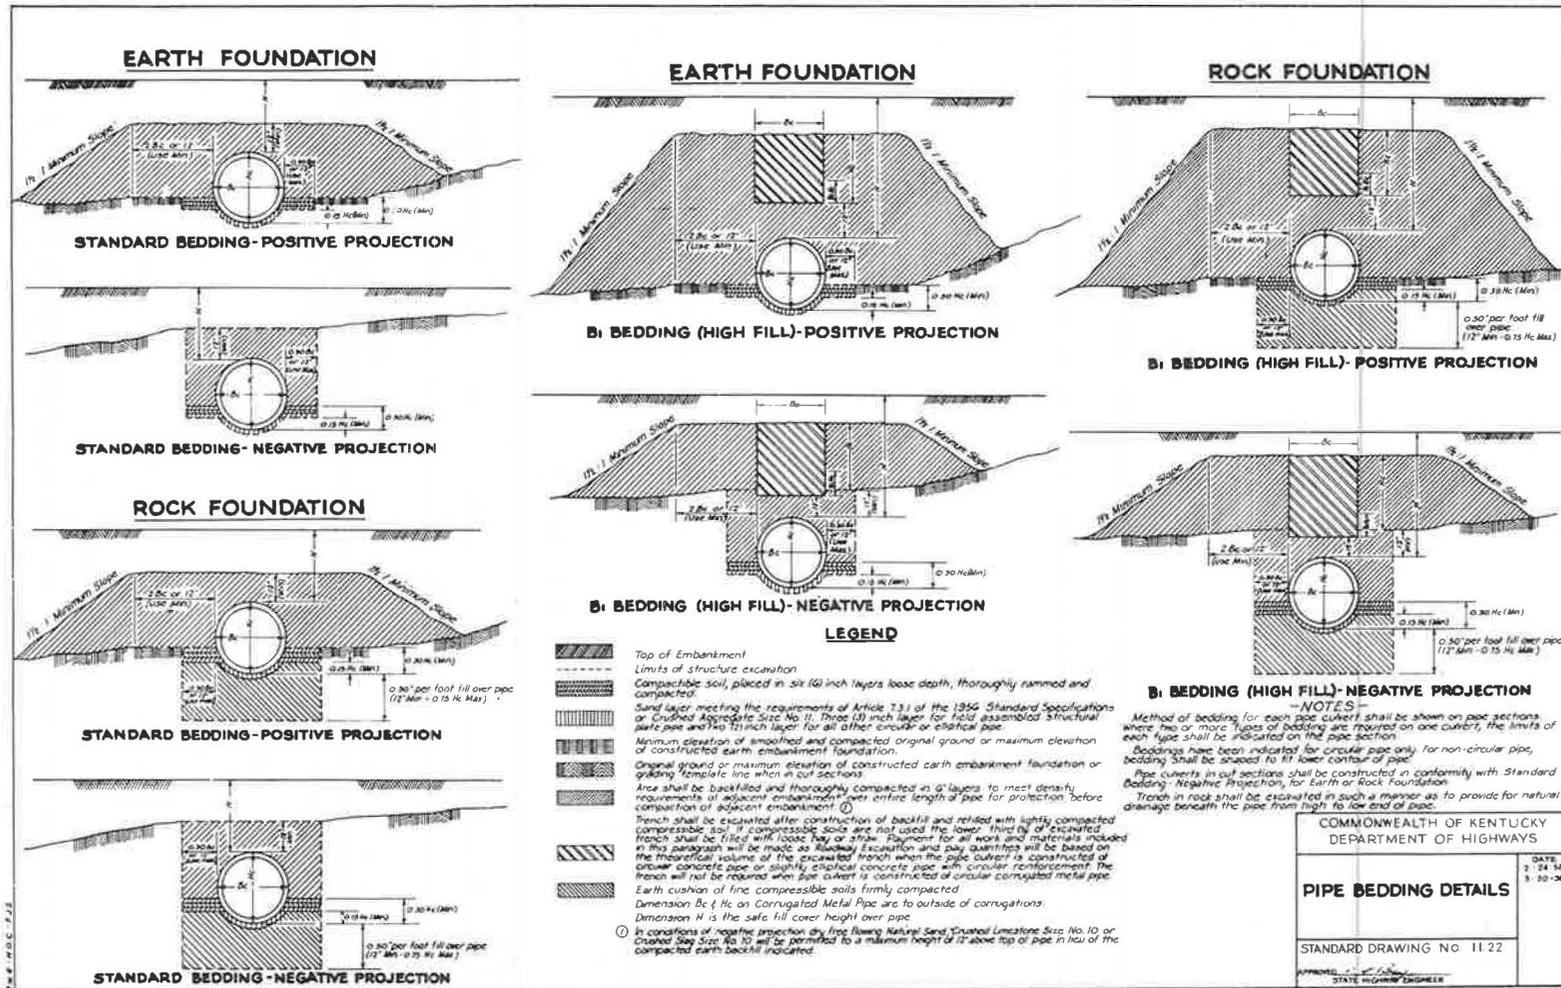
KENTUCKY DEPARTMENT OF HIGHWAYS STANDARD DRAWINGS
SHOWING PIPE BEDDING DETAILS AND ALLOWABLE FILL HEIGHTS

Figure 3. Kentucky pipe bedding details.

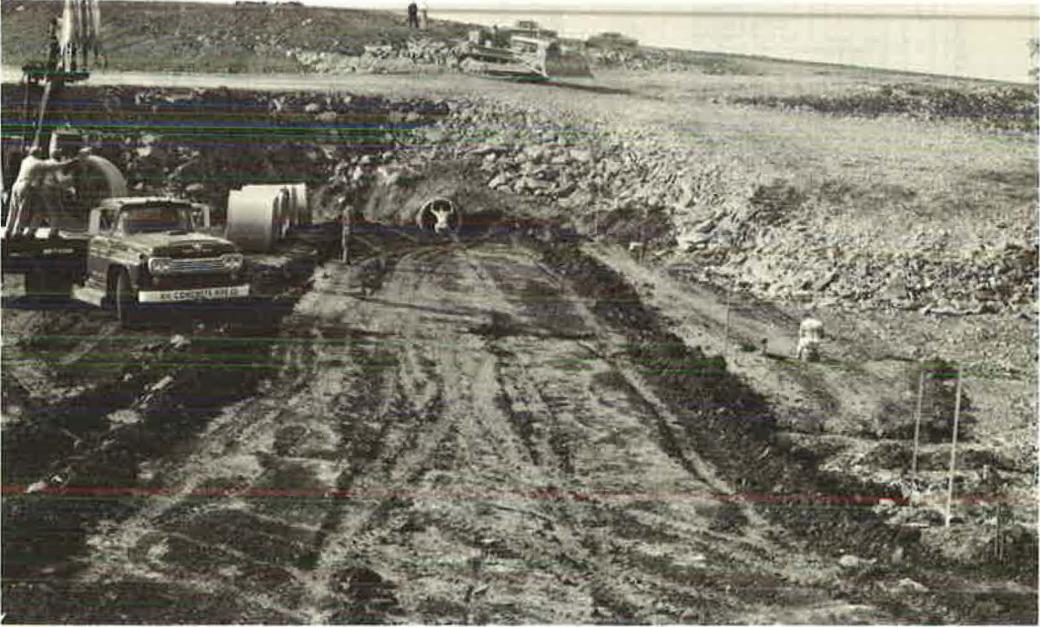
Figure 5. Pipe bedding prepared: Undesirable material removed and replaced with selected compacted backfill.

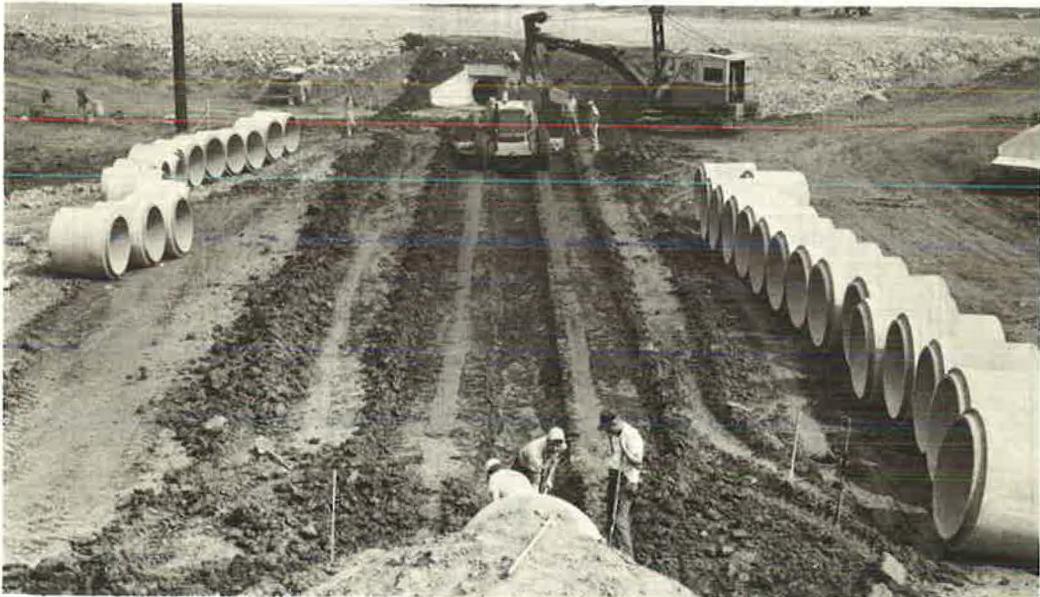
Figure 6. Patrol grader with special blade preparing soil for laying pipe.

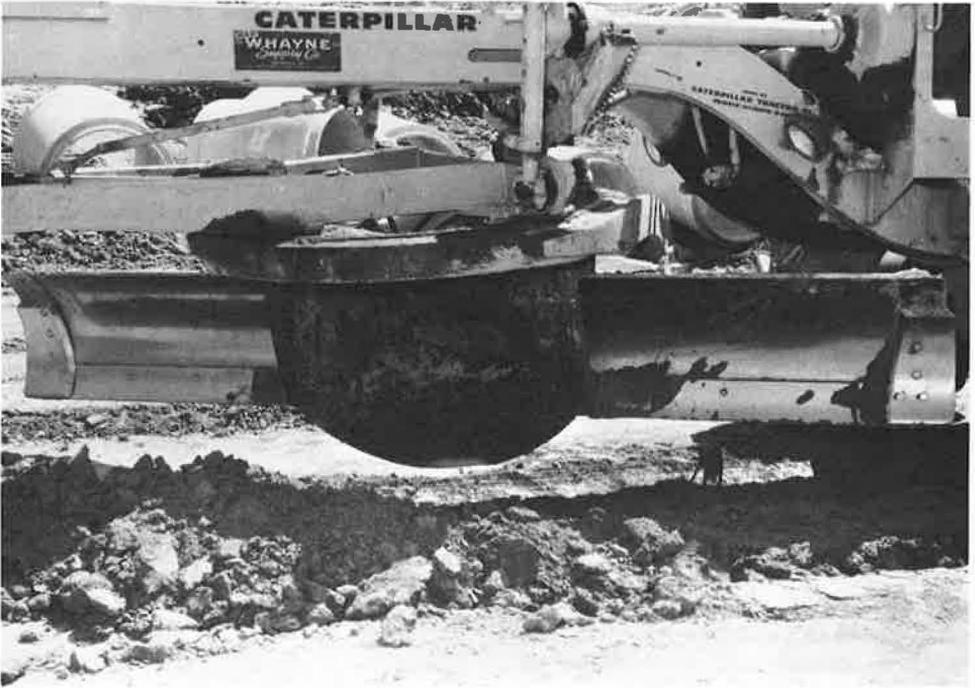
Figure 7. Close-up of special blade on patrol grader.

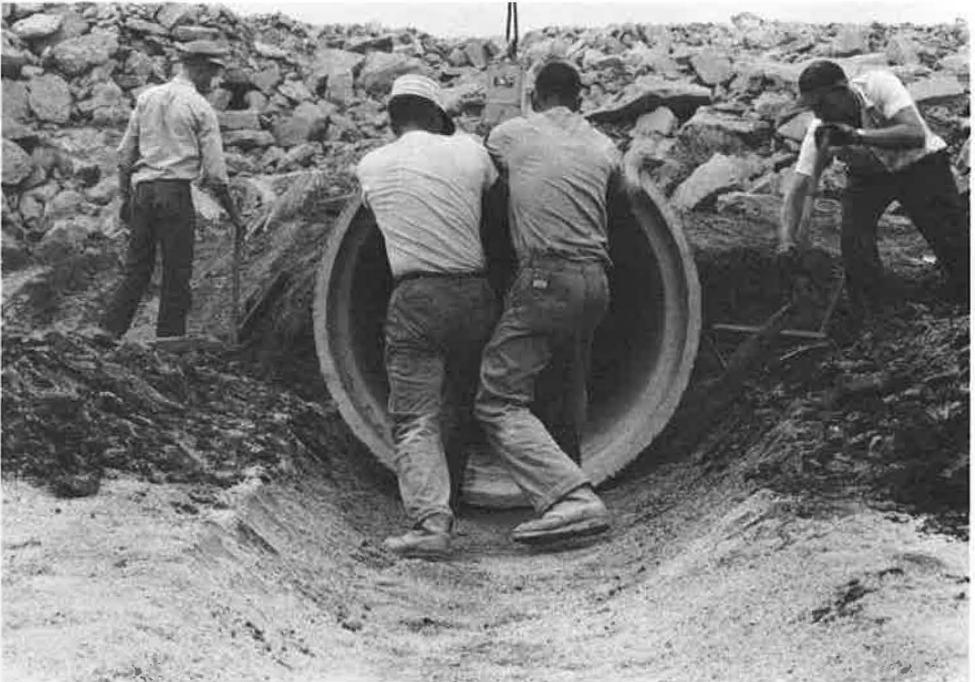
Figure 8. Placing pipe in sand cushion bedding.

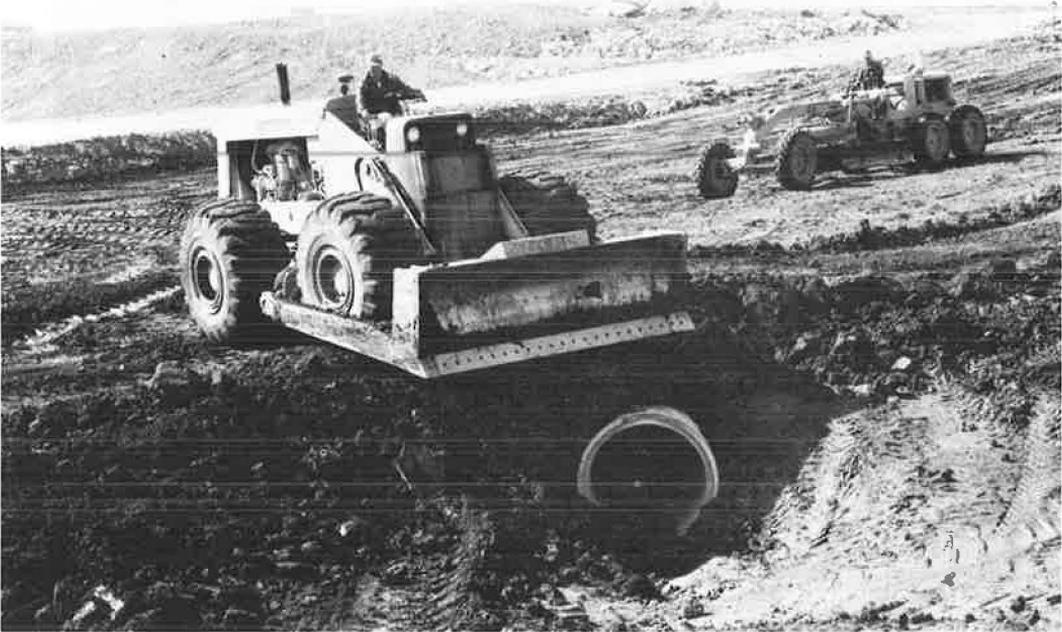
Figure 9. Placing backfill before construction of the imperfect trench (when specified).

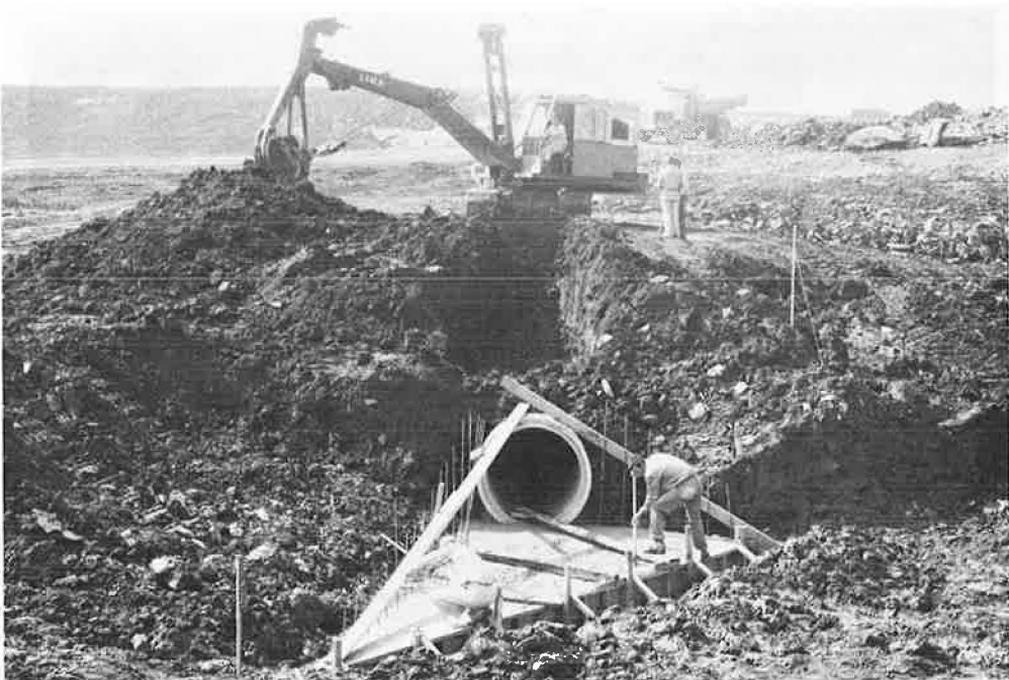
Figure 10. Construction of the imperfect trench (when specified).

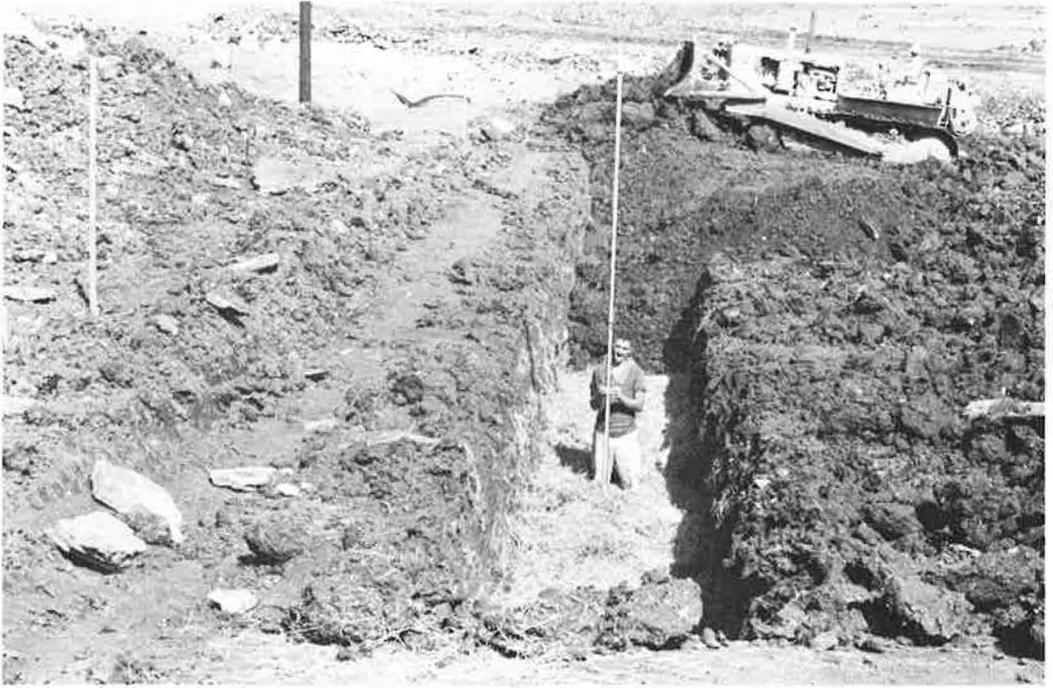
Figure 11. Loose backfilling of imperfect trench: Straw placed to a depth of one-third trench depth.

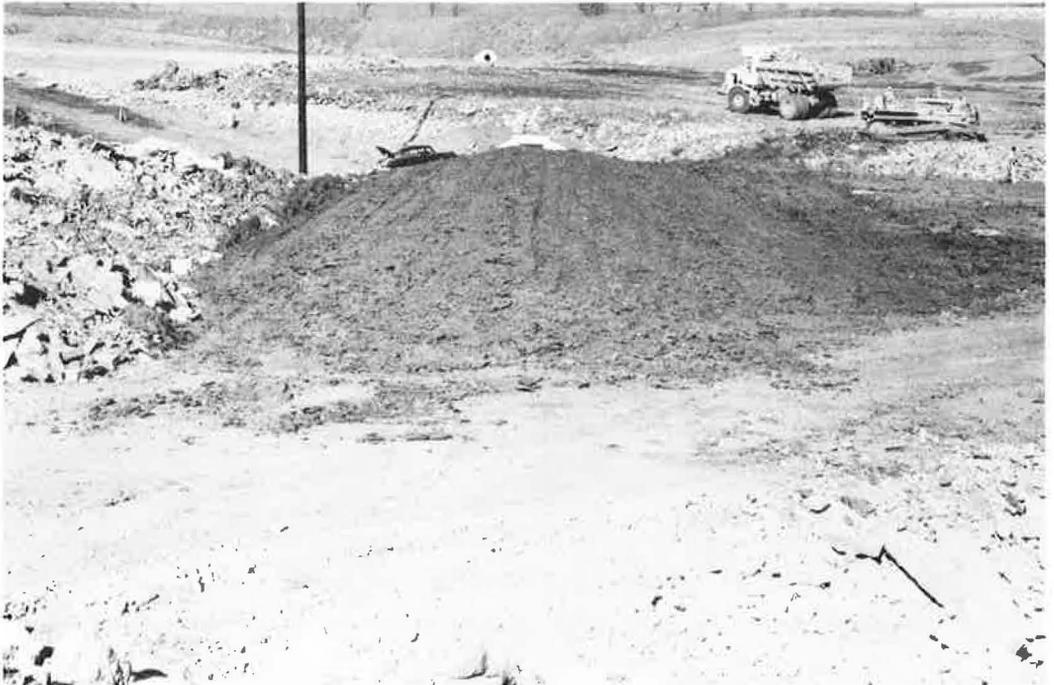
Figure 12. Completion of the imperfect trench: Embankment placed 2 ft above top of trench.

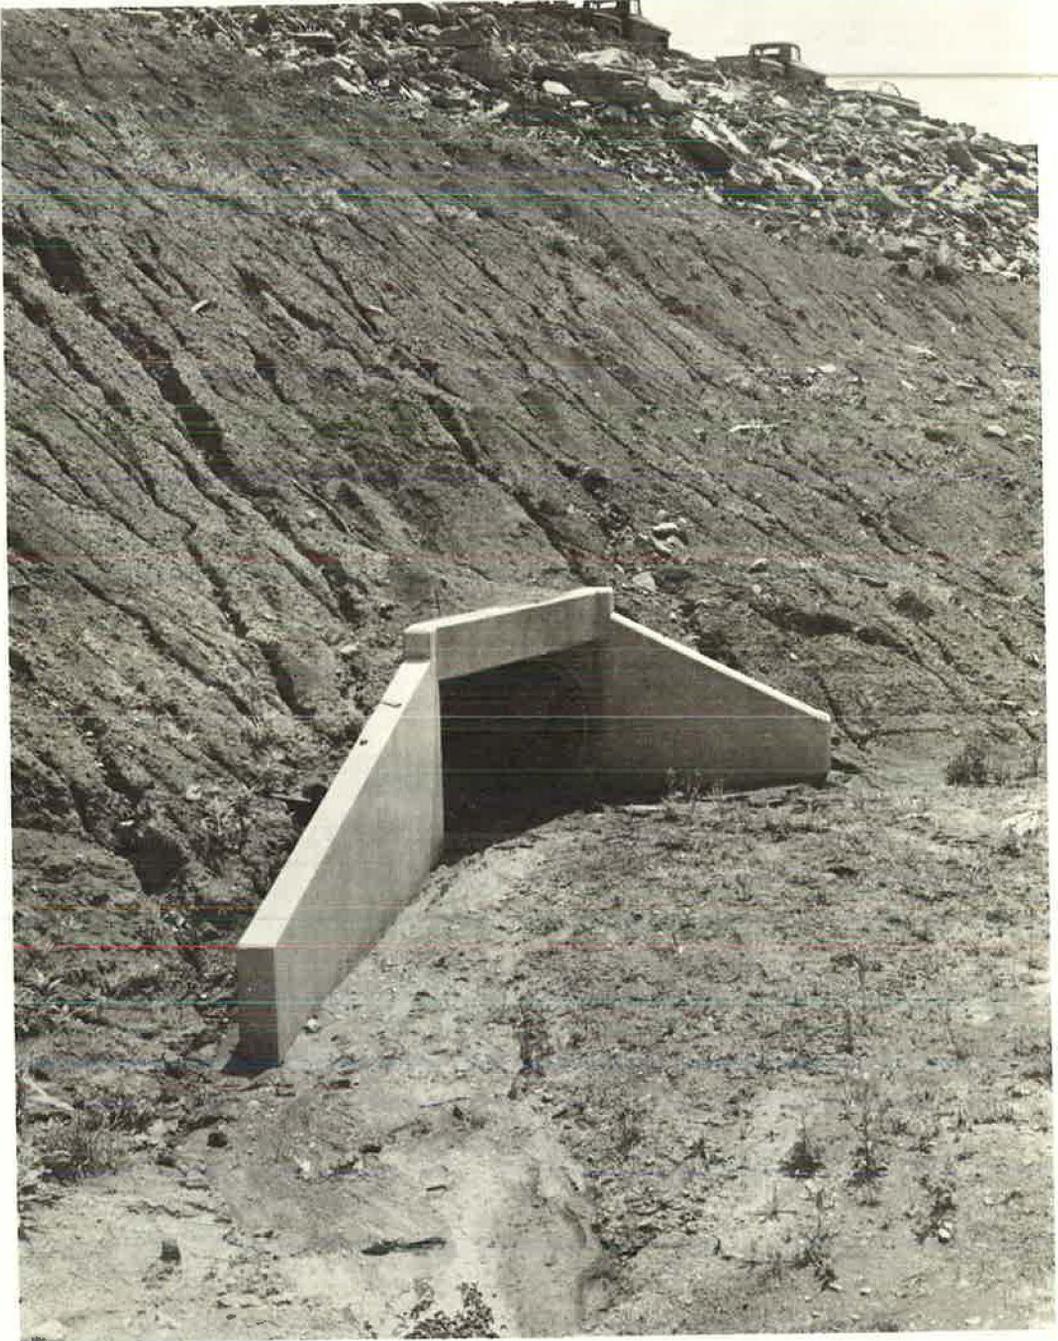
Figure 13. Embankment material placed over culvert: Line between soil and rock material shown.

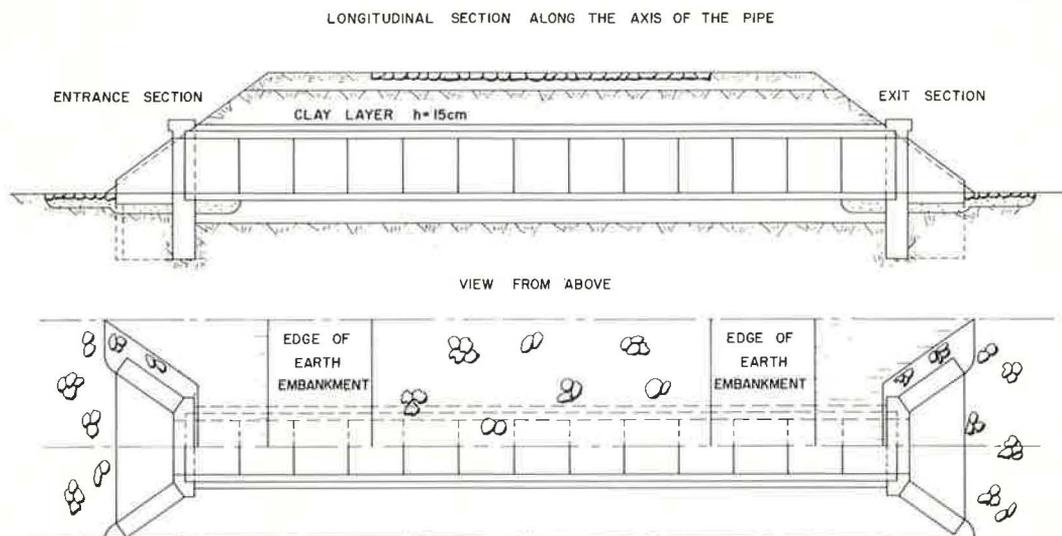
Figure 1. Typical standard reinforced concrete culvert.

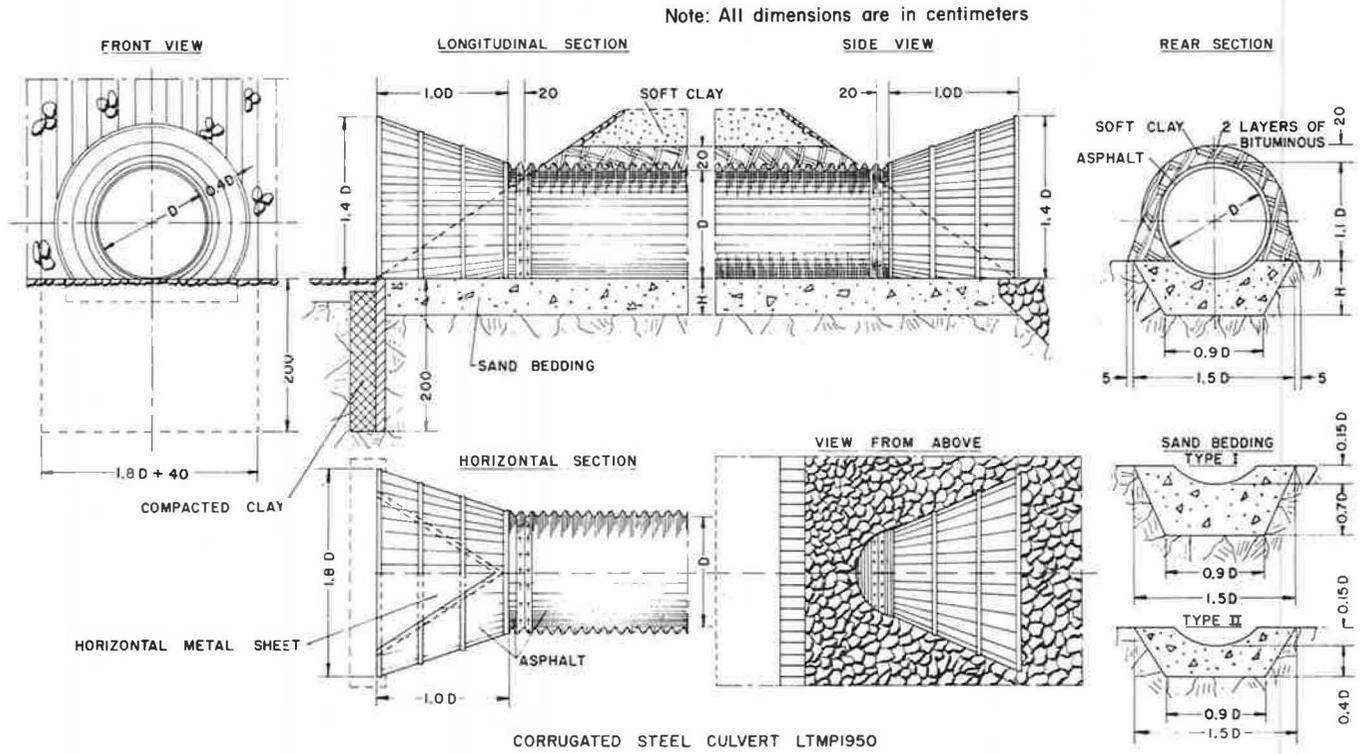
Figure 2. Typical standard corrugated steel culvert.

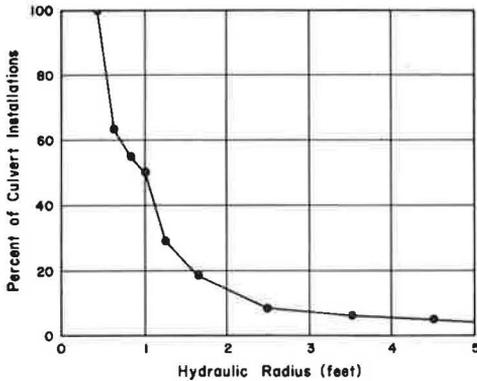
Figure 3. Distribution of culverts according to size.

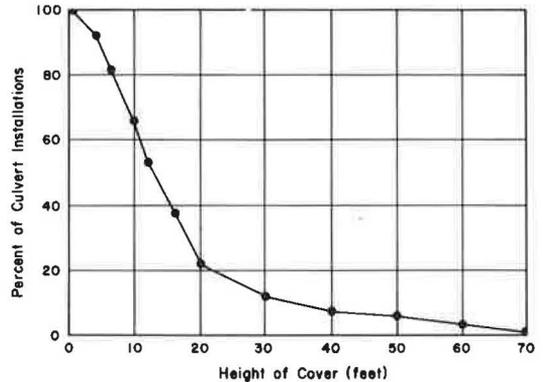
Figure 4. Distribution of culverts according to height of cover.

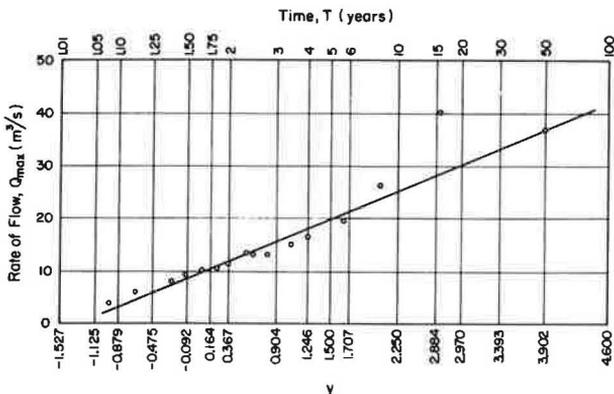
Figure 5. Peak flows of the Bühlot River (West Germany).

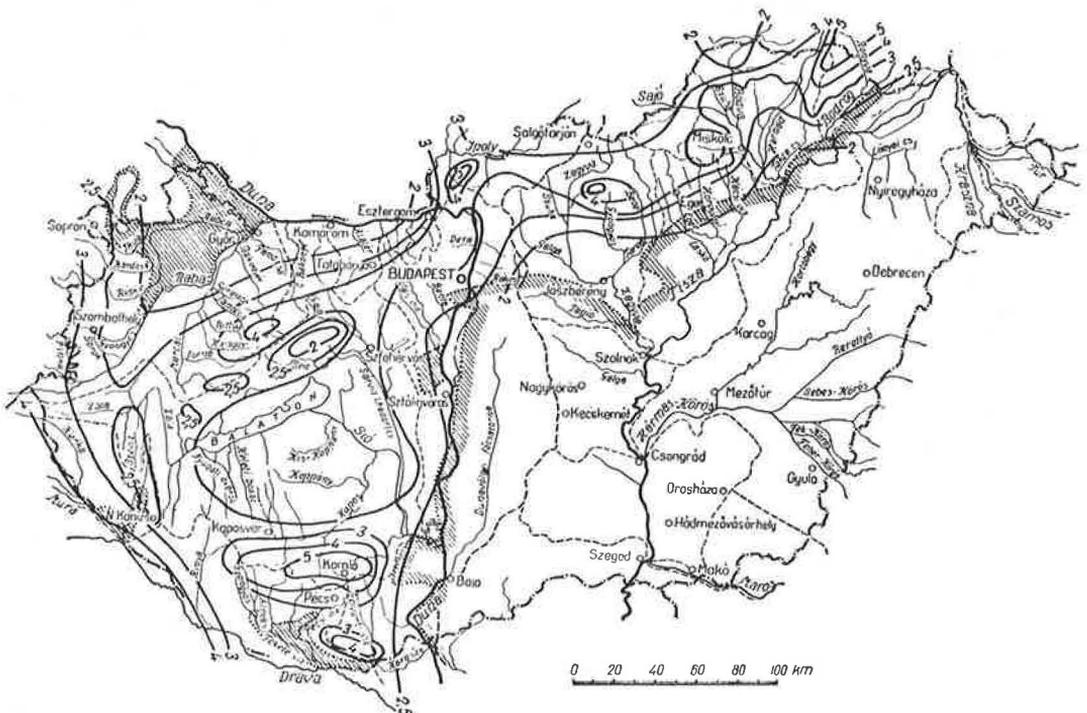
Figure 6. Typical designation for specific discharge factor α .

where α is a factor that depends on the climatic and geographical conditions and A is the catchment area. Values for α are specified according to geography and are usually

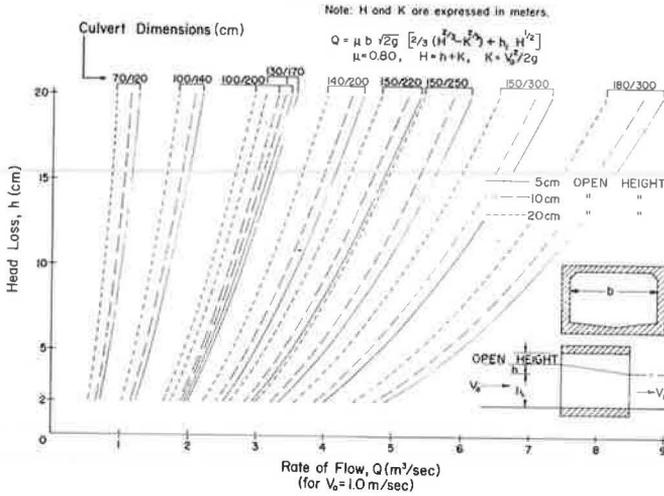
Figure 7. Chart for hydraulic design of rectangular culverts.

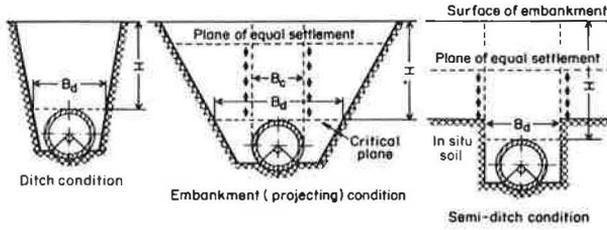
Figure 8. Classes of conduits according to DIN 4033.

In most European countries, there are no special standards or regulations for the structural design of culverts; such design procedures are usually included in general specifications and standards for roads, bridges, reinforced concrete and steel structures, etc. In Germany, however, the load on a pipe, installed as shown in Figure 8, is specified by a standard (16). The dead and live loads are usually determined by the methods of Frühling (17) or Marston (18). Although the Marston method is almost universally used, some doubts have arisen as to the acceptability of this method in view of changing construction methods, the complete change in live loads, etc. Recognizing the needs in this field, studies have been undertaken in England, Germany, Czechoslovakia, and several other European countries.

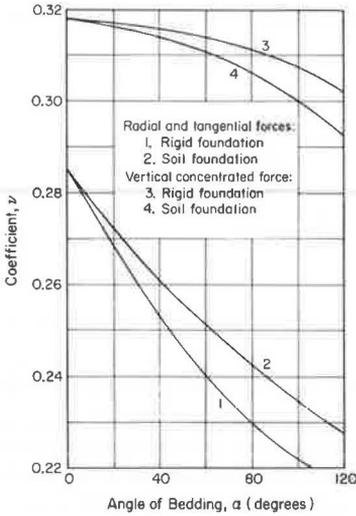
Figure 9. Effect of foundation type and angle of bedding on coefficient ν .

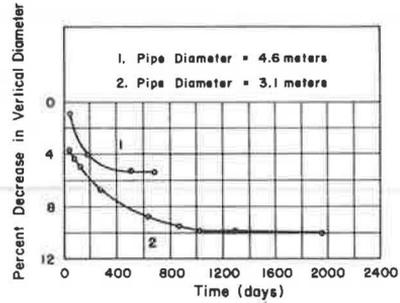
Figure 10. Change in vertical diameter with time.

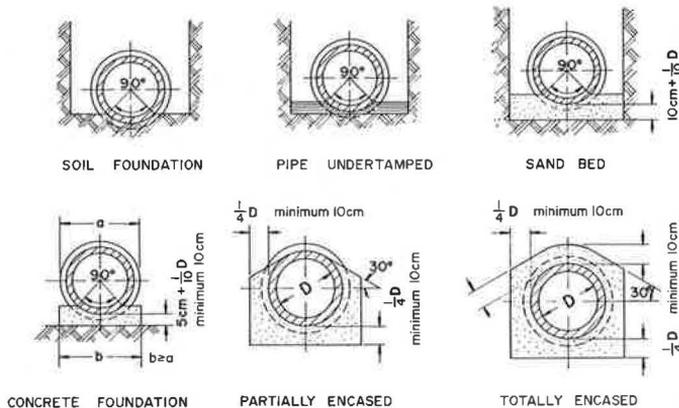
Fig. 11 Typical Bedding Conditions

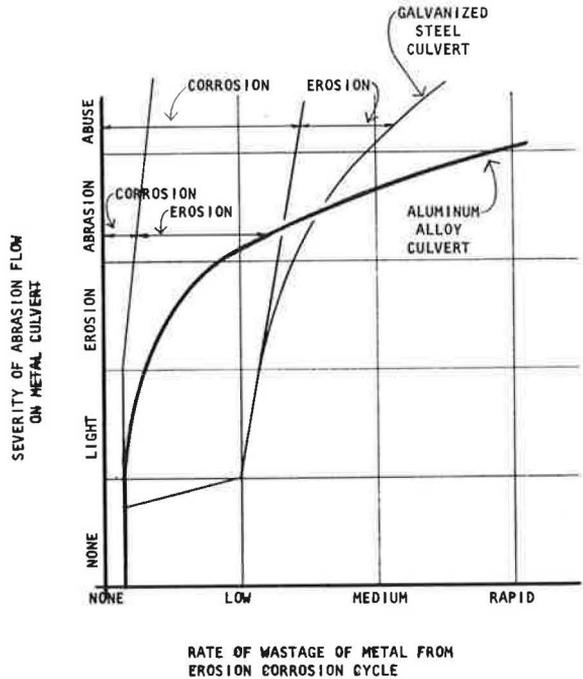
Figure 1. Cumulative curve of erosion-corrosion.

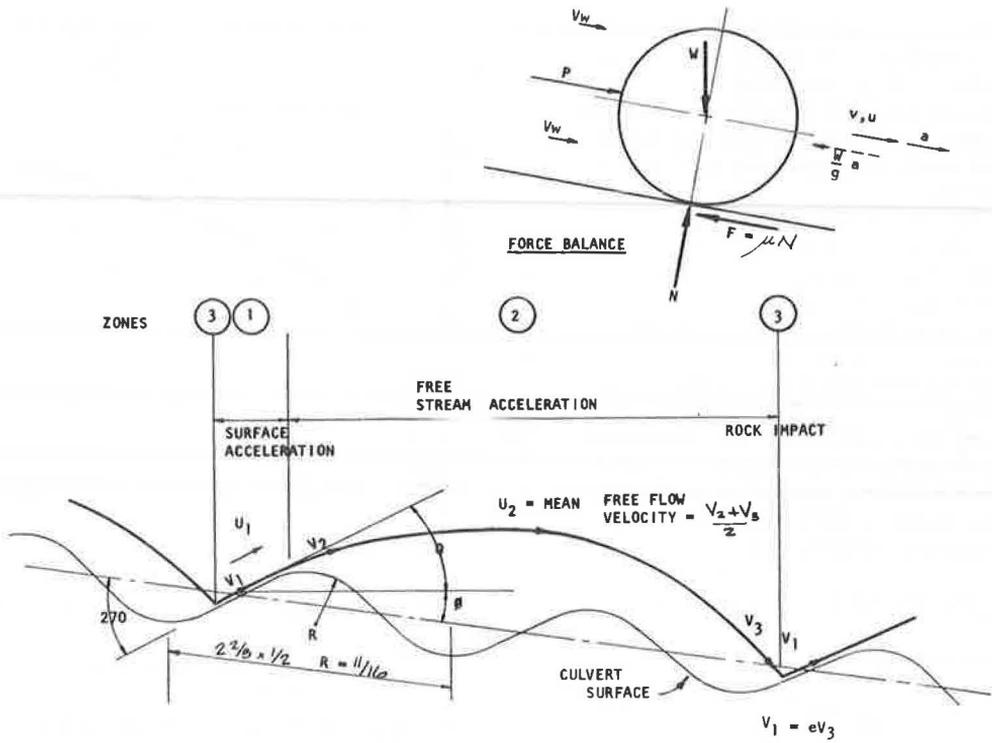
Figure 2. Rock cycle path.

This solution requires analysis of the rock flow cycle (Fig. 2). A series of rock flow tests were run in culverts. From these tests calculation curves of both the velocity impact factor $(1 - e)$ and the energy impact factors $(1 - e)^2$ were prepared as shown in Figure 4.

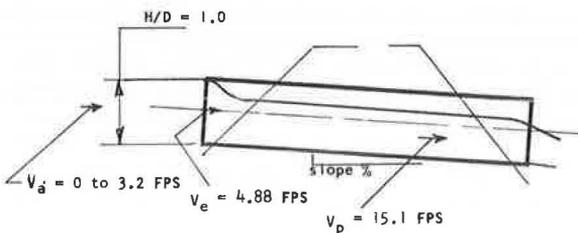
3A Conditions at Submerged Entrance, Typical $Q_{10} = 47$ CFS

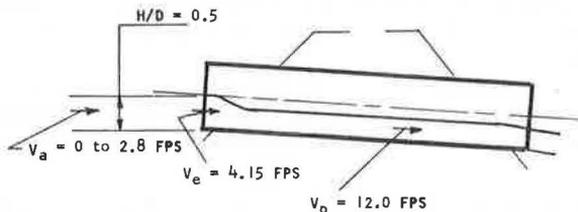
3B Conditions at Half Submerged Entrance, Typical $Q = 20$ CFS

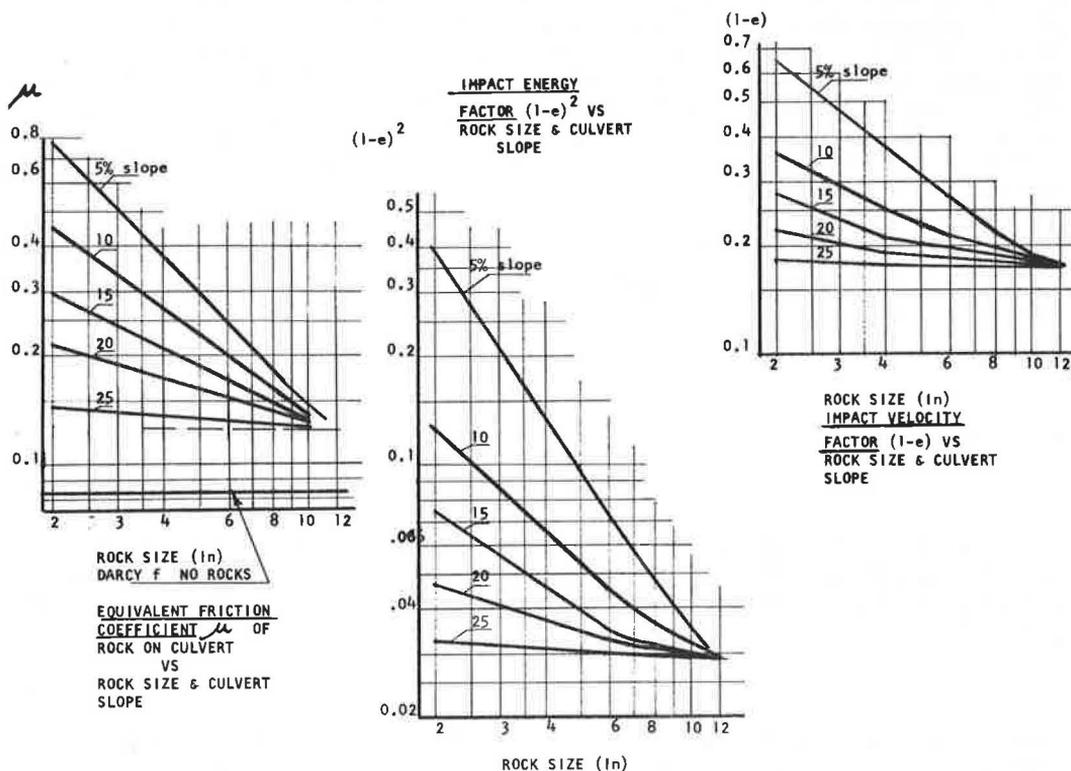
Figure 4. Curves of friction and energy factors—aluminum alloy culvert.

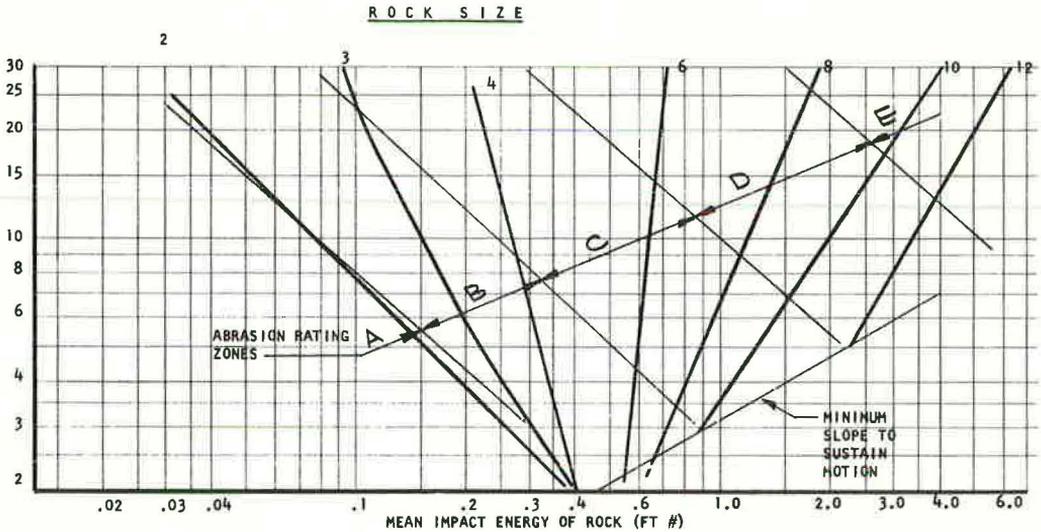
Figure 5. Typical mean impact energy curves for 48-in. culvert.

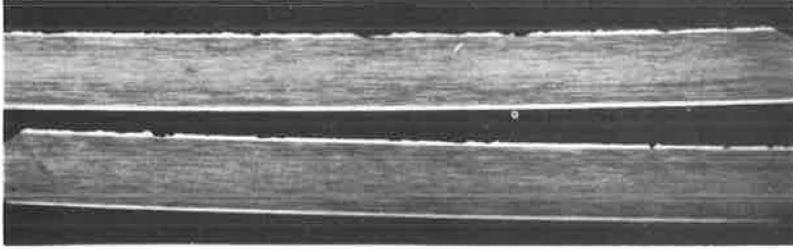
67-330

ABRASION RATING A/B

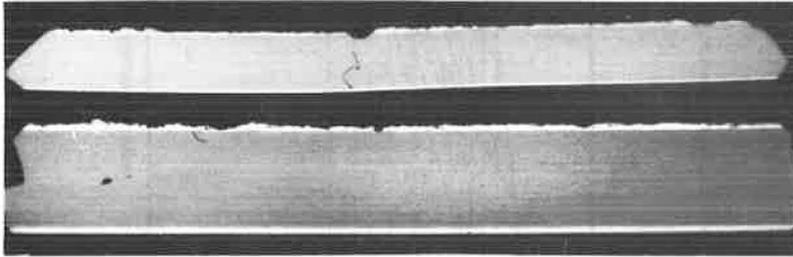
67-354

ABRASION RATING B

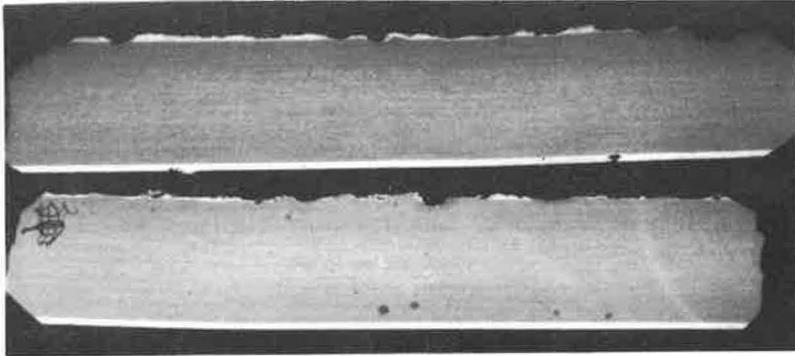
ABRASION RATING C

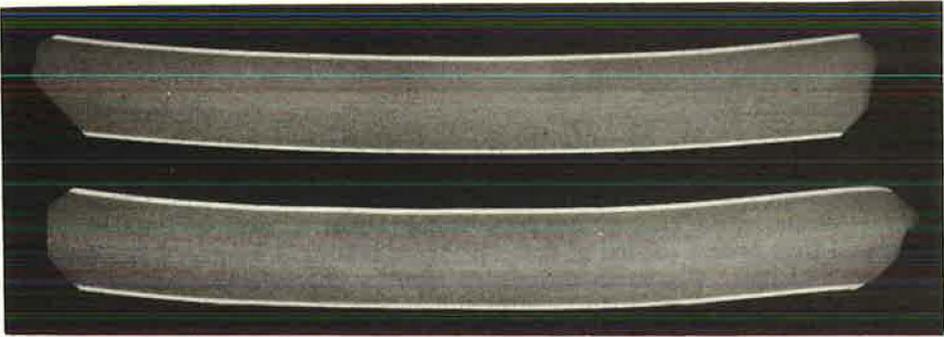
Rating A—No corrosion (Note: Cladding each side 5 percent of thickness).

Figure 2. 5x sections showing examples of corrosion ratings.

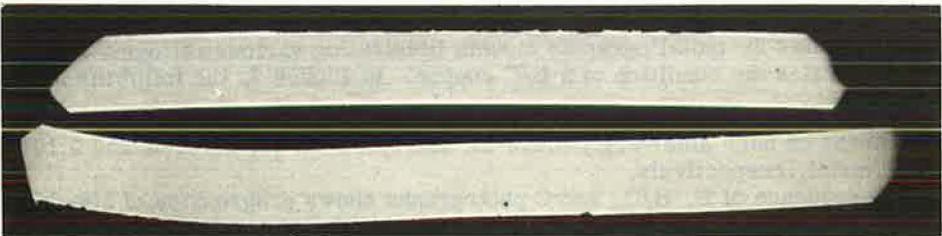
Rating B/C—5 to 50 percent of surface attacked on worst square foot (Note: Corrosion is only half depth on cladding).

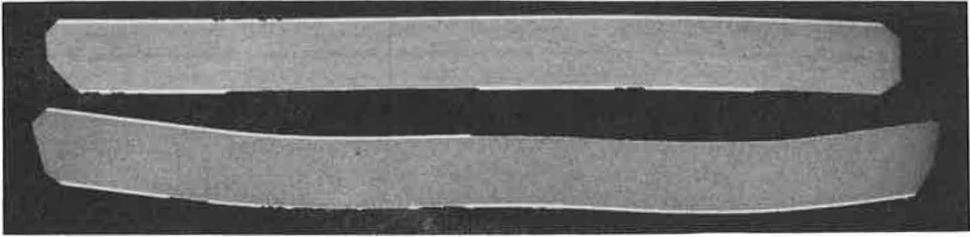
Rating C—Over 50 percent of surface corroded on worst square foot
(Note: Corrosion confined to cladding).

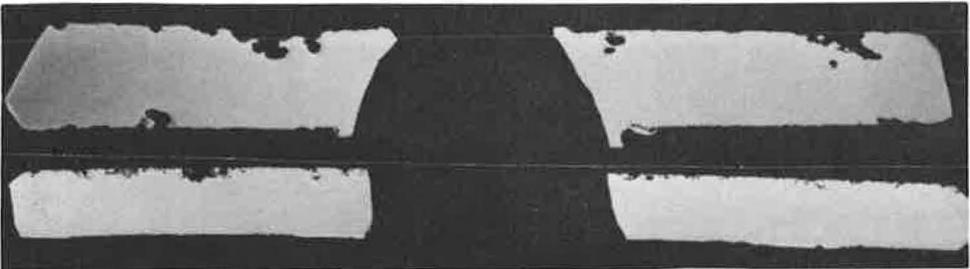
Rating D—Attack of core.
