HIGHWAY RESEARCH RECORD

Number 262

Pipes
and
Culverts

REBUILT WOLF CREEK CULVERT BEHAVIOR	
Alfred C. Scheer and Gerald A. Willett, Jr.	1
Discussion: M. G. Spangler.	10
PERFORMANCE OF A REINFORCED CONCRETE PIPE CULVERT UNDER ROCK EMBANKMENT	
Robert C. Deen	14
Discussion: M. G. Spangler.	27
CULVERT DESIGN IN SOME EUROPEAN COUNTRIES	
Gabor M. Karadi and Raymond J. Krizek	29
THE MECHANISMS OF ABRASION OF ALUMINUM ALLOY CULVERT, RELATED FIELD EXPERIENCES, AND A METHOD TO PREDICT CULVERT PERFORMANCE	
Almont H. Koepf.	44
CORROSION EVALUATION OF ALUMINUM CULVERT BASED ON FIELD PERFORMANCE	
T. A. Lowe, R. H. Vaterlaus, R. I. Lindberg and L. R. Lawrence	56

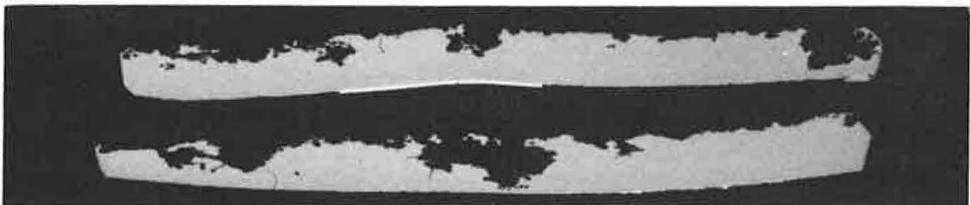
Rating E—Perforation of core.

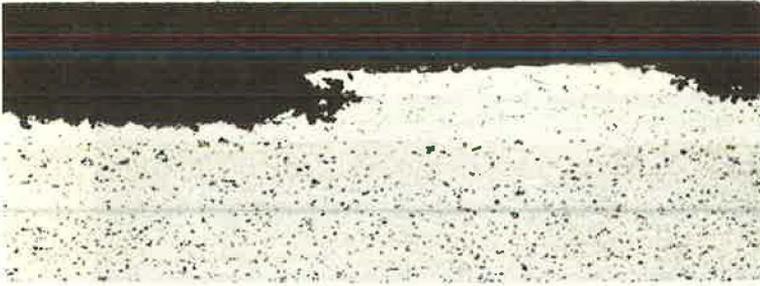
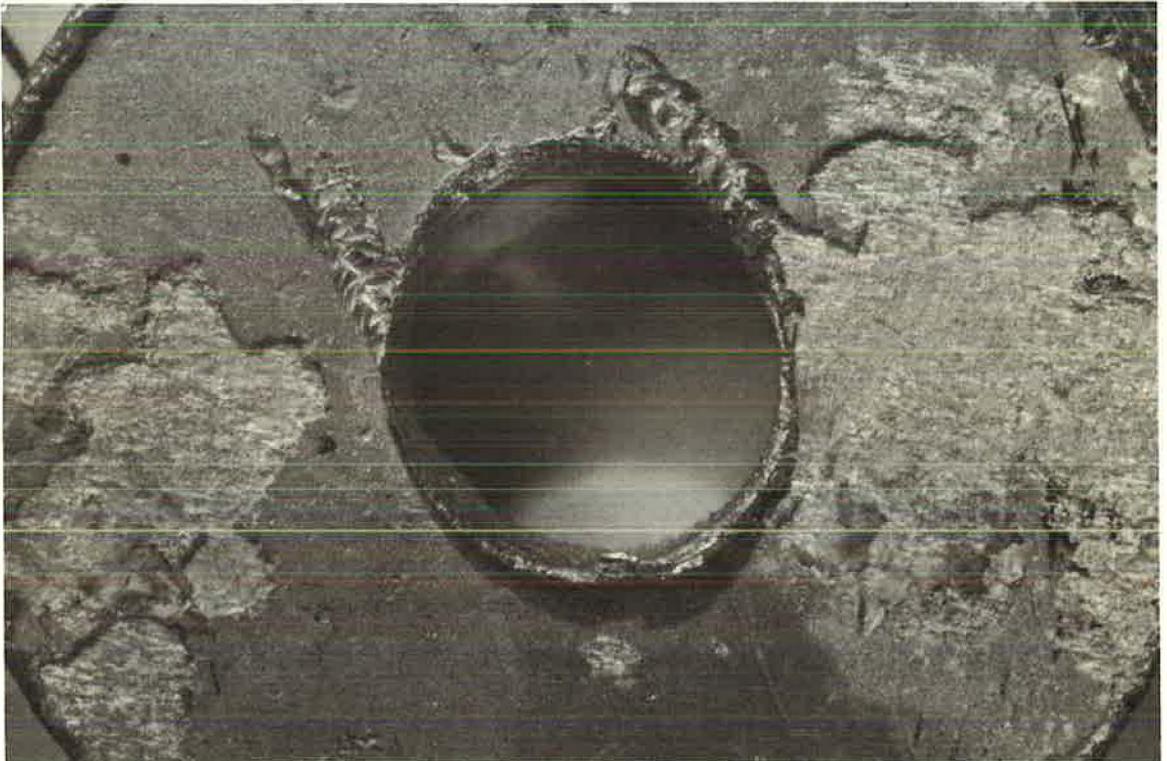
Attack limited to partial cladding thickness (100x).

Attack to full cladding thickness.

General surface appearance (5x) of a B/C-rated coupon.

Figure 3. Nature of cladding corrosion. Evaluation of coupon shows varying degrees of attack, progression of corrosion, and effectiveness of cladding.

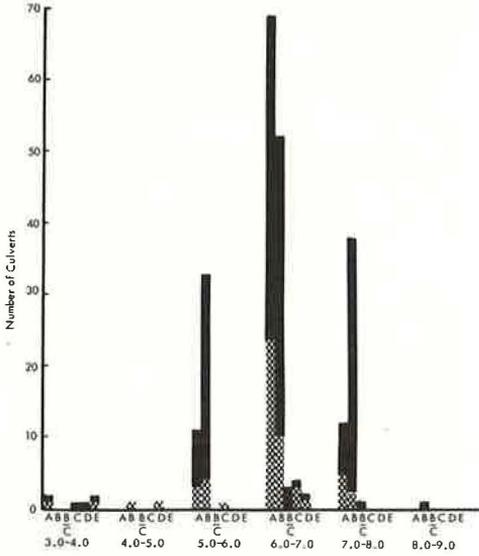
Figure 4. Culvert performance rating as influenced by water pH (cross-hatched bar represents culverts 6 years old and older).

Figures 4 through 7 show the number of culverts in each rating as a function of water pH, water resistivity, soil pH, and minimum soil resistivity. Each bar chart

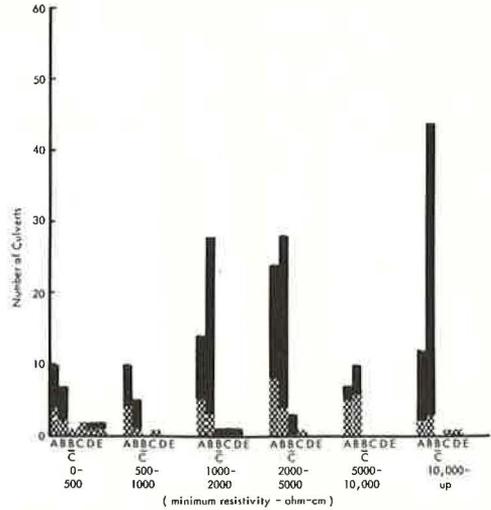
Figure 5. Culvert performance rating as influenced by water resistivity (cross-hatched bar represents culverts 6 years old and older).

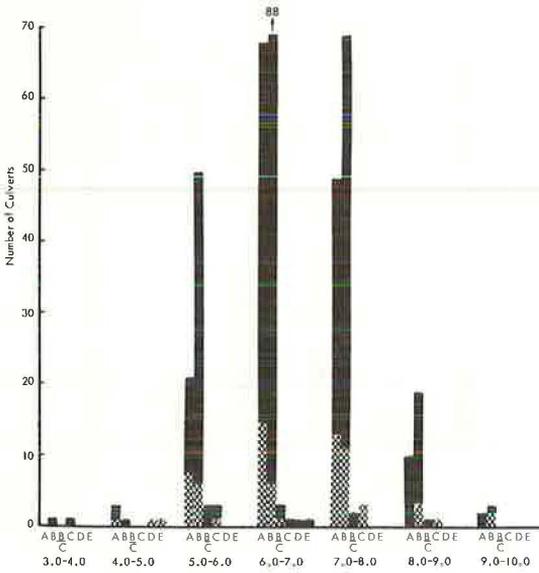
Figure 6. Culvert performance rating as influenced by soil pH (cross-hatched bar represents culverts 6 years old and older).

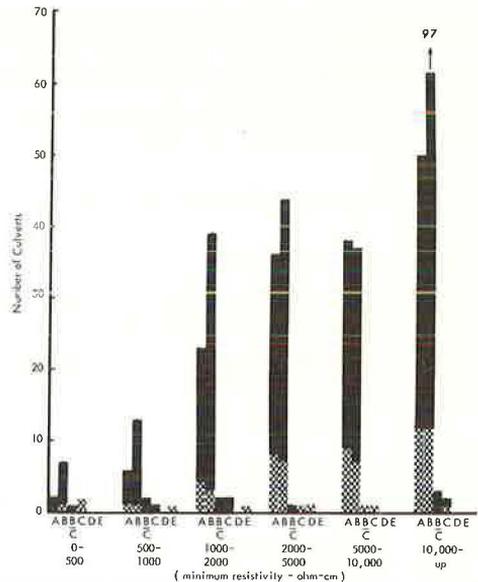
Figure 7. Culvert performance rating as influenced by soil minimum resistivity (cross-hatched bar represents culverts 6 years old and older).

The influence of minimum soil resistivity is shown in Figure 7. Those sites characterized by highly acid runoff or by chloride-contaminated heavy soils (Table 5) caused lower ratings
