Geologic Setting of Landslides Along South Slope of Pine Mountain, Kentucky

ALBERT J. FROELICH, U.S. Geological Survey, Middlesboro, Kentucky

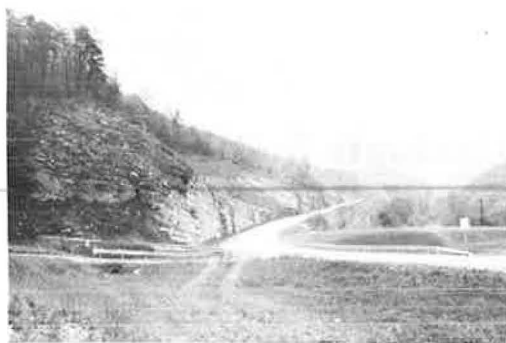
Figure 2. Generalized lithology of strata exposed along south slope of Pine Mountain in Wallins Creek quadrangle.

Bedrock along the south slope of Pine Mountain includes part of the Breathitt Group and Lee Formation, both of Carboniferous age (Fig. 2). The upper part of the Lee Formation and the basal sandstone of the Breathitt Group (Fig. 3) consist largely of resistance hogback-forming sandstone beds that are not disrupted by landslides. The overlying strata are largely an incompetent sequence of interbedded siltstone, impure sandstone, carbonaceous clay shale, and coal with underclay. Several hundred feet of these beds underlie the foot-hills south of Pine Mountain. Ancient and all recent landslides north of the Cumberland River have occurred in these strata.

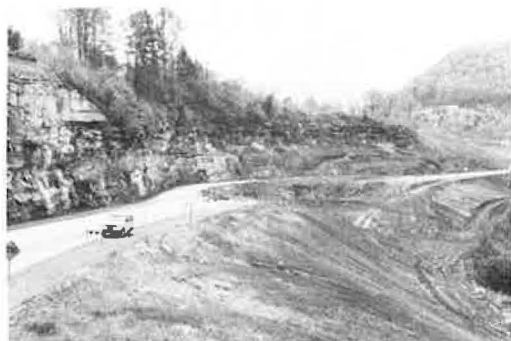
Figure 5. Cross sections showing relation of landslides to geology and position of Cumberland River.

Relations among geology, topography, and landslides are shown by three cross sections. The Church slide, northeast of Tremont, is shown in cross section A-A' (Fig. 5); it is wholly within bedrock of the lower part of the Breathitt. The Church slide is on the west flank of a local transverse flexure that is cut by a small fault. Although the strata dip less than 10 degrees toward the Cumberland River, they are unstable even at that low angle. During road construction in 1968, a 50-ft thick plate of sandstone and siltstone about 800 ft wide by 500 ft long failed and slid

The third example, cross section C-C' (Fig. 5), is west of Coldiron where for 2 miles no lower Breathitt is present north of the river. The lower Breathitt rocks long

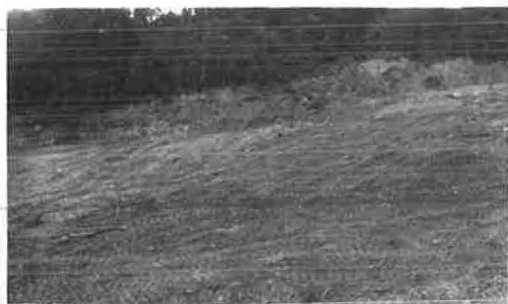
Figure 6. Strata in lower, unstable part of Breathitt Group at Church slide. Roadbed taken out by 1969 slide, rebuilt on strata that continue intermittent down-dip movement toward observer.

along a floor of coal and underclay. The unstable bedrock upslope from the slide was removed by the contractors. Nevertheless, several hundred feet of highway reconstructed across the slide slipped into the river in 1969 (Fig. 6).

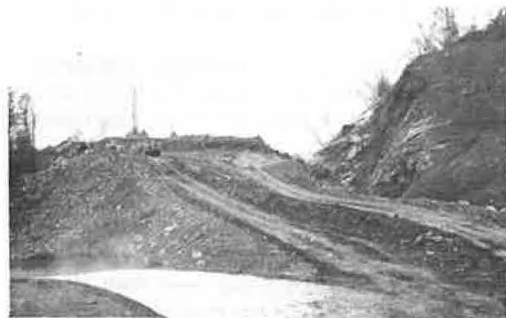
Figure 8. Offset boreholes in shale and siltstone intersected by road cut. Sliding of plates along bedding planes is toward observer in direction of dip of strata with lower plate having moved relatively more than upper.

Where the lower part of the Breathitt remains north of the river, much of it is slowly moving down dip, even in areas not mapped as landslides. Drill holes made just prior to recent road cut excavation are offset (Fig. 8), indicating movement along slippage or glide planes that are parallel or subparallel to bedding planes. Thick beds of sandstone have slid down dip slopes on coal beds or shale (Fig. 9) into recent road cuts. Slides are aided by joints (Fig. 10) that have broken the bedrock into discrete units, which may move coherently.

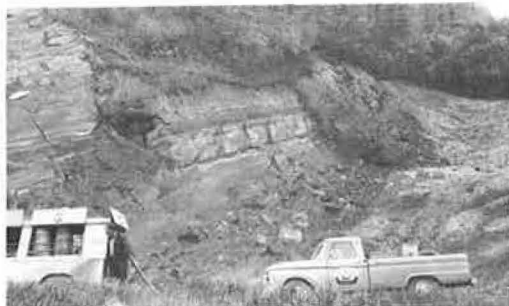
Figure 9. Southwestward view of deep roadcut west of Wallins Creek quadrangle where sandstone, shale, and siltstone in lower part of Breathitt Group slid down a dip slope into the excavation.
